December 8, 2023  
223384

**Re: 1050-1058 PANDORA AVENUE HERITAGE BUILDING  
TAX INCENTIVE PROGRAM THIRD-PARTY STRUCTURAL ASSESSMENT**

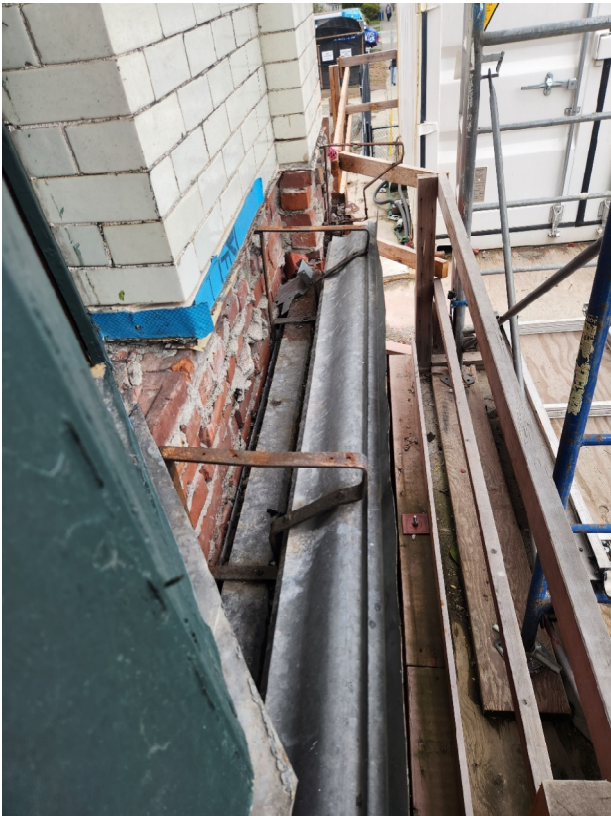
Figure 5 – Second Storey Cornice along Cook

The second storey floor framing consists of a solid 2x8 wood floor stacked vertically, which in turn are supported by heavy timber beams and posts below. The roof framing consists of 1" tongue-and-groove planking supported by a double 2x joist system, with the upper set of joists sloped to suit and supported by regular pony stud walls which in turn are supported by the second set of joists which also serve to support the interior ceiling. The roof joist system is supported by 2x stud walls, which land on the solid 2x8 floor system below.

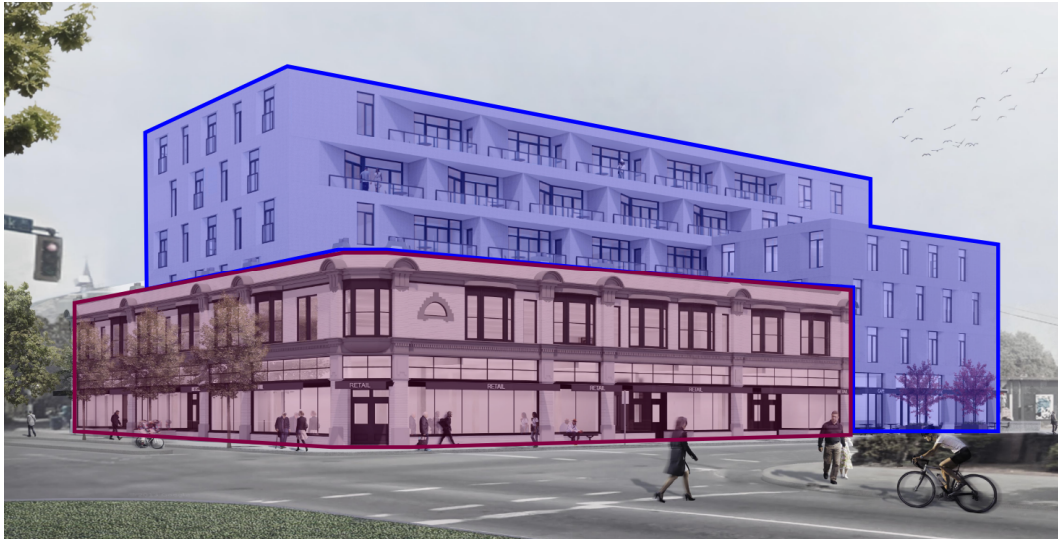
**Figure 9 – Rendering of New Parkway Development**

For reference, the new development consists of one level of below-grade parking level with an at-grade suspended slab and second storey concrete transfer slab that supports an additional four storeys of woodframing above. A portion of second storey of the heritage structure is being cut back to accommodate the new structure, with the existing 2x8 floor system being connected to the new concrete slab. The new woodframing above the second storey is being laterally supported by plywood-sheathed stud shearwalls, and the lower concrete structure is being supported by reinforcing concrete shearwalls and foundations.

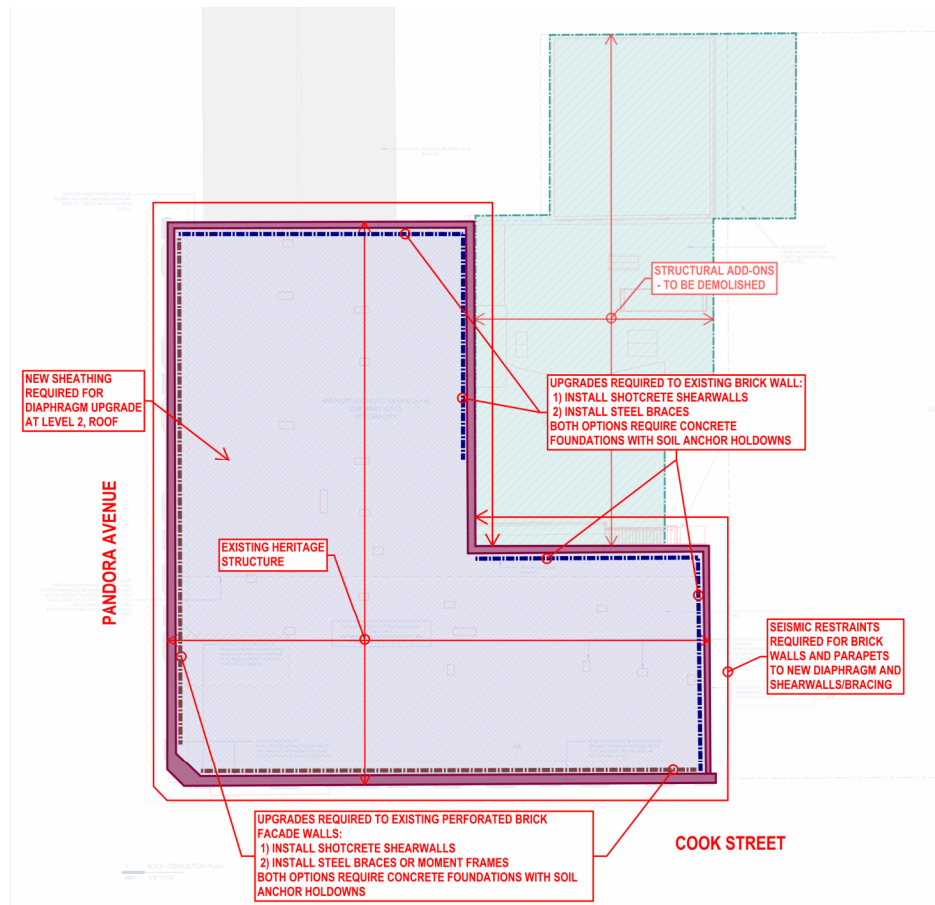
Figure 10 – Original Heritage Structure Layout

The original structure built at 1050-1058 Pandora Avenue consists of an “L” shape with the long legs along Cook Street and Pandora. There have also been extensions built and attached at the north-west portion of the structure which are not being considered as part of the heritage retention.

It is possible for the existing heritage structure to be retained but to do so would require extensive retrofit. Given the seismic design requirements mentioned previously and the inadequacy of the existing structure, new seismic resisting elements are required to support the structure; possible options include concrete shotcrete shearwalls and steel braces or moment frames. All of these lateral force resisting systems will require extensive new concrete foundations, likely complete with soil anchors drilled to provide overturning resistance. The existing diaphragms require upgrade, likely with a combination of new plywood sheathing and steel straps or alternatively a reinforced concrete topping, to drag seismic loading back to the new shearwalls/braces. Additional to this, back-up framing would be required to support the exterior walls to tie the existing framing back to the new diaphragms.

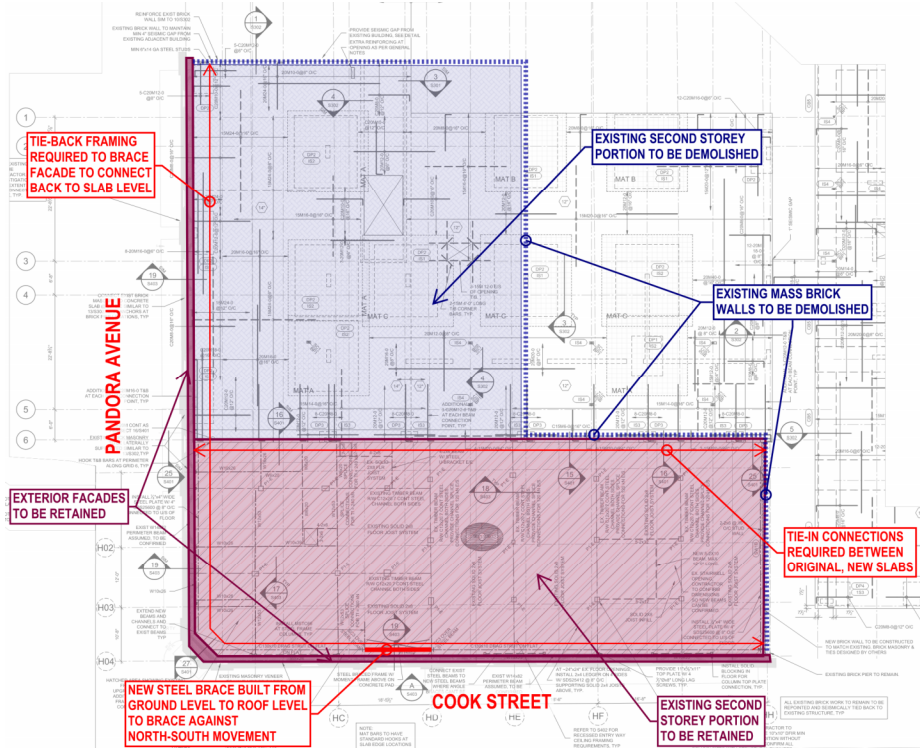
Figure 11 – Second Storey Heritage Retention Plan (As Proposed by Developer)

The new development has retained the following heritage items:

- Cook Street and Pandora Avenue façade framing, including parapets and cornices
- Roughly 50% of second storey framing, including solid 2x8 vertically stacked slab and heavy timber dropped beams and posts

The following items have been demolished:

- Remaining north and west mass brick walls
- Roof slab framing and supporting stud walls at second storey
- Remaining 50% of second storey framing
- Ground level foundations including concrete spread footings and slab-on-grade

Roughly half of the existing second storey slab framing will be retained as part of the new proposed development. While the existing 2x8 slab and dropped timber framing (with new steel beam reinforcing) is adequate to support gravity loading, there is insufficient diaphragm capacity to distribute the seismic loads from both the slab and façade weights to new vertical steel braces or

concrete shearwalls; new supplemental plywood sheathing will be nailed to the top of the existing slab.

The existing slab portion to be retained will be connected to a new concrete slab to the west. Additionally, a steel brace frame is being constructed to brace the east side of the slab portion just behind the brick façade along Cook Street to brace both the second storey and new roof framing against north-south seismic loading. All of the seismic loading from the façade and remaining second storey framing will be resisted by the new steel frame along Cook Street as well as the concrete shearwalls to the west supporting the new second storey concrete slab.
