# SCOTT BUILDING

2659 DOUGLAS STREET, VICTORIA, BC

## CONSERVATION PLAN

AUGUST 2019

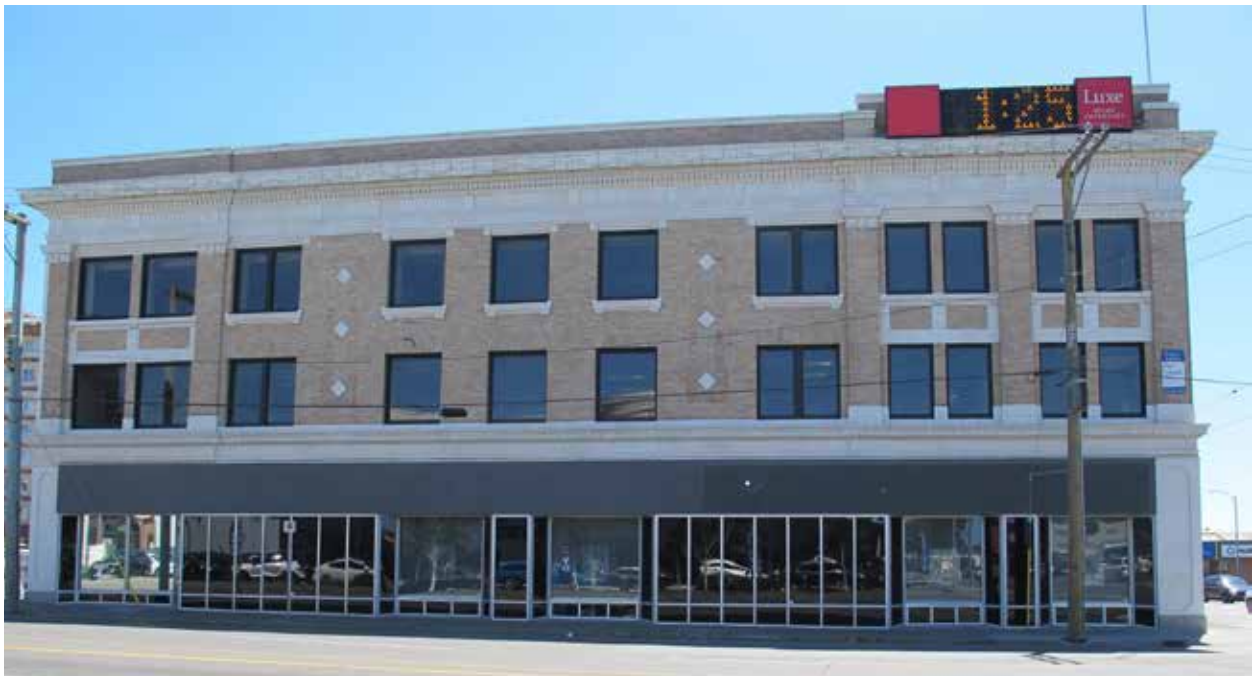
Overall, the brick cladding is in good condition with general weathering present and localized areas of deterioration. There are multiple areas where organic buildup has occurred, particularly the parapet around the later added digital clock and the “Scott Building” sign. There is also staining and organics below the parapet cornice and at

**Above:** Buff brick laid in running bond with light coloured mortar. Brick is present on the second and third floors, and parapet of primary façades.

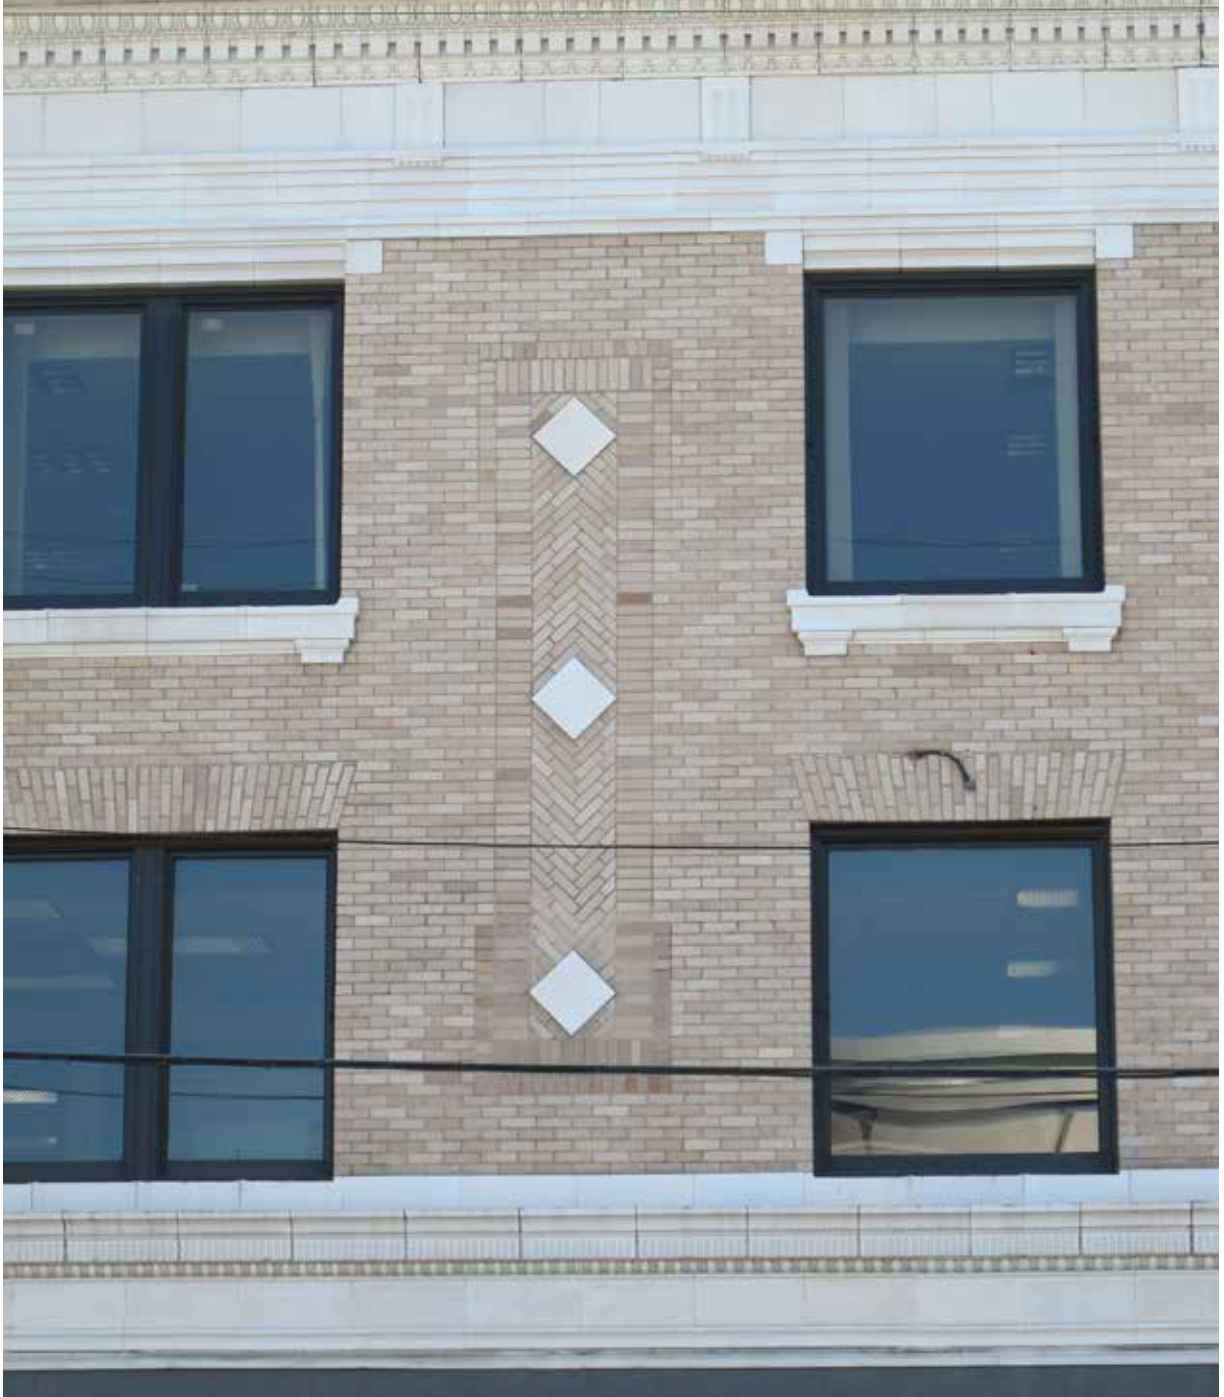
**Above:** Buff brick laid in running bond with light coloured mortar. Brick is present on the second and third floors and parapet of primary façades. Jack arch brick lintels on primary façades. Redundant fixtures, anchors, and conduit should be removed and brick and mortar repaired. Eight panels (two on north façades and six of west façade) of patterned brick with terra cotta diamond elements.

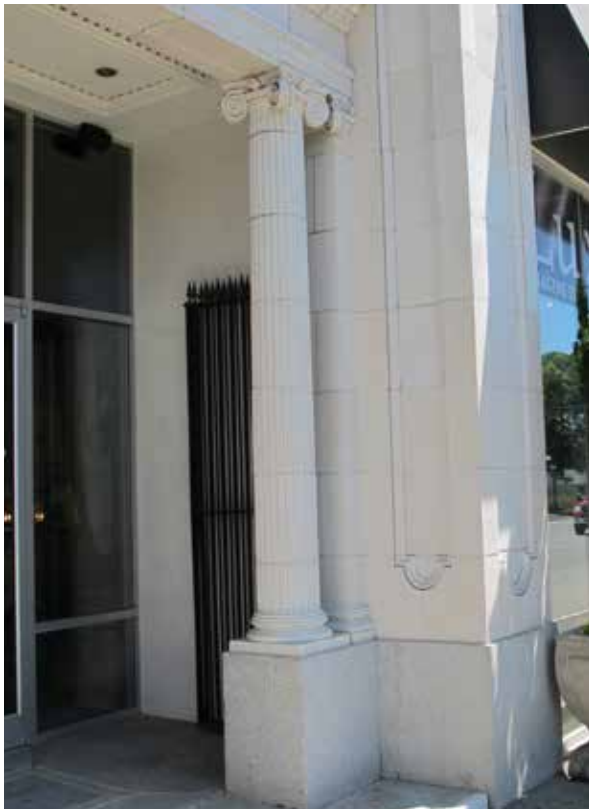
**Above:** Engaged square column with volute capital and Ionic column with volute capital on grey granite base present on both sides of Douglas Street entry. Metal security gates are a later intervention

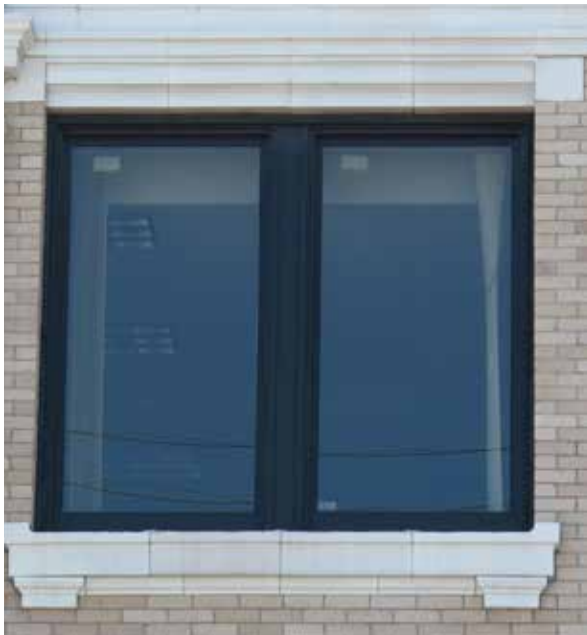
**Left:** Double assembly window with sashes replaced and wood frames, mullion, and brick mould intact. Intact window elements to be preserved and existing fixed single light window sashes replaced with 1-over-1 hung wood windows.

of 1-over-1 configuration should be installed in second and third floor windows on the north, south, and west façades. New wood sashes are to be solid Douglas Fir and through mortise and tendon construction with double glazing. Existing wood frames are to be preserved and milled to suit new sashes, if possible. The ground floor fenestration of the rear façade have been heavily altered. Archival drawings and photographs can be used as a guide for the replacement window sashes.
