Heritage Alteration Permit Application for 700 Government Street (Lower Causeway)

Location | Lower Causeway

**Proposal | Repair and replace existing paving material along apron**

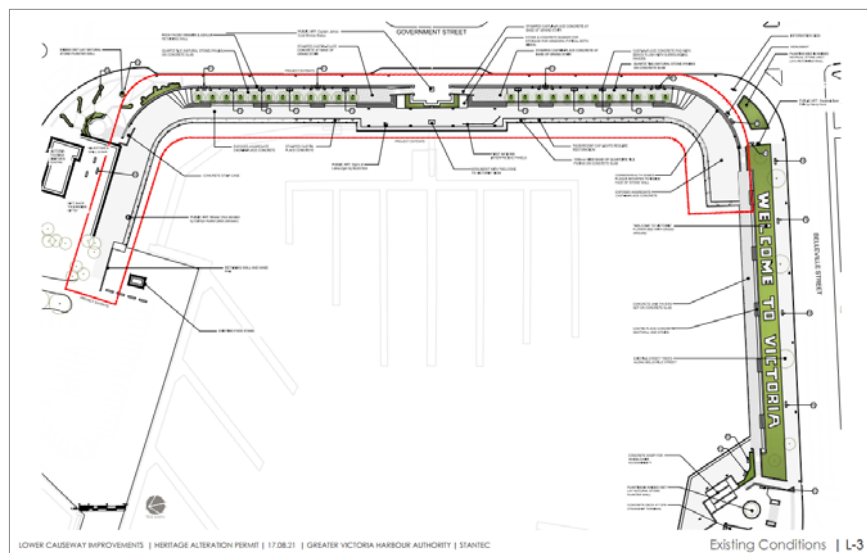
Plan | Existing conditions of the Lower Causeway

Existing Conditions | Lower level edge paving and lights

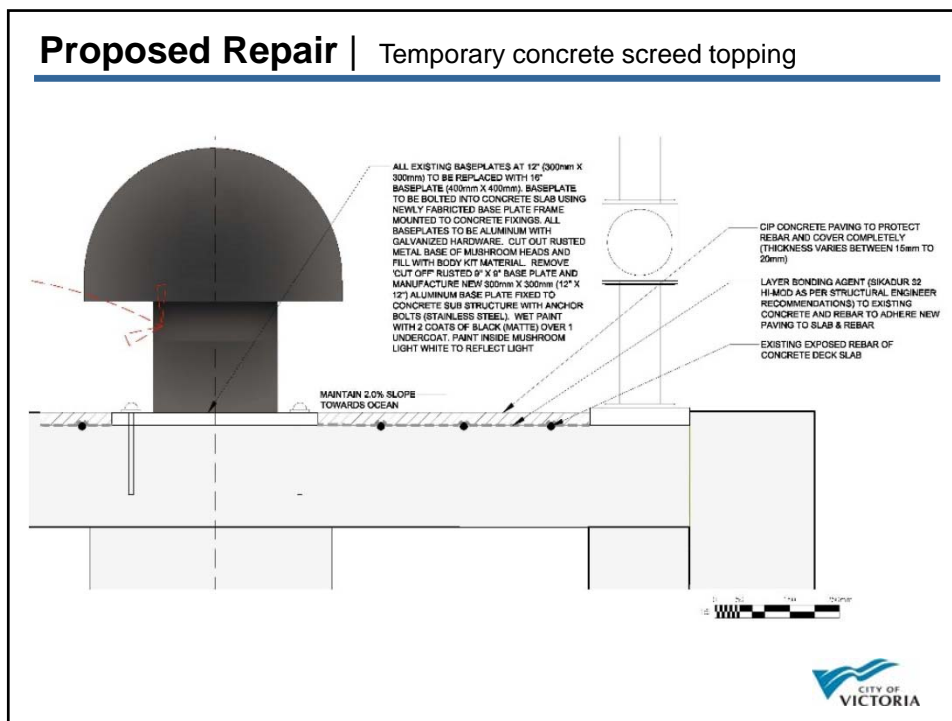
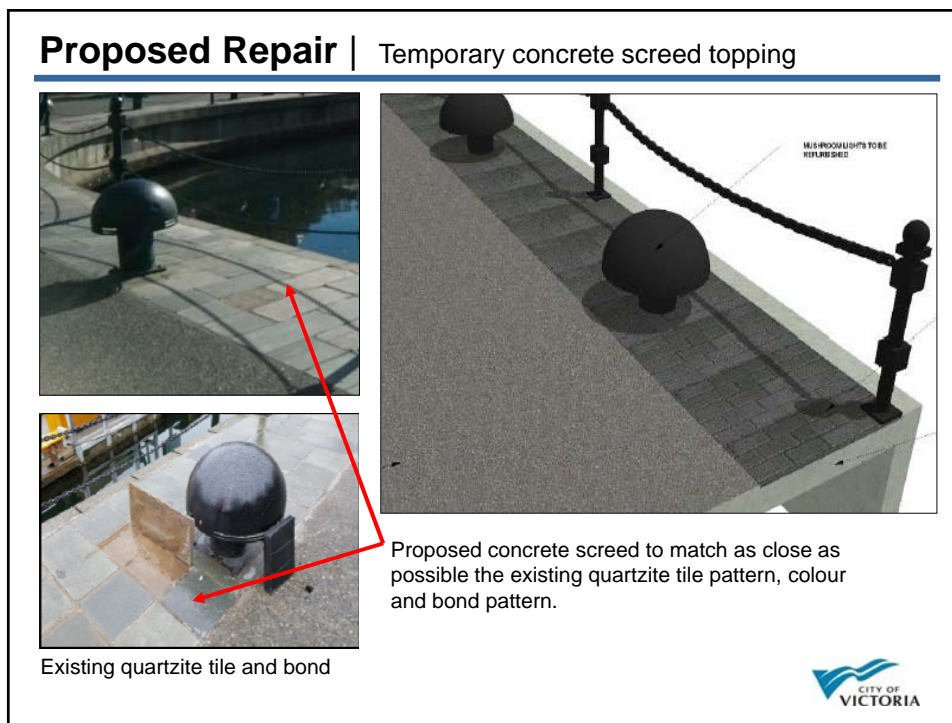
Engineer Summary | Paving and light bases

The issues with the pavers at the lower causeway are most likely attributed to the original construction detail that was used in 1973. The 1" slab depression does not allow for installation of a 3/4" paver, which would fare better in this high traffic area than the 1/2" pavers that have been used. The top reinforcing in the concrete slab does not have adequate protection from chlorides and freeze thaw, and may be contributing to these tiles becoming un-bonded.

It is recommended that these pavers are removed and replaced with a concrete screed topping. A bonding agent such as Sikadur 32 Hi-Mod can be used to protect the existing reinforcing and to ensure a proper bond between the existing concrete and the new topping.

As part of this replacement the "mushroom" light bases can be replaced with aluminum bases, as per details previously used by GVHA. Crack control details can be utilized at each side of the existing "mushroom" lights, to reduce concrete cracking.
