Planning and Land Use Committee Report

Subject: **Development Permit Application #000347 for 845 Yates Street**
Application to remove existing tile on the east elevation and apply a painted mural.

RDH Building Engineering Limited was retained by Strata Plan VIS 6115 to review the condition of the tile and adhered thin stone applied to the east exterior concrete wall of the building known as the Wave, located at 845 Yates Street, Victoria, BC (refer to RDH proposal dated November 30, 2011).

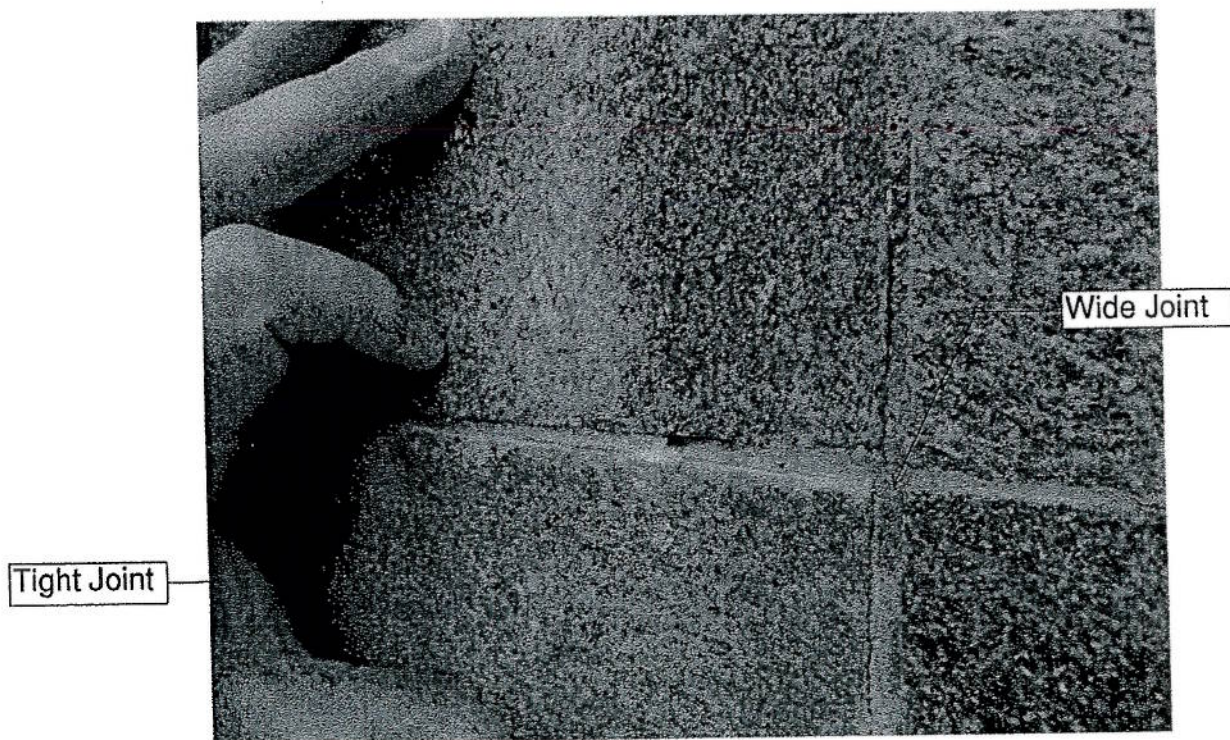
Photo 4

- Joints between stones also varied from tight to approximately 5 mm (Photo 4,5)
- Surface irregularity of stone resulted in offsets and ledges at most joints (Photo 6).

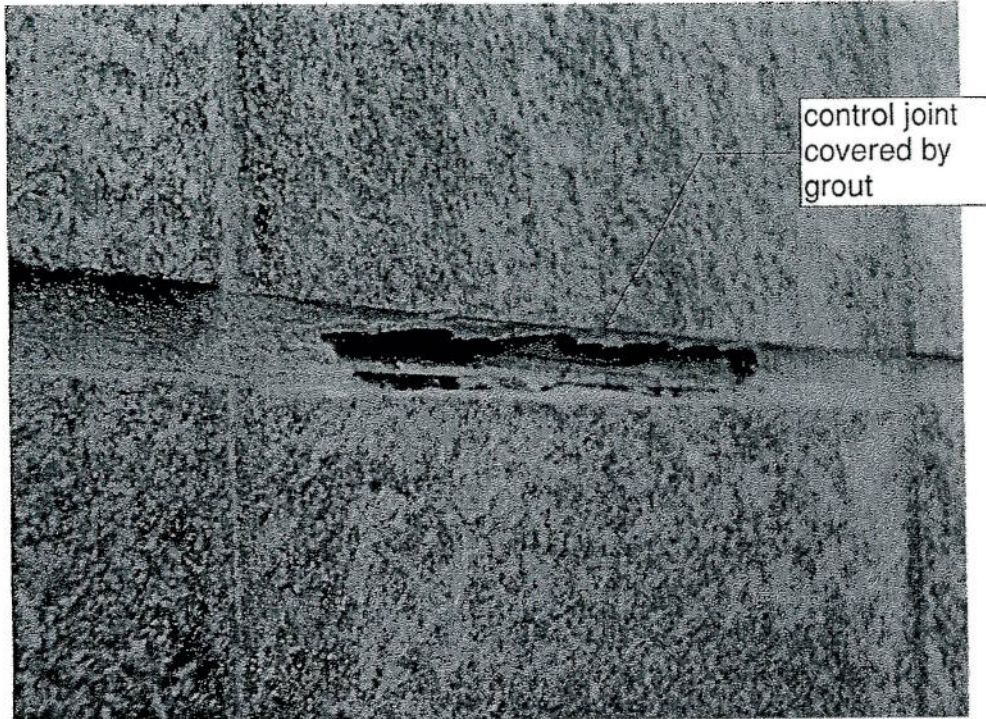
Photo 11

- Removal of "hollow" sounding stone units revealed poor adhesion (Photo 9).
- One removed stone had been scored with a saw (Photo 9).
- A metal control joint was covered with grout (Photo 10 & 11)

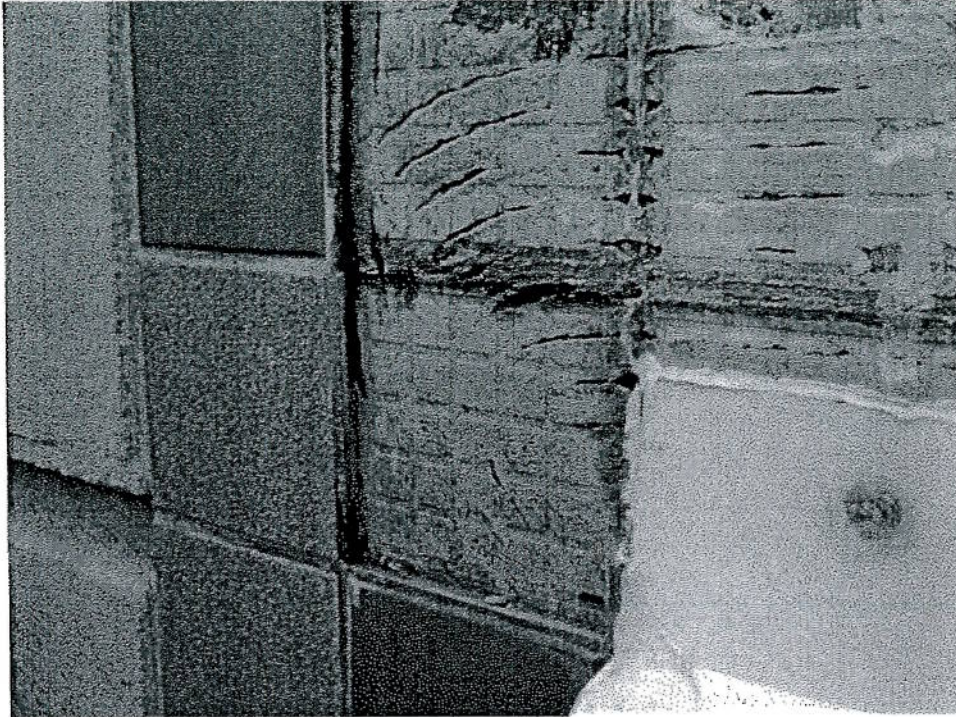
Photo 21

- White staining was observed on the surface of the tiles. The stains originate from joints between tiles (Photo 14 & 18).
- Removal of "hollow" sounding tiles confirmed poor adhesion (Photo 19 & 20).
- The mortar at locations of tile removal appear compressed and in contact with the back of the tiles (Photo 21).
- Tile and concrete interfaces were not sealed to prevent water entry (Photo 22 & 23).
- Removed tiles revealed poor mortar adhesion (Photo 24).
