The City of Victoria
Facility Condition Assessment and Capital Plan
Fernwood Community Association, 1921-1923 Fernwood Rd., Victoria

PROPERTY DESCRIPTION

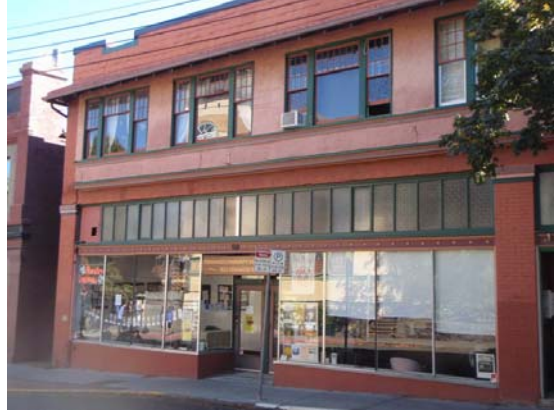
Photo 01

2	A10 Foundations	Replace	01	Where reviewed the foundations, footings and walls, were cast in place concrete. The foundation wall extends above grade at all elevations. No evidence of major settlement or heaving was reported or observed. The age of the original foundation is not know. The age of the west addition is approximately 1914.	Fair	1914	102	100	25	The foundations are expected to last the life of the building. No major capital expenditures are expected to be required.	Repair Allowance	3 - Future Renewal	Yes	No	Yes	No																				
	3	A1030 Slab on Grade	Repair	01	The floor is concrete slab-on-grade. We noted normal, isolated, narrow cracking. No evidence of major settlement or heaving was reported or observed.	Fair	1914	102	5	5	Budget for repairs at isolated locations on a periodic basis. City staff confirmed that this work would be completed through the facility maintenance program. Costs associated with this work have not been included in the cash flow tables.	Repair Allowance	3 - Future Renewal	Yes	N/A	Yes	No

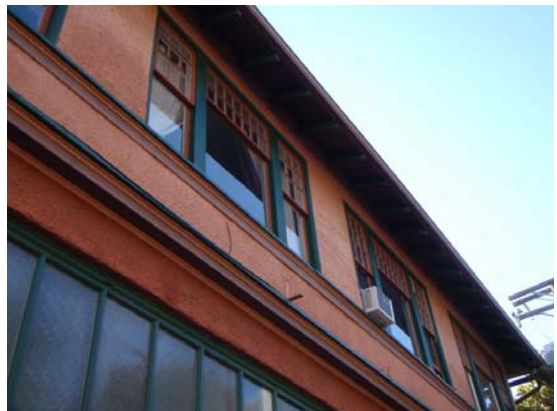
Photo 05

8	ENVELOPE																																			
	9	B2010 Exterior Walls - Brick	Throughout - Replacement	05	The walls are brick at the exterior and gypsum board over wood framing. The brick veneer walls are supported by the foundation walls, no provision for drainage is present. Facility staff confirmed repointing work was undertaken in 2010. Isolated areas of deterioration of mortar joints were noted on the South elevation.	Fair	1909	107	20	7	The masonry walls are expected to last the life of the building. A contingency has been included for localized brick replacement and mortar joint repointing.	Repair Allowance	3 - Future Renewal	Yes	No	Yes	No			2310	\$7	SF	\$15,015	10%	15%	15%		\$22,000						\$22,000			
	10	B2010 Exterior Walls - Stucco	West Elevation - Replacement	06	Stucco is used on the second floor of the west elevation. Cracking and bulging of the stucco was noted on this elevation. We assume this stucco is original to the building.	Fair	1914	102	50	15	Replace face-seal stucco system with rain screen stucco system.	Replacement	3 - Future Renewal	No	Yes	Yes	Yes			440	\$35	SF	\$15,400	10%	15%	15%		\$23,000
