**City of Victoria - Crystal Pool
& Fitness Centre – Life Cycle
Upgrades Design Report**

Prepared for:
The City of Victoria

January 9, 2015

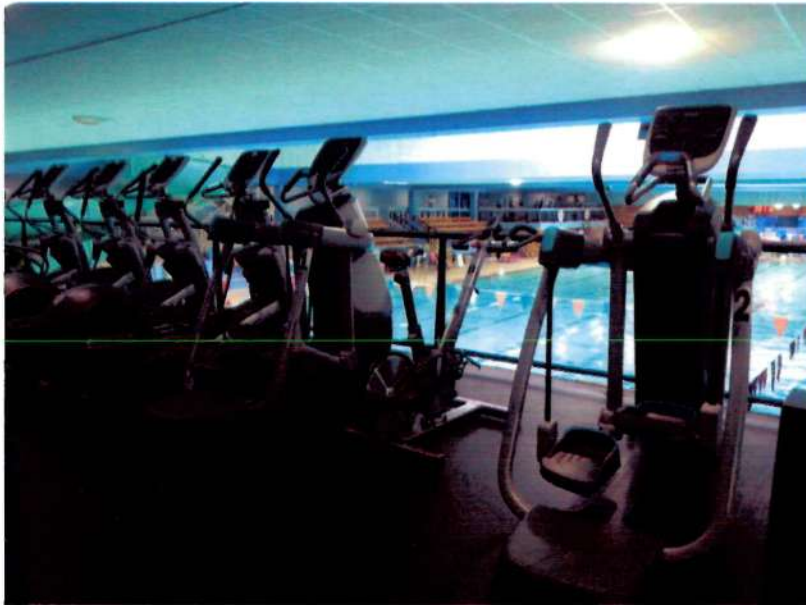
existing level 2 floor layout. The existing fitness facility is comprised of a series of exercise equipment that ring the pool at the level 2 mezzanine. The machines and occupants share the same environment as the pool, unsuitable for the durability of machinery and comfort of users. The intent of the new facility will be to congregate the fitness program functions in one general area, and to environmentally partition that function from the remainder of the building.

Figure 14: Existing work-out equipment open to pool environment

A level 2 building addition will be provided to the south of the existing building that will include male and female change-rooms, enclosed fitness and storage rooms, and an open weight training room. The addition will be seismically separated from the remainder of the building in order to meet the current requirements of the British Columbia Building Code. The addition will employ a new brick façade compatible with the existing facility exterior, thermally protected with rigid insulation outboard of sheathing, metal stud framing, and painted gypsum wall board interior finishing. Abundant insulated glazing within sections of aluminum curtain wall system will face the park to the south will provide substantial views and natural light to the fitness spaces. An insulated structural metal roof deck will be provided, with a new SBS roof membrane system. A new solar energy system will be located to augment the building power system. The addition will include 2 new storage rooms to support Parks, Recreation & Culture staff and programs. As well, a new corridor and exit door set will be provided to the exterior from the pool deck.
