Talbot Mackenzie & Associates

## Re: Proposed subdivision at 1322 Rockland Avenue.

**Assignment:** To review the location of the proposed new driveway off Royal Terrace (see attached site plan) and provide recommendations for mitigating any potential impacts to Garry oak number 373.

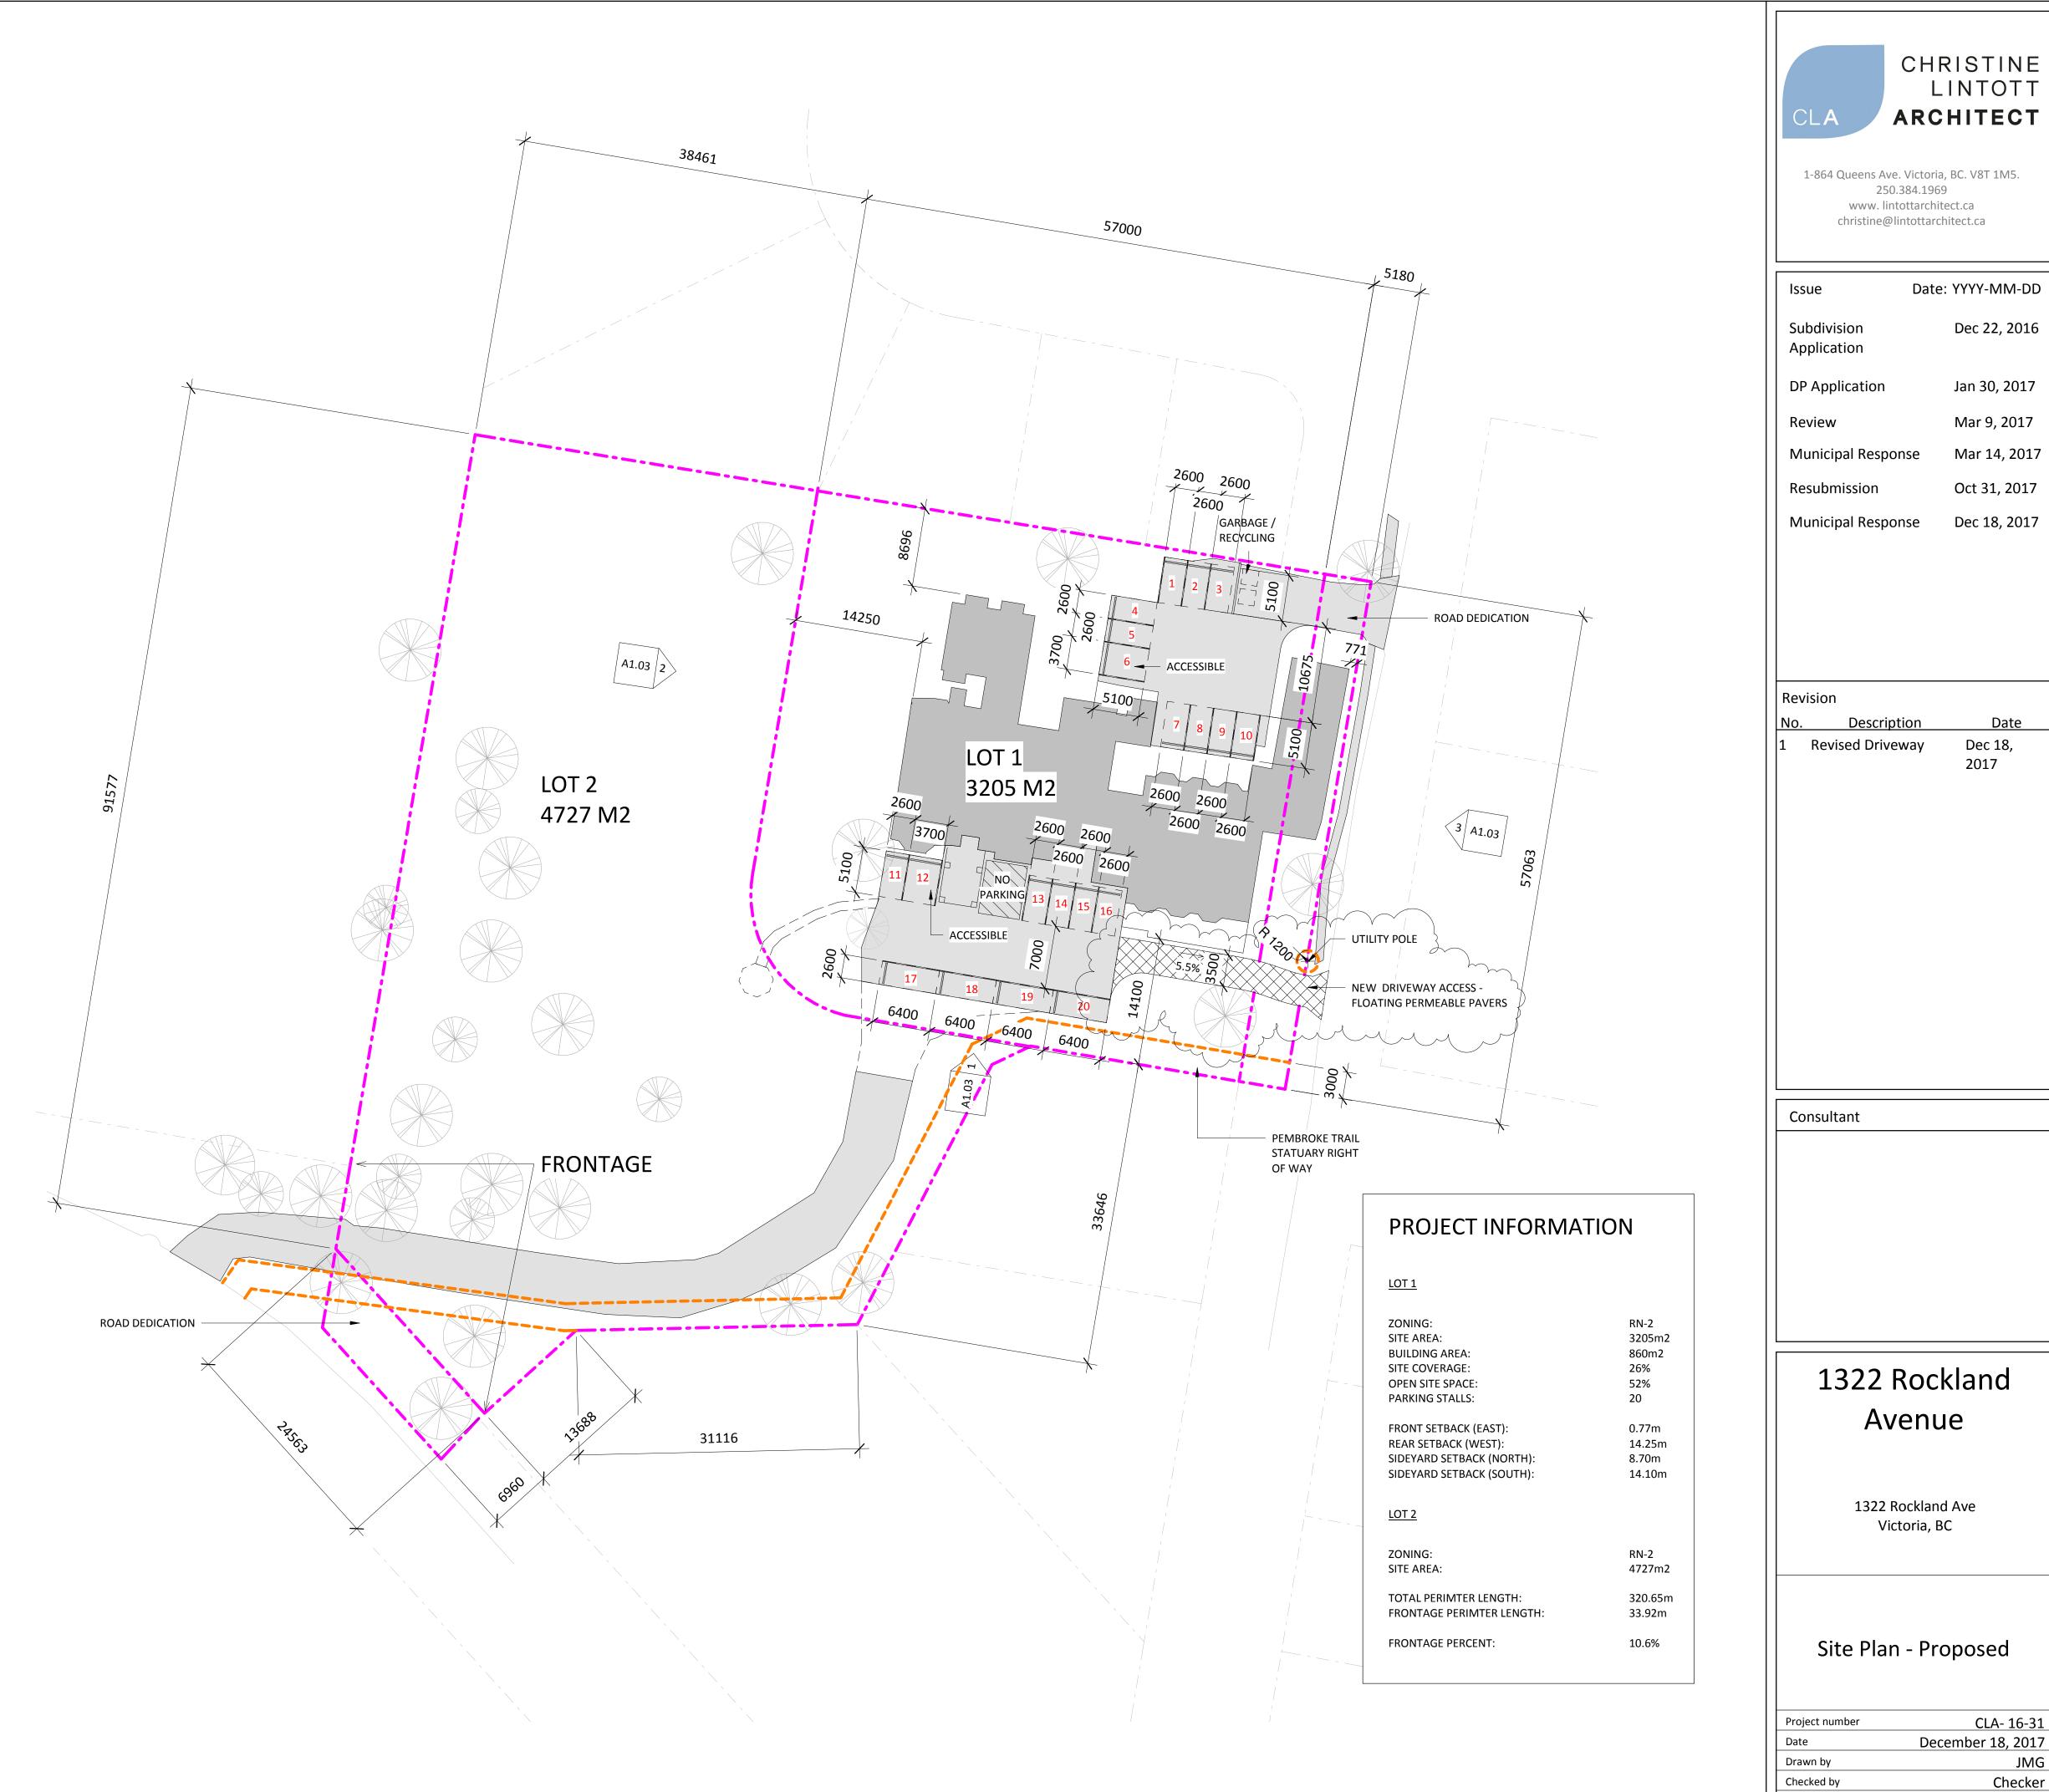
A1.03

**Observations:** The majority of the proposed driveway will be located within an area that has had a retaining wall installed, fill soil added, and a laurel hedge planted (see attached sketch 1). There will be a portion of the driveway nearest the road on municipal property that will be installed where there is no existing retaining wall.
