**HERITAGE REVITALIZATION AGREEMENT  
(251 ESQUIMALT ROAD) BYLAW**

# E & N NATIONAL HISTORIC SITE VICTORIA, BC

## 2.1 ROUNDHOUSE

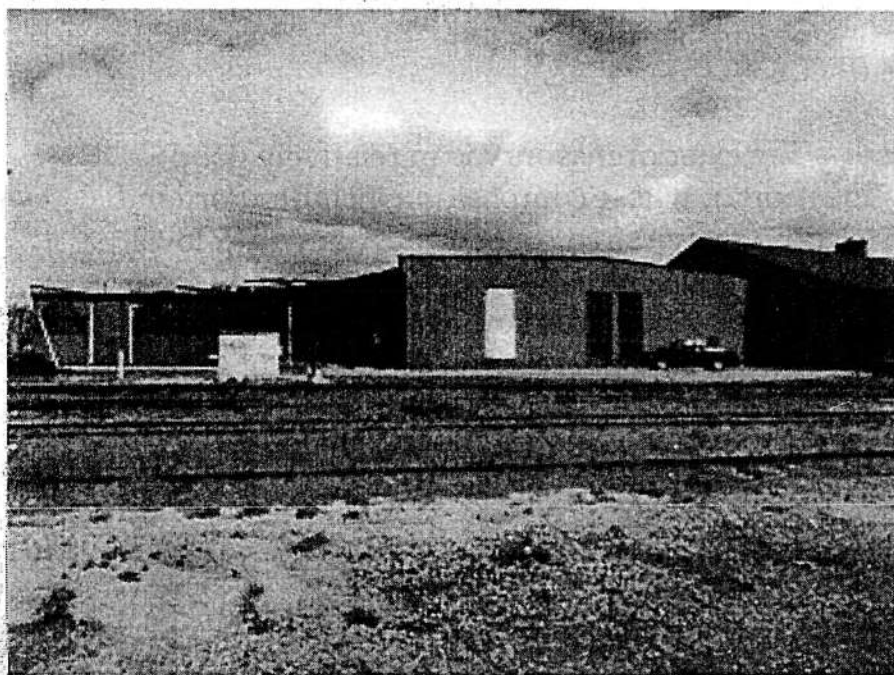
1.2 Roundhouse from south

The Roundhouse is the major component of the National Historic Site and as such has to be very carefully considered with any interventions and changes. Below is given the overall condition of the different physical elements and an assessment of the recommended remediation followed by the proposed interventions.

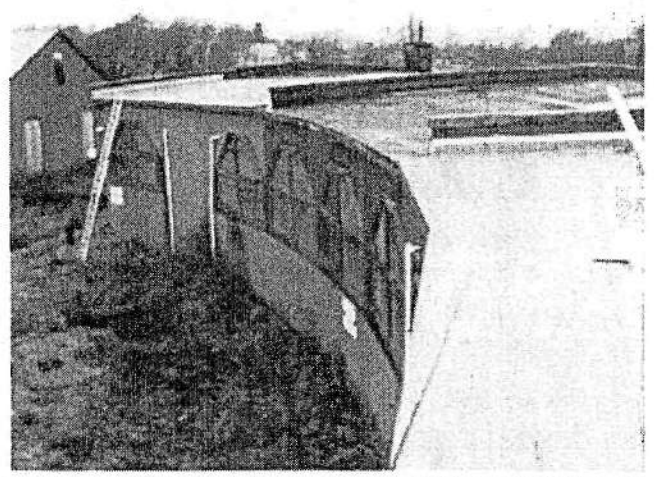
1.7. Parapet between bays 4 & 5 and 7 & 8 (2009 Jan 06)

i. **Observations** - There are five (5) parapet walls to the Roundhouse, two at the exterior and three above the dividing walls of the bays sections. The capping of concrete is in poor condition. The brickwork to the walls is damaged where the original flashings for the roof was located. This damage has been aggravated by the failure of the roof membrane in these locations. From the observations made in 2006, 2009, and 2014, it was established that the brickwork and the concrete coping has

been compromised due mainly to the failure of the associated flashings.

- ii. **Remediations** - The brickwork to the demising parapet walls at the roof level will be repaired with bricks to match the existing, pointed with appropriate mortar and new sheet metal cap and counter flashings. The concrete capping will be repaired using an appropriate Jahn concrete repair product. Full mortar mix details will be provided at the Building Permit stage.

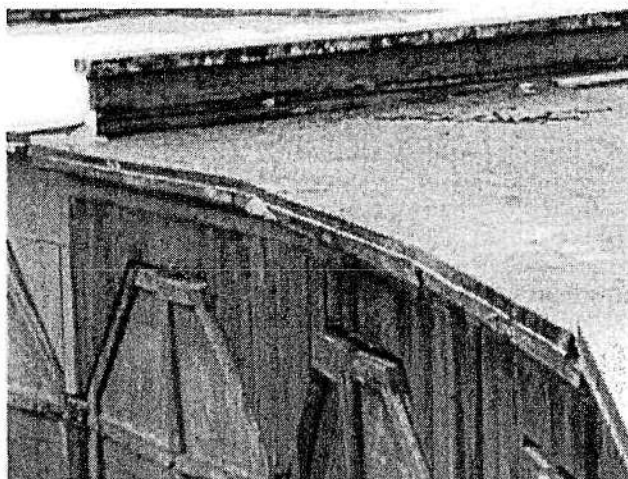
1.14 Remains of original gutter

Gutters and downpipes had been removed, causing the rain water to run down the walls and eroding the mortar in some locations. Temporary gutters and downpipes have since been installed to mitigate this problem.

- ii. **Remediations** - The temporary gutters to both sides of the mono pitch roof will be removed and replaced with new galvanized sheet metal profiled gutters to match the original. This will include the replacement of the existing temporary fascia board with new wooden board to replicate the size and profile of the original. Rainwater down pipes will be of galvanized steel to match the original based on archival research
- iii. **Proposed Interventions** - None.

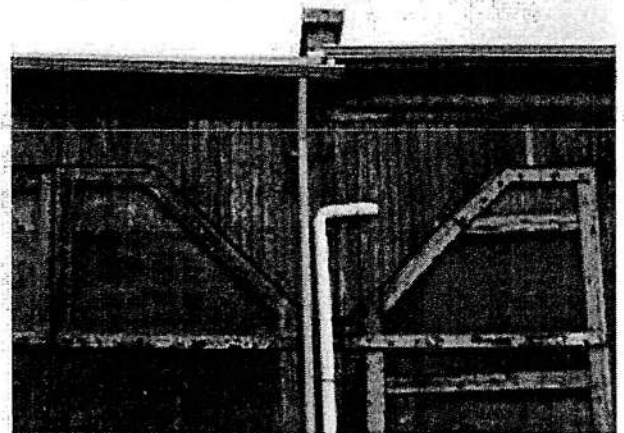
- i. **Observations** – At the present time the original gutters and down pipes have long since been removed. This was replaced in 2009 with a temporary system of aluminum gutter connected to aluminum and ABS down pipes

1.17. ABS & aluminum down pipes (2012 April 18)

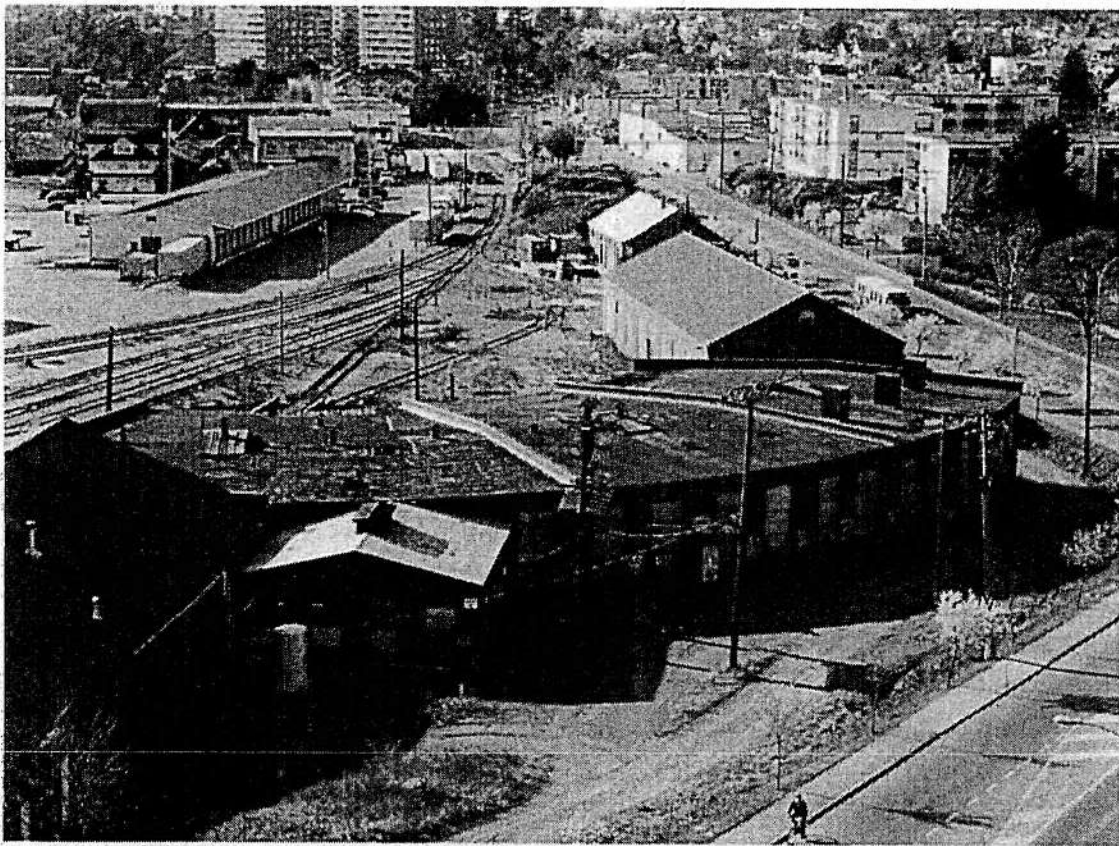
- i. **Observations** - The circular vent stack to the stalls are made of galvanized sheet metal. Some still exist in their original location whereas others have been removed. It would appear that there were original at least ten (10) stacks.

1.20. Roof showing vent stacks & skylights

ii. **Remediations** – The existing stacks should be retained and new stacks installed to replicate the original, their locations would be based on both site evidence and archival photographs.

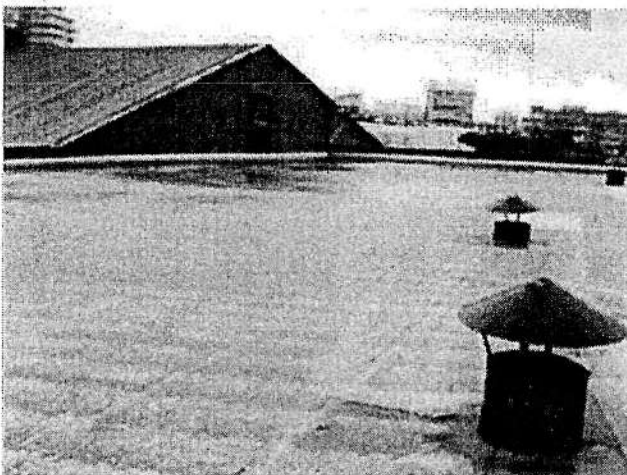
1.21. Original vent in temporary roof (2009 Feb 13)

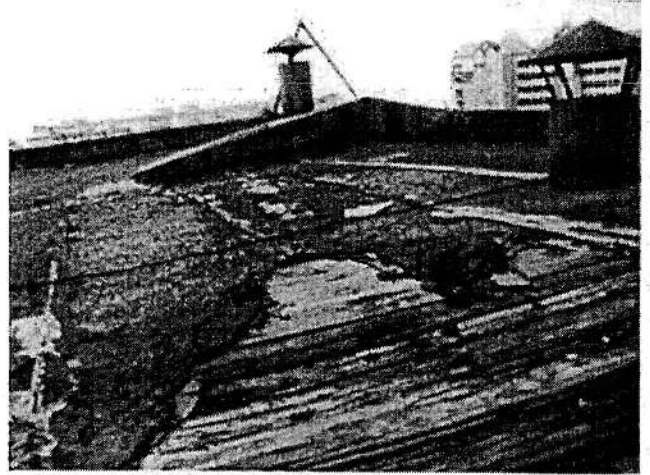
1.22. Original round stacks & skylight (2003 May 21)

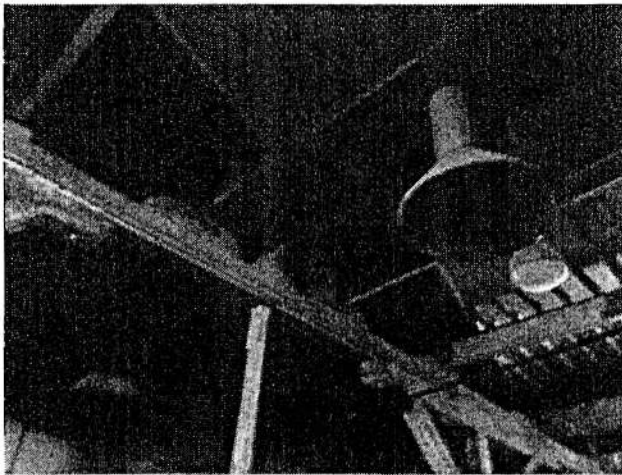
1.23. Original round stacks (2014 Feb 05)

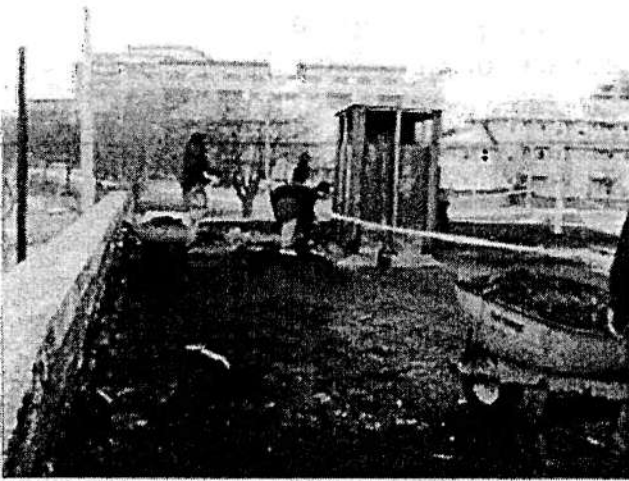
i. **Observations** – In addition to the circular smoke stacks were are nine (9) rectangular smoke stacks. Currently there are two (2) remaining. During the re-roofing in 2007 both of these stacks were retained and the asbestos cement board encapsulated with plywood.

1.24 Square vent stack with temporary re-roofing underway (2006 Jan 20)

ii. **Remediations** – To replicate the missing square smoke stacks to follow the size and pattern of the remaining unit and in addition to archival photographs F-05352, F-05359 and 1.25 and 1.26 of this Report

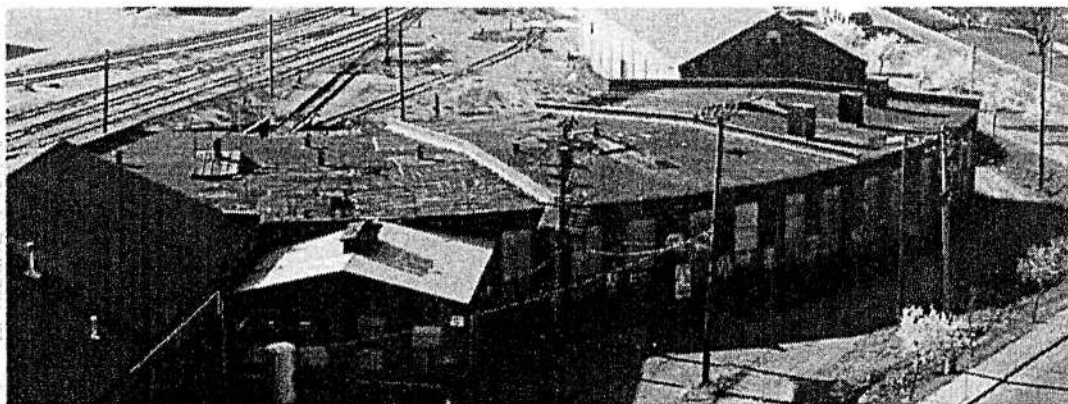
i. **Observations** - Three skylights were located on the roof of the Roundhouse in 2003, but with the two temporary re-roofing projects they were removed. These skylights were an integral part of the function of the building providing day lighting above bays 2, 6, 9 and between 3 & 4.

1.27. Roof showing vent stacks & skylights

- ii. **Remediations** – Based upon both archival photographs ( in particular B C Archives – A-06561F-05355, F-05359), measured drawings and on site measurements to replicate the form and shape of the three (3) skylights. The glazing will be as required by current B C Building Code requirement.
- iii. **Proposed Interventions** – With the replication of the skylights original types of materials may be adjusted to suite today's requirements, however the form and shape of the skylights will be as the original. The materials used will be metal for the skylight construction with either wired or laminated glass.

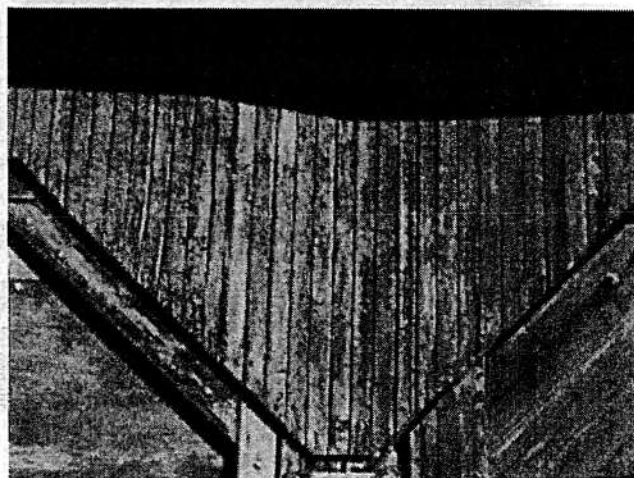
130. Siding between doors

- i. **Observations** – Around the 10 main stall doors is a combination of heavy timber and framing clad on the exterior with vertical 4" T G & V jointed boards. In many areas these vertical boards have been covered up with sheets of plywood thus by the condition of the areas that are exposed it is assumed that this condition is throughout.

- ii. **Remediations** – To remove all the protective plywood in order to assess the condition of the rotten and damaged with new material of same profile and type. All exterior woodwork will be re-painted to an approved paint system to MPI standards. Colours of all surfaces will be determined by onsite paint analysis. Actual colours that are proposed to be used will be submitted after this analysis.
- iii. **Proposed Interventions** – none.

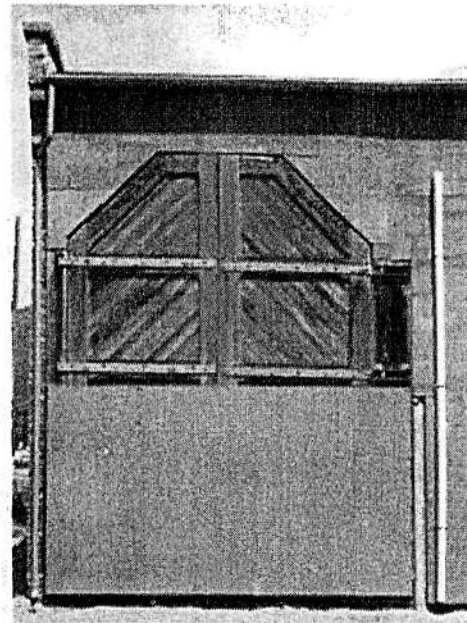
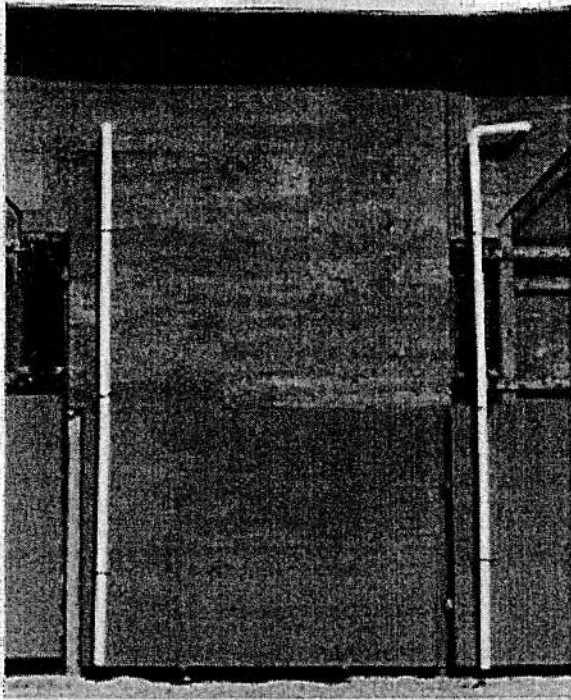
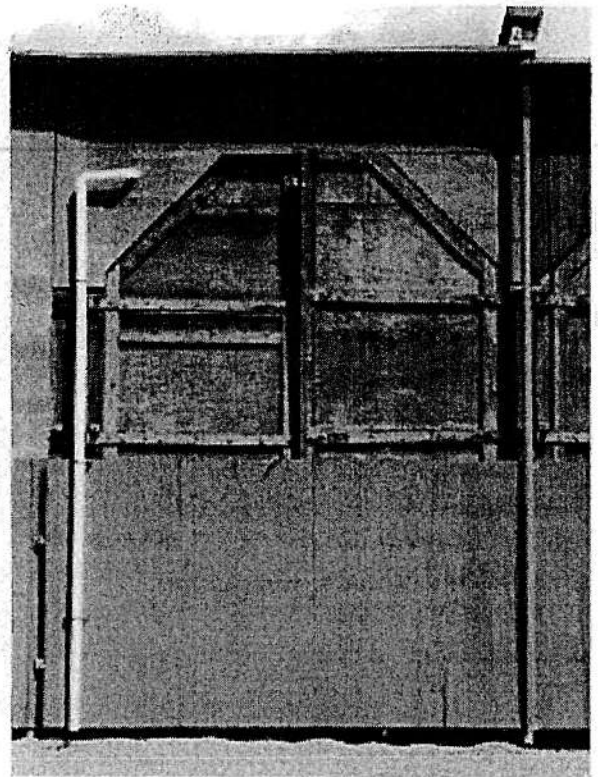
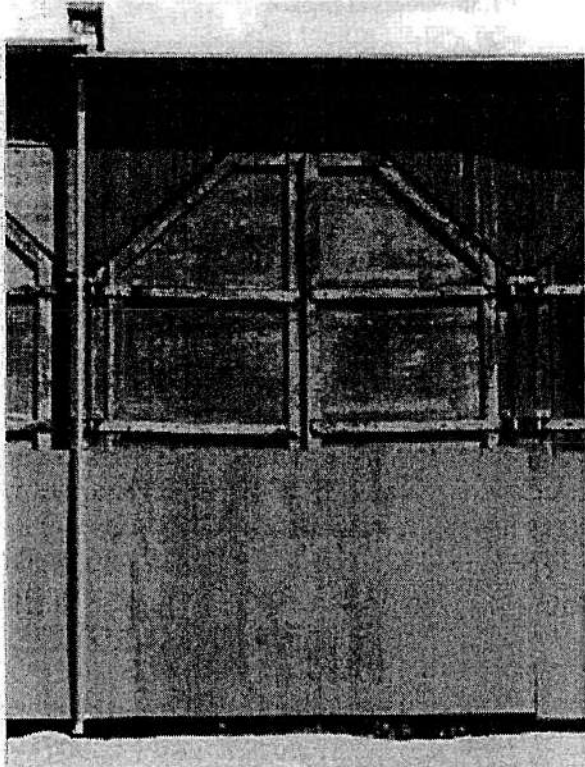
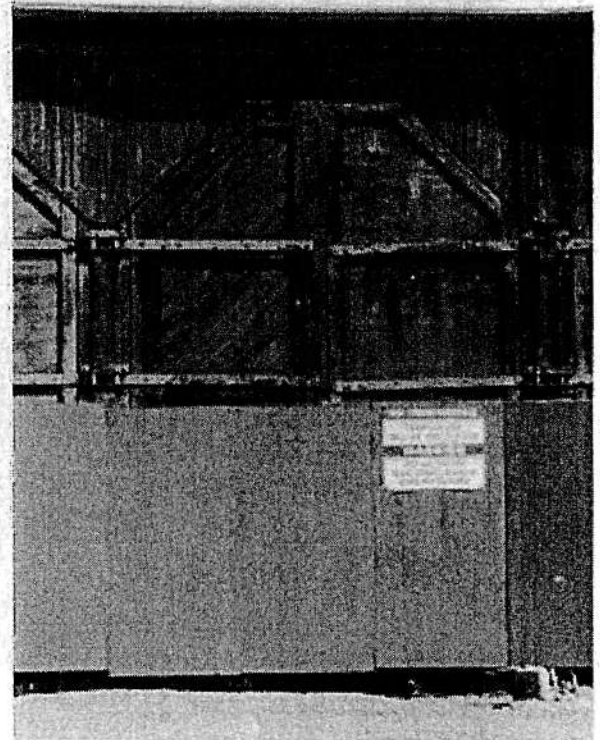
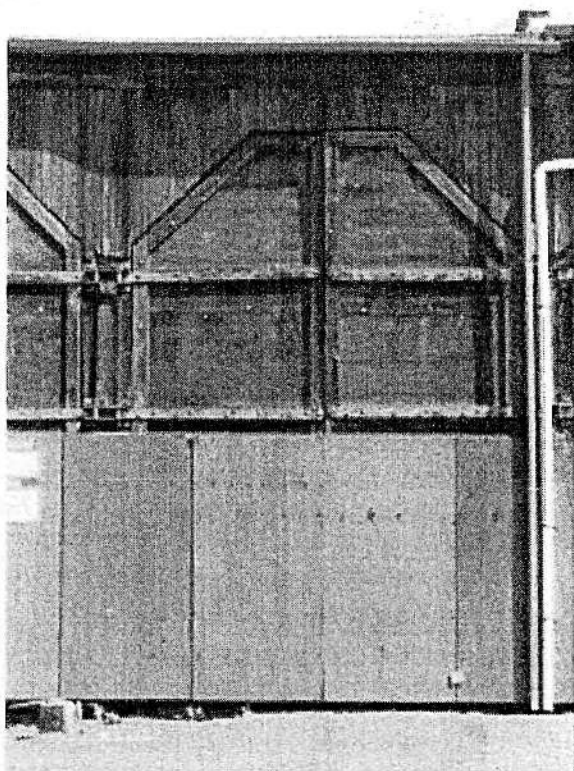
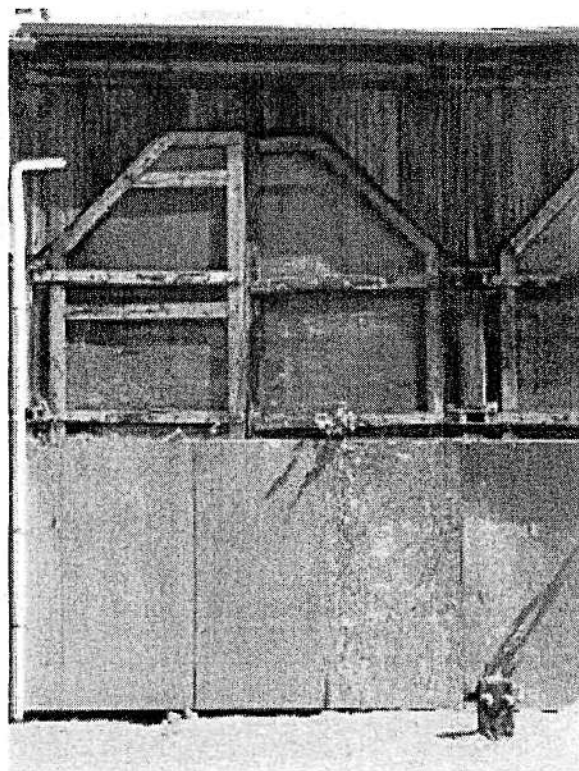
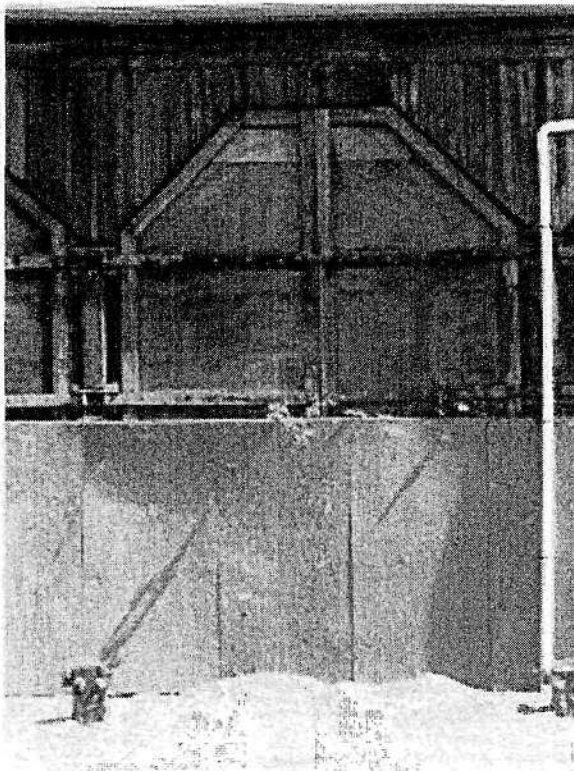
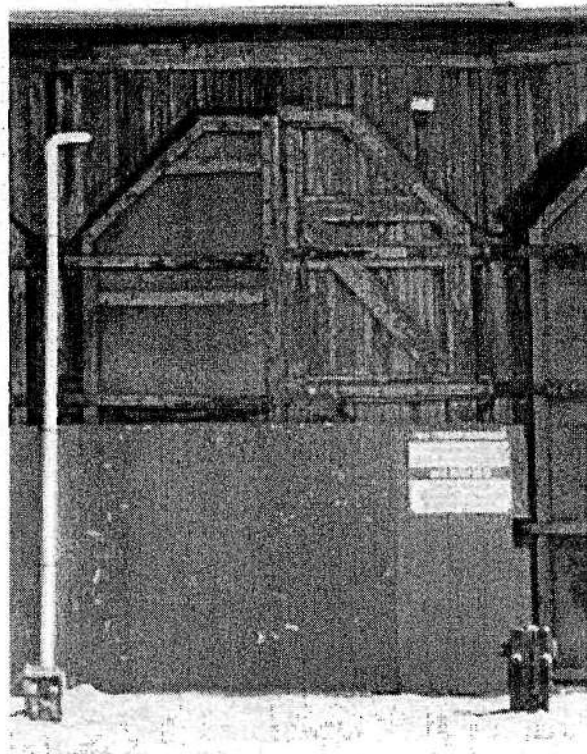
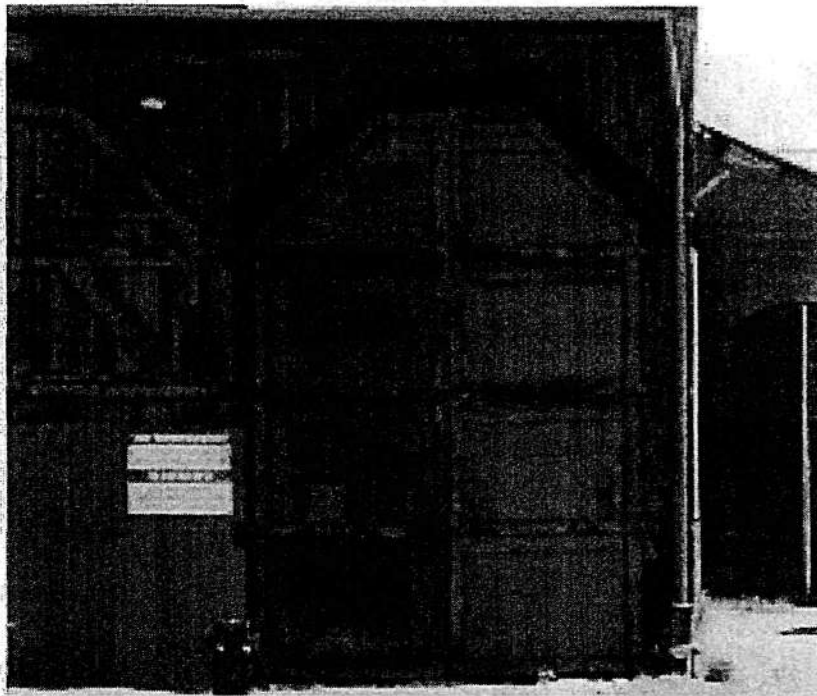
- i. **Observations** – The 10 stall doors are in poor condition. They are suffering from some decay and are sagging on their hinges. These doors are the major Character-Defining Elements CDE of the historic site and require careful consideration.

- ii. **Remediations** – The doors will be taken down and stripped so they can be inspected and repaired, where necessary, to bring them back to operational condition. Where hardware is missing, it will be replicated. Those that have been replaced (the number is uncertain, because several are boarded up) should be reconstructed to resemble the original doors. It may also be necessary to replace the main posts that support the door hinges, so that the doors can be properly set.

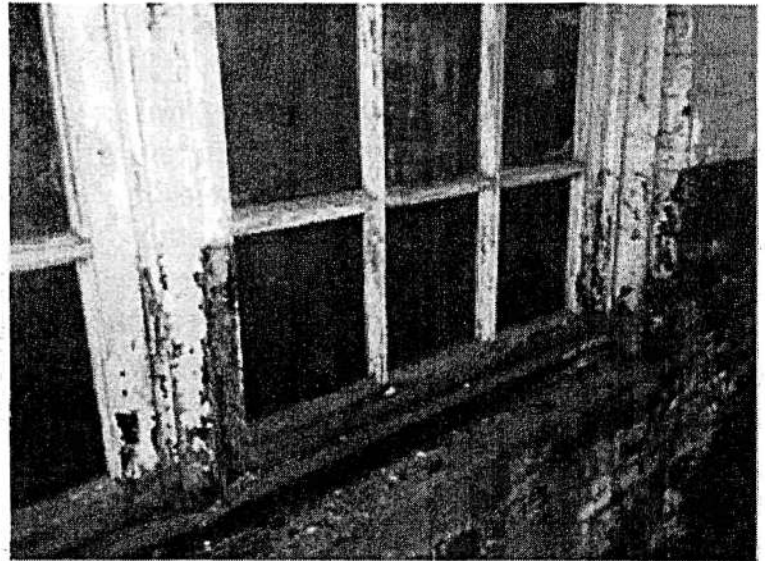
- i. **Observations** – The wood window frames and sashes have some areas of decay, particularly at the sills, but in general are considered to be in repairable condition. Vintage Woodworks carried out a basic on-site investigation in July 2011 that confirmed that all can be repaired. There are 63 windows, including the Boiler Shop, and 220 multi-lite sashes. Of these approximately 70 sashes will require extensive restoration. – see Appendix B for copy of this report.

1.48 Interior of window sill to track 1

- ii. **Remediations** – These should be removed, sanded, repaired and then repainted. The frames at 13 windows will require this. Most of the glazing is broken, so the windows will have to be re-glazed as needed. The wood frames and sashes of all the windows will be refurbished, and where required, new material incorporated. The existing glass will be retained and, where missing, replaced with glass matched to the same thickness.

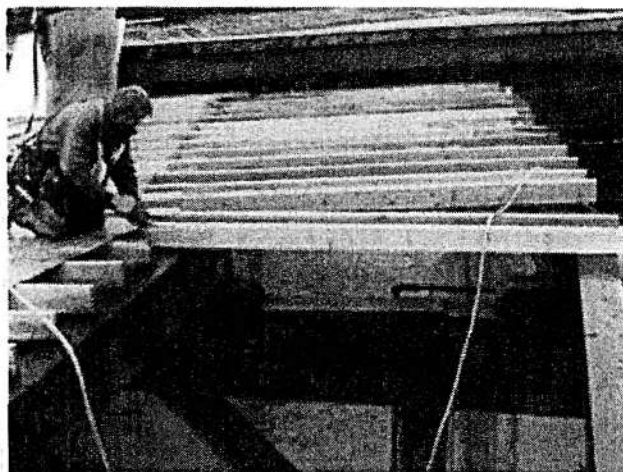
1.57 Temporary roof installation (2009 Jan 06)

- ii. **Remedations** – Due to lack of maintenance over a long period of time, a large portion of the original 4" T&G roof deck was rotten and was removed in 2007 and replaced with a temporary 2" x 6" joisted roof, with plywood decking and a membrane roofing system. This temporary roof system will be removed and replaced with a 4" T&G decked roof to match the original.

In addition to the demolition and replacement of the original roof decking, the roof failure resulted in degradation of the upper surfaces and interior of a number of the main support beams. All defective beams will be replaced with new beams of the same dimension and species of the original. Refer to Read Jones Christoffersen's structural drawings for details.

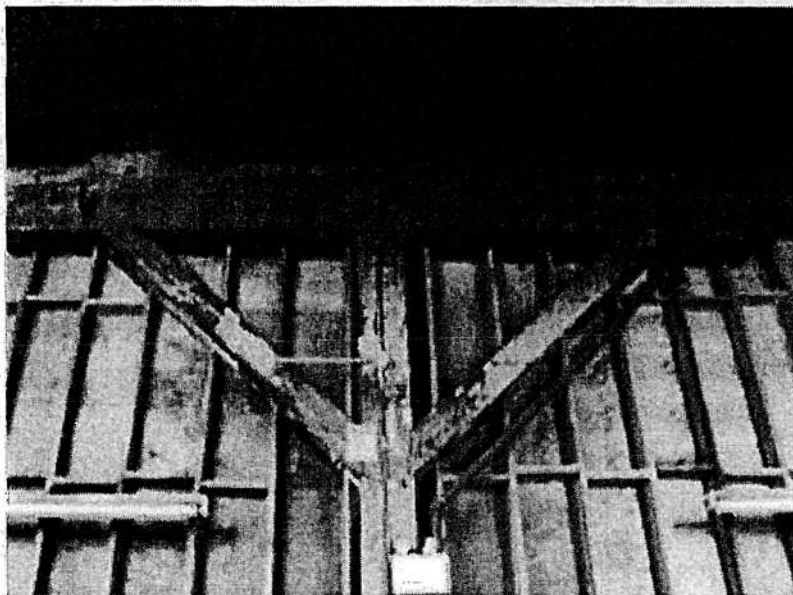
- i. **Observations** - The paint is peeling from the interior masonry and from the timber structure.

1.60 Paint on timber structure

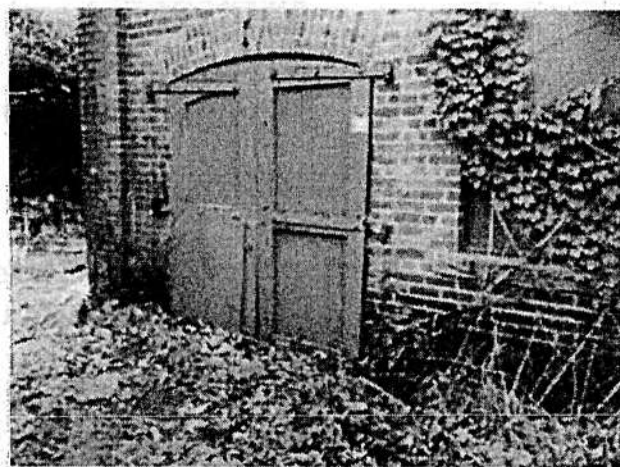
- i. **Conditions** – The wood window frames and sashes have some areas of decay, but in general are considered to be in repairable condition. Many glazing bars and several panes are broken on the south wall. Some windows have been boarded up from the exterior for protection.

2.7 Doorway to be expanded for loading bay entry

- ii. **Remediations** – Remove, sand, repair, and repaint all window frames, about 35 units in all. Replace broken glazing bars and glazing as required.

- iii. **Proposed Interventions** – Existing door and window openings will be used in a number of places to provide the necessary required access of the adaptive reuse. The doorway shown in photo 2.7 will be removed and the opening increased in size to accommodate the adaptive reuse with new roll-up door– see DIALOG BS-A502. If it is found that the new use can work with the existing opening without increasing its size efforts will be made to accomidate this alternative solution. A freestanding glass canopy is proposed, and is acceptable from a heritage perspective as it does not touch the building or alter the existing building.

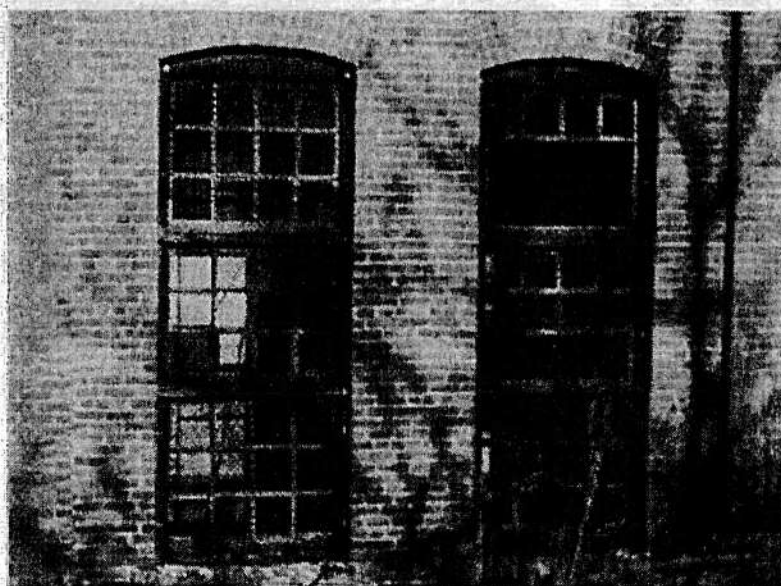
2.8 Windows to south elevation – 3# 12 over 12. (2014 Feb 05)

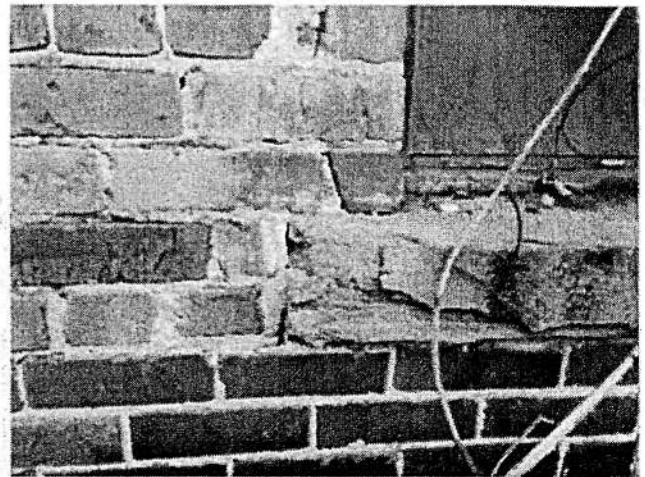
- i. **Conditions** – The sandstone window sills (35 in all) have failed in some locations.

2.10 Detail of sill & brickwork (2014 Jan 21)

- ii. **Remediations** - Where the window sills are badly damaged, they are to be removed and replaced with new sandstone units of stone to match the original in colour and texture. Quantities to be determined by detailed on site survey during the pre-construction phase. Where not severely damaged, to be repaired using JAHN or other appropriate approved product to match both colour and surface texture of the original.

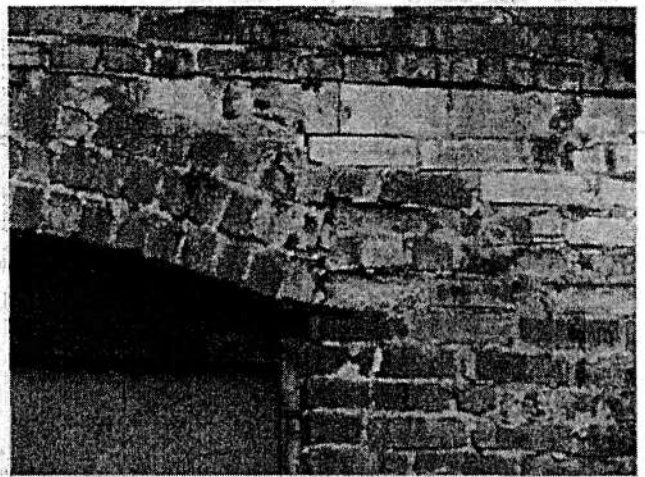
- i. **Observations** – The exterior masonry is in relatively fair condition but has suffered in a number of areas with structural cracks and settlement. The mortar has a compressive strength of approximately 6 to 12 Mpa. There are some areas on the exterior surface where the mortar has been etched by water running over the surface. Some of the softer salmon-coloured brick units have failed in some areas.

3.5 Detail - poor brickwork at head (2014 Jan 21)

- ii. **Remediations** – The areas where the mortar has been damaged will require repointing. In addition there will be some areas of brickwork to be rebuilt where failure has taken place. Some salmon-coloured bricks will require replacing. Perform shear tests to evaluate the shear resistance of the brick walls.
- iii. **Proposed Interventions** – None.

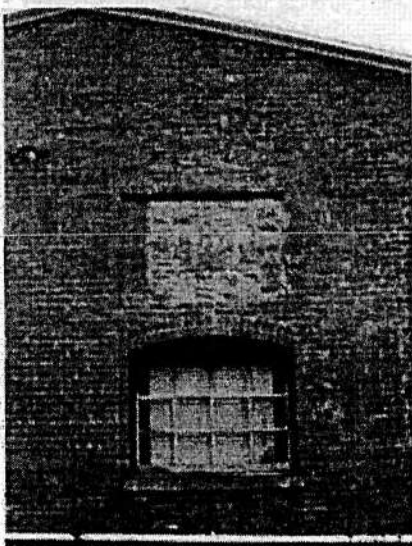
3.6 Blocked up window (2014 Jan 21)  
window (2014 Jan 21)

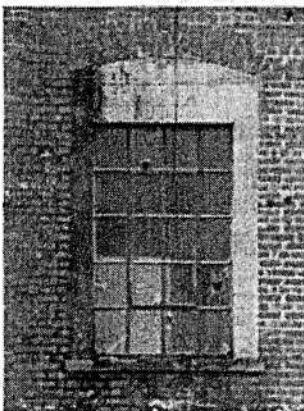
- i. **Conditions** – The steel window frames and sashes have some areas of rusting, but in general are considered to be in repairable condition. Several panes of wired glass are broken.

3.10 Metal window set in concrete in original opening (2014 Jan 21)

- ii. **Remediations** – Remove, sand, repair, paint and refurbish all of the metal framed windows and replace broken glazing as required and then reinstalled within the existing opening.
- iii. **Proposed Interventions** – none.

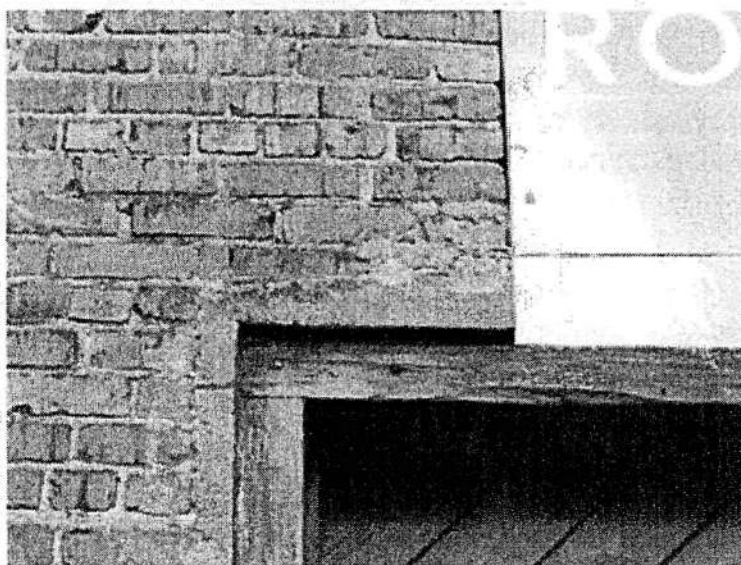
- i. **Conditions** – The exterior masonry is in relatively good condition. The mortar has a compressive strength of approximately 6 to 12 Mpa. There are some areas on the exterior surface where the mortar has been etched by water running over the surface. All present are settlement cracks adjacent to the large door on the west elevation

4.3 Extended opening c/w concrete (2014 Jan 21)

- ii. **Remediations** – The areas where the mortar is damaged will require repointing. Mortar repointing is also required beneath the purlins where they penetrate the walls on both the interior and the exterior. Perform shear tests to evaluate the shear resistance of the brick walls.
- iii. **Proposed Interventions** - none

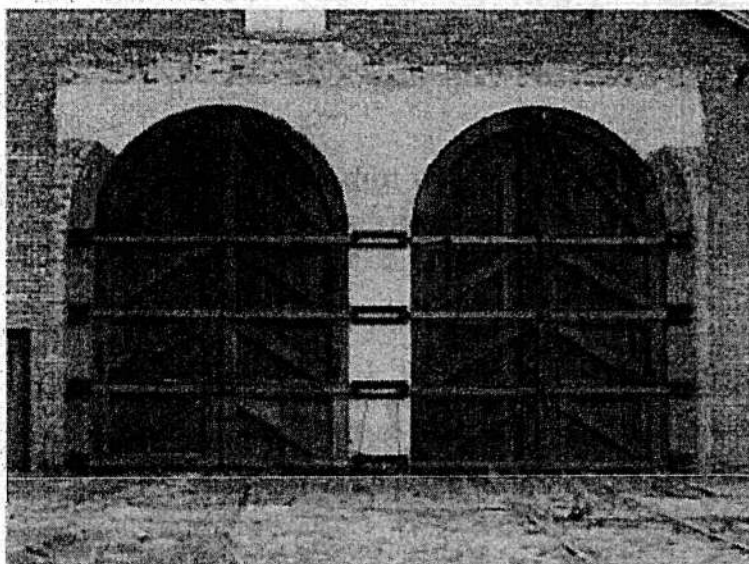
In the location of the pair of large twin semicircular headed doors at the west end appear to have been reset at some time into a new opening with concrete lintels and a central concrete pillar. By observing the brickwork coursing it is possible to identify the original and replacement bricks. This is to be retained as part of the history of the building.

4.5 Concrete lintel and column to west doors (2012 April 18)

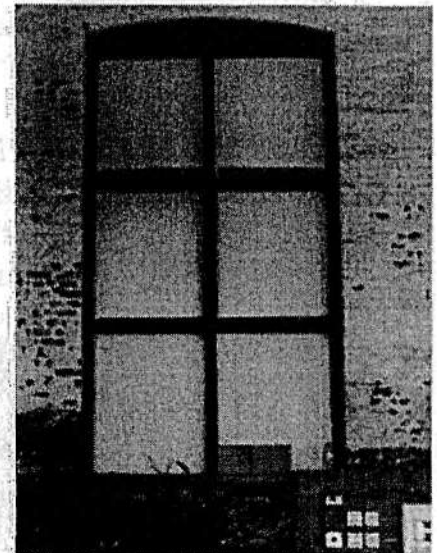
- i. **Conditions** - The wood window frames have some areas of decay, particularly at the sills, but in general are considered to be in restorable condition. All except two of the original glazing units have been removed and the windows are covered with translucent fibreglass panels.

4.10 Interior showing 6 frames for missing sashes (2014 Feb 05)

- ii. **Remediations** - The windows frames should be removed, sanded, repaired and then repainted. They should be re-glazed as necessary, original all the missing sashes were 9 pane units.

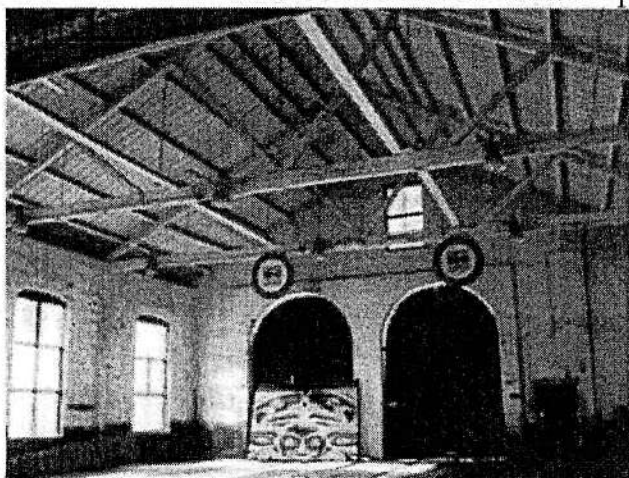
- i. **Conditions** - The paint is in reasonable condition and as with the other buildings it consist of original lime wash that has since been overlaid with other white paint products. At the base there is a black painted dado.

4.11 White painted interior

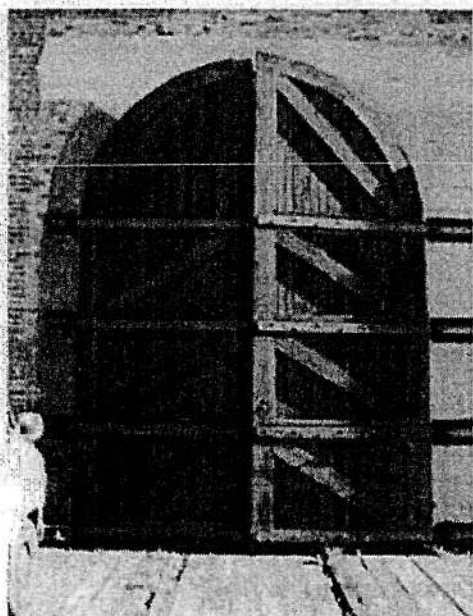
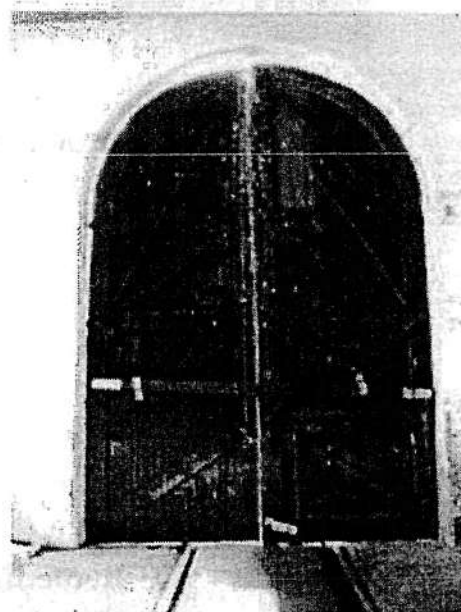
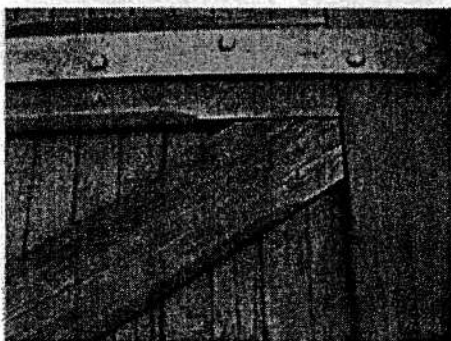
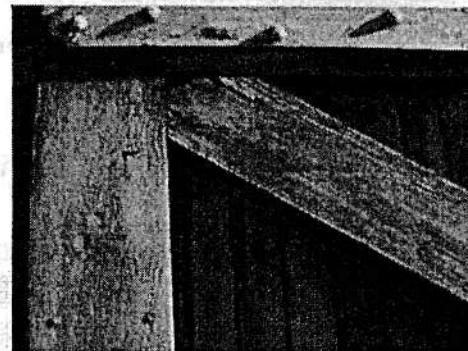
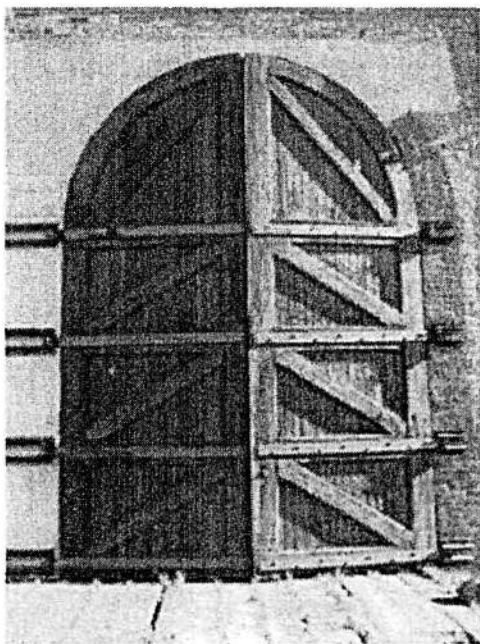
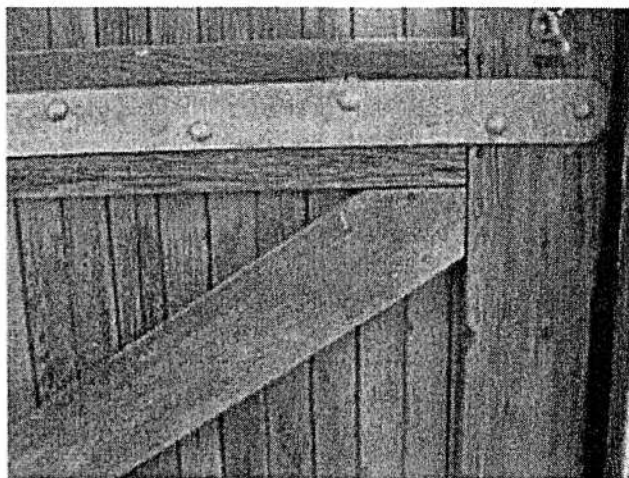
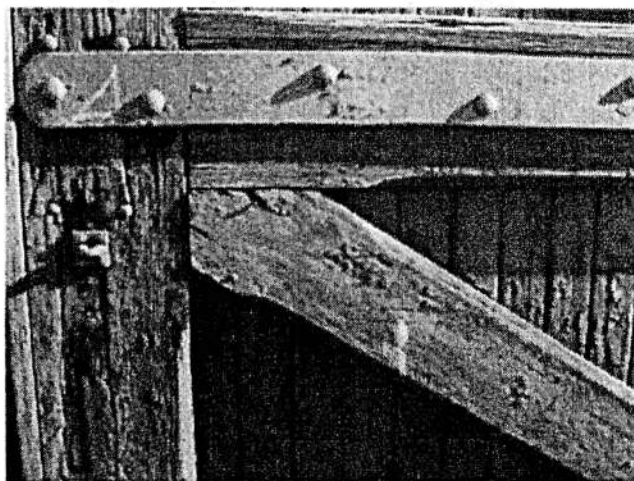
- i. **Conditions** – The main west facing doors are in fair condition. They are suffering from some decay but are only sagging slightly on their hinges. Of the four leaves only two are original.

- ii. **Remediations** – The doors should be repaired where necessary so that they are fully operational.
- iii. **Proposed Interventions** – none

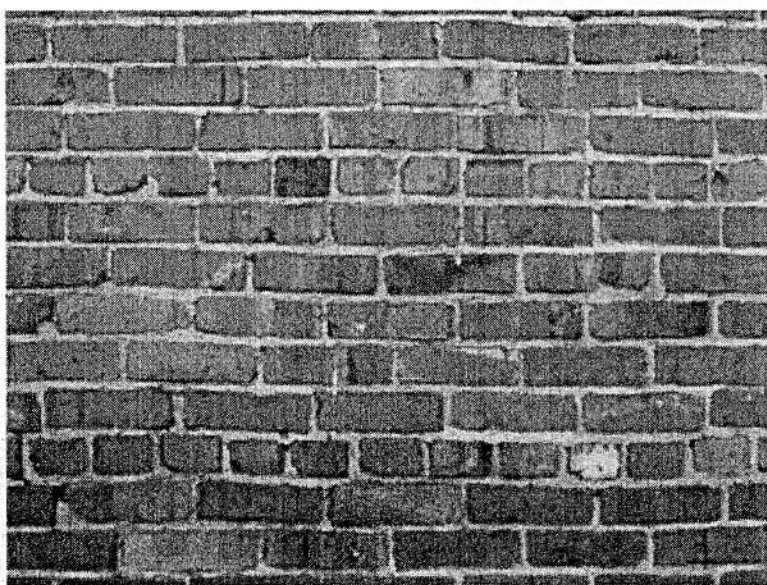
- i. **Conditions** – The exterior masonry is in relatively good condition. The mortar has a compressive strength of approximately 6 to 12 Mpa. There are some areas on the exterior where the mortar has been etched by water running over the surface. The masonry brickwork chimneys are in good condition; however, maybe are in need of additional seismic restraint.

5.5 View of brickwork

- ii. **Remediation** – The areas where the mortar is damaged will require repointing. For additional seismic restraint for the chimney see DIALOG drawings ST-A501 and ST-A502.

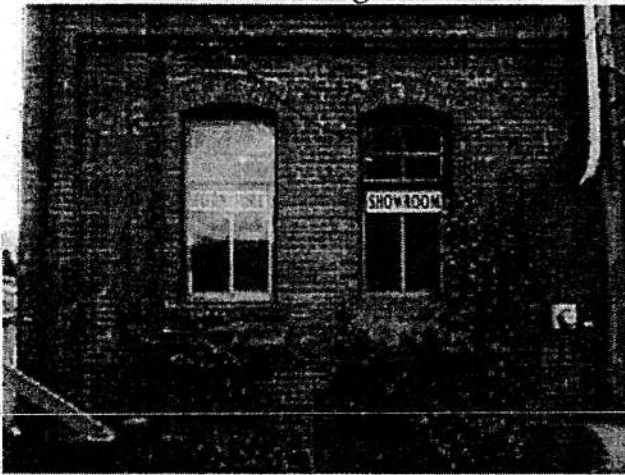
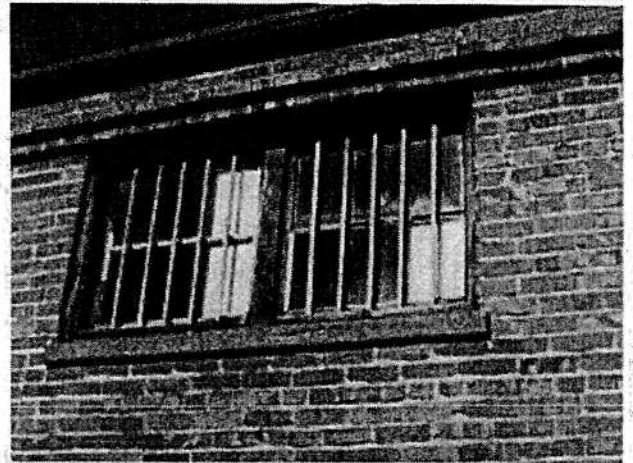
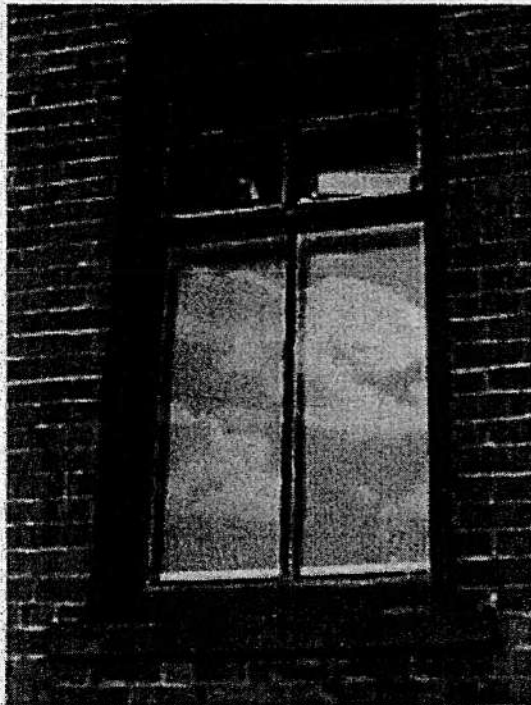
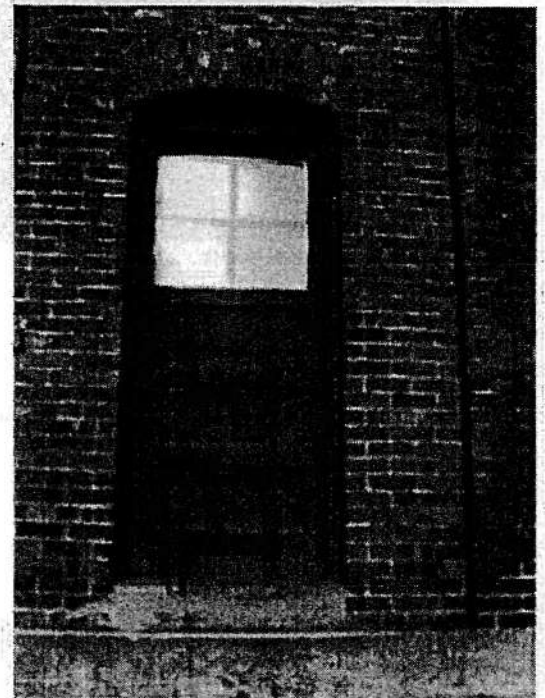
- i. **Conditions** - The wood window frames and sashes at the south wall have some areas of decay, particularly at the sills, but in general are considered to be in repairable condition.

- ii. **Remediations** – The damaged frames and sashes should be removed, sanded, repaired, and then repainted.
- iii. **Proposed Interventions** – In order for the building to function in its adaptive reuse of the six (6) existing high level (clearstory) widows have four (4) modern glass door inserted below them on new openings to the existing brickwork. Two (2) existing wood doors will be replaced with modern glass doors.

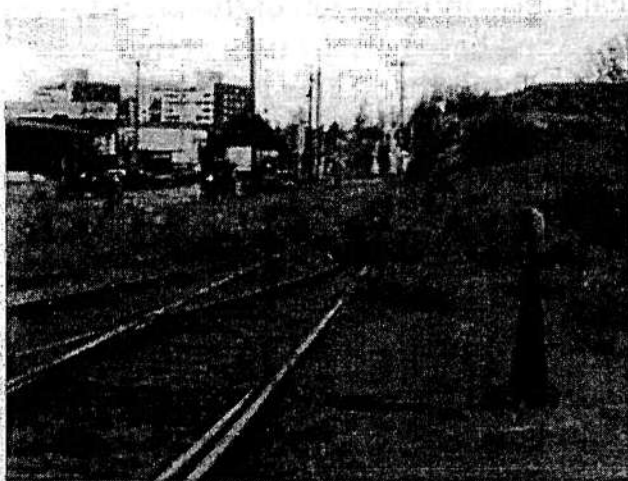
7.1 Looking west  
(2012 April 18)

- i. **Conditions** – Over the years the configuration of the layout of the railway tracks have varied based on the uses at that time. At the present time the connecting tracks from the Turntable to Bays 2 to 10 of the Roundhouse and to the Back Shop have been removed. The four (4) Passenger Car Sidings are still in place as are the two (2) Freight Car Sidings. The tracks around the north of the Car Shop and Roundhouse have been removed.

- ii. **Remediations** - To preserve as much as possible of the existing railway track in order to provide good interpretation of the site with particular reference to the Roundhouse.
- iii. **Proposed Interventions** - Tracks will be returned to all the bays of the Roundhouse, to the Turntable and to the Back Shop. The more recent tracks to the four sidings will not be re-installed. The landscaping will interpret the layout of the tracks to show the working of the Railway Yard.
