# Topaz Park Improvement Plan

ENGAGEMENT SUMMARY REPORT  
MAY 2017 – APRIL 2018

## Topaz Park Artificial Turf Field Development Study

May 7, 2018

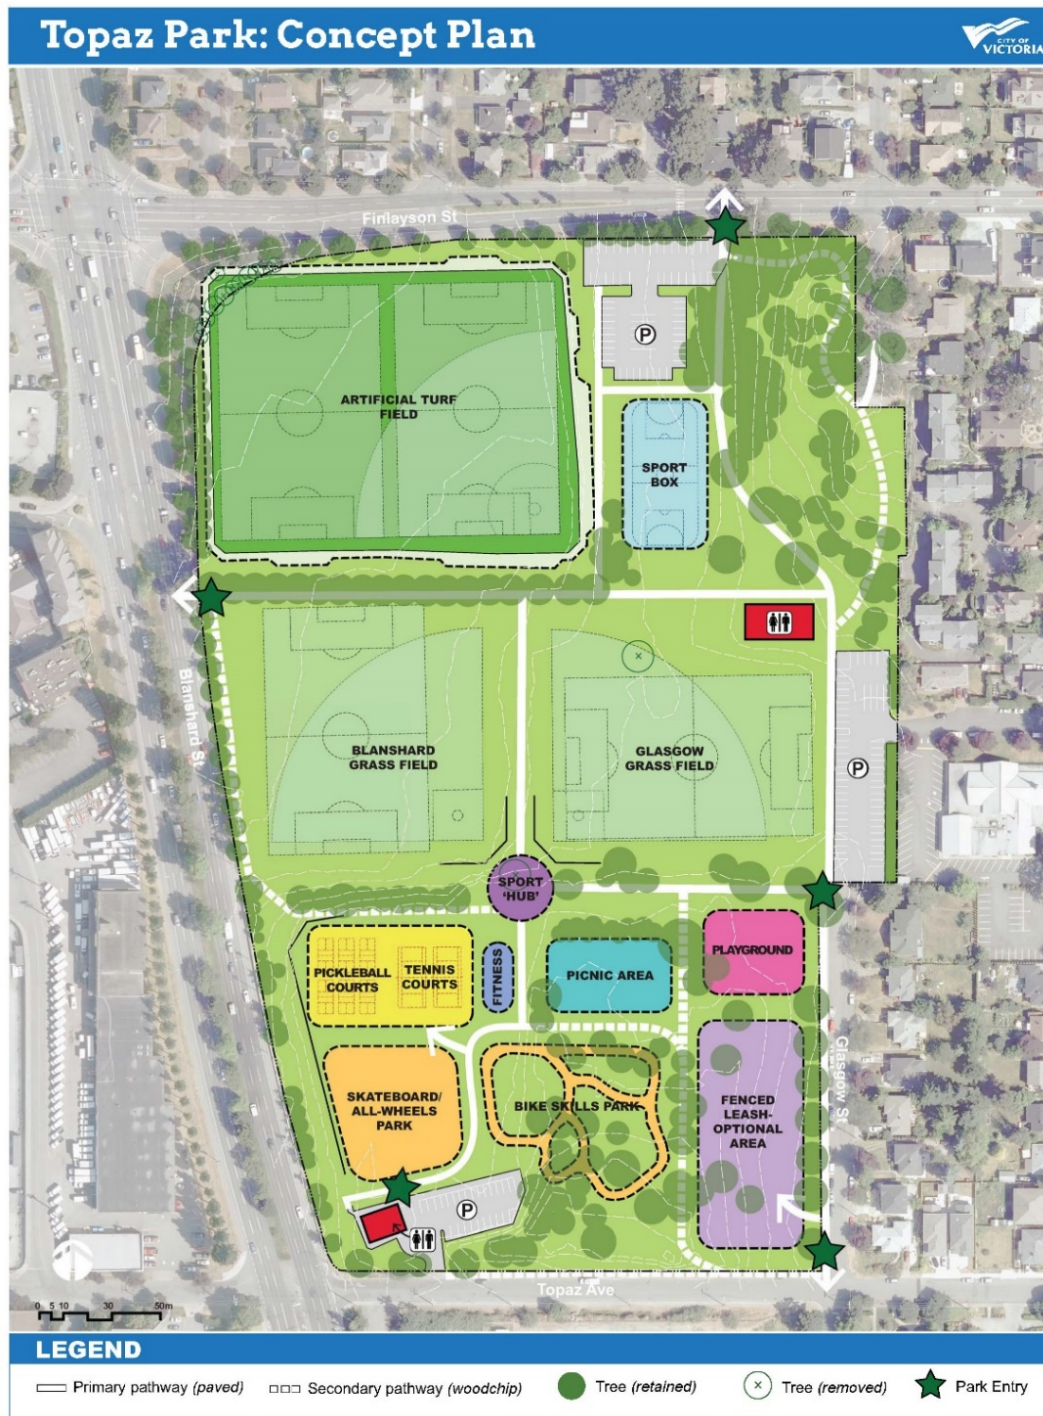
On April 9, 2018 we launched Phase 3 and shared the proposed park improvement plan with the community.

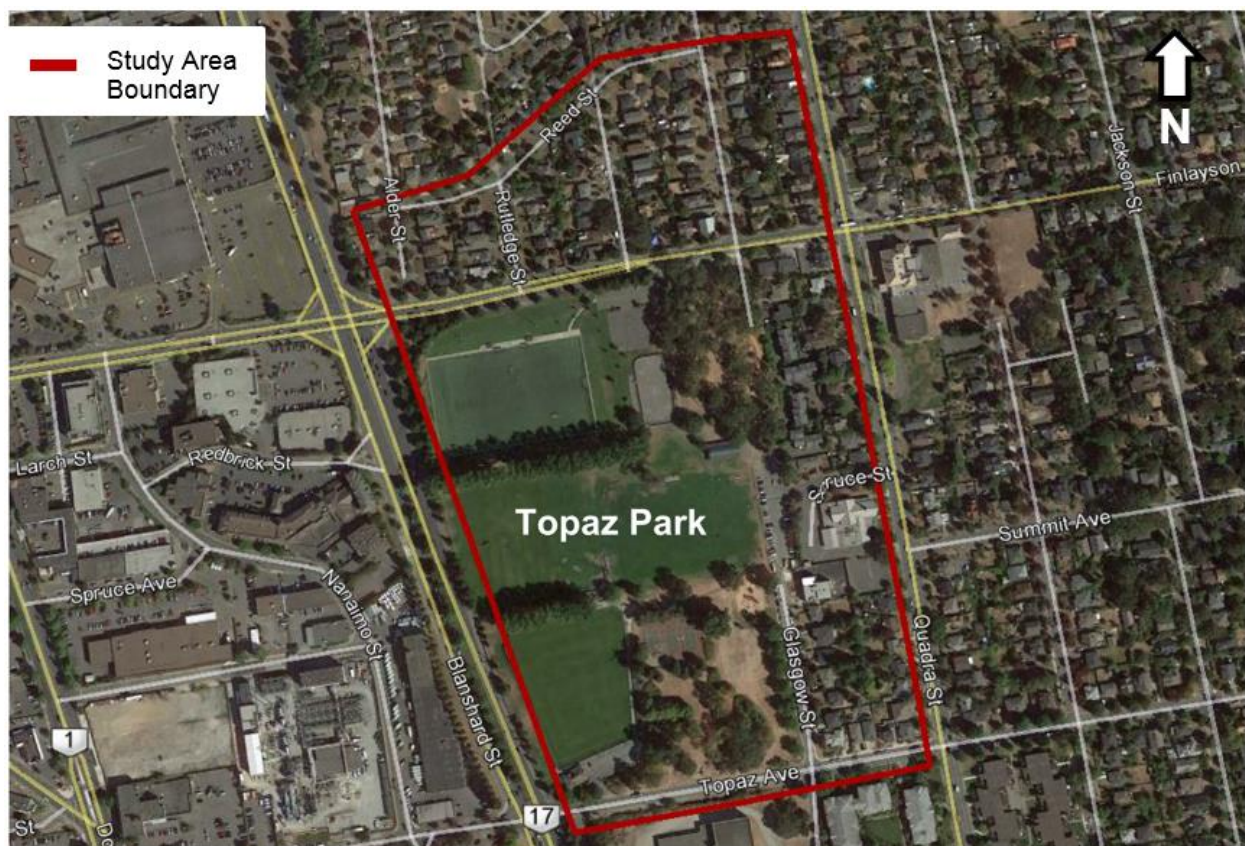
**Figure 1.0 – Topaz Park Parking Study Area, Victoria BC:**

This study area is shown in **Figure 1.0** (below).

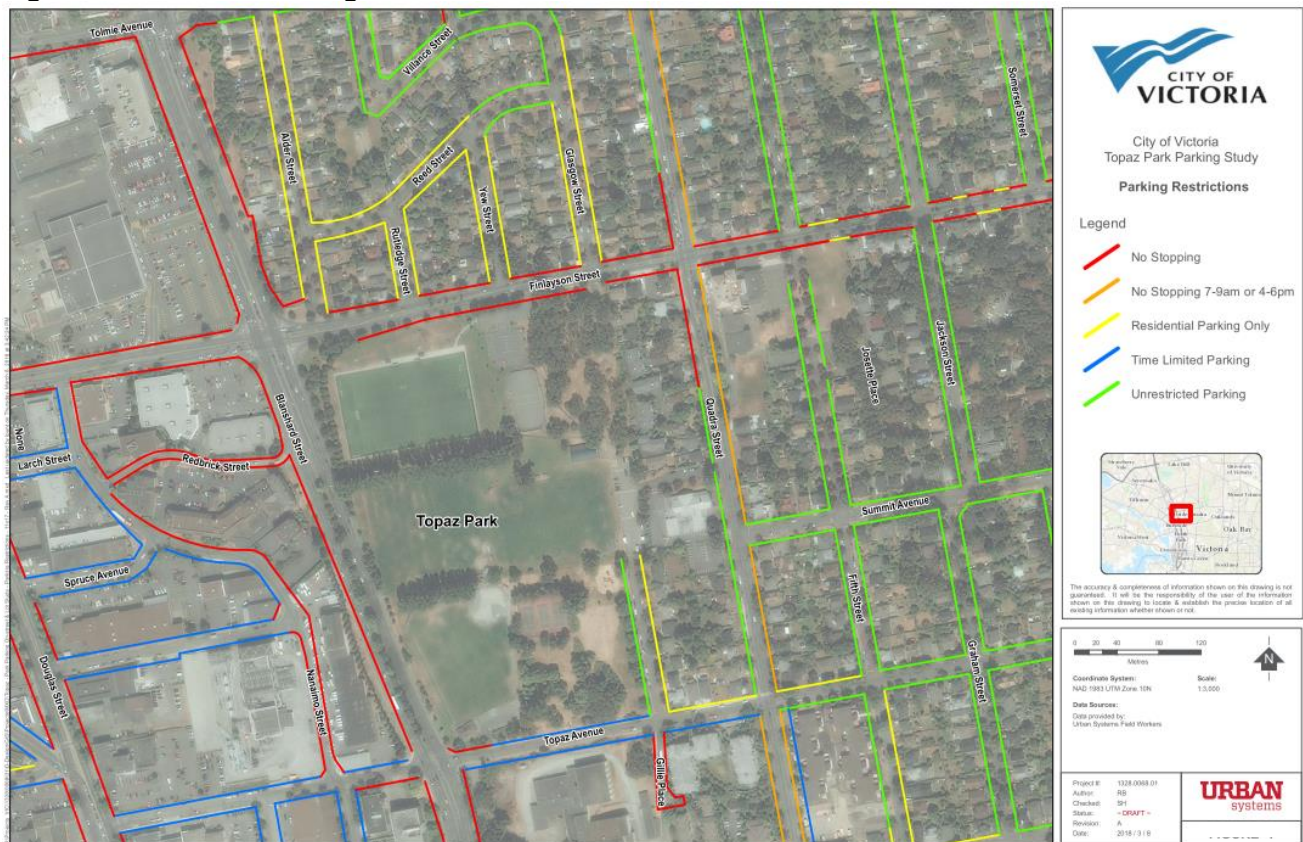
**Figure 2.0 – Current Parking Restrictions**

The study area currently contains a number of existing parking restrictions on residential streets. Most residential streets in the study area have resident only parking restriction with some streets having 2 hour parking zones and a few having no parking restrictions. Current parking restrictions are shown in **Table 1.0** and **Figure 2.0** below.

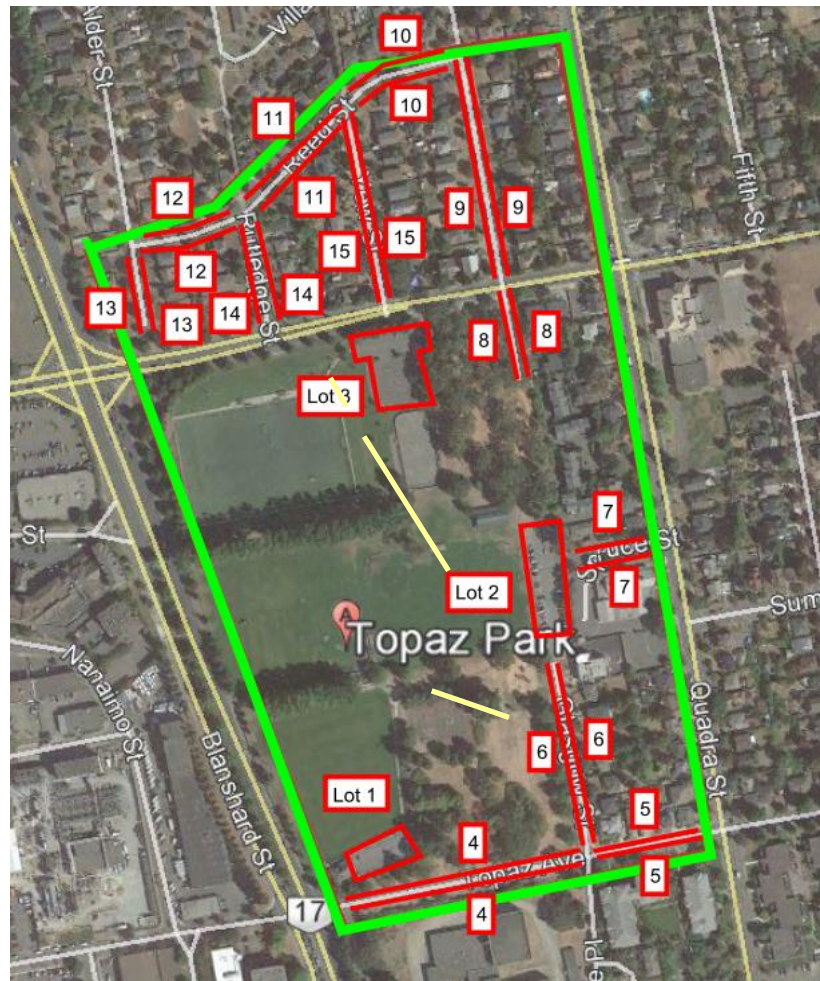
**Figure 3.0 – Parking Locations by ID (see Table 1.0)**

The following section provides an overview of existing parking supply, including all available on-street and off-street parking in the study area (see **Table 2.0** and **Figure 3.0** below).

As shown by **Table 2.0** and **Figure 3.0**, the current off-street parking capacity of the Topaz Park site is 153 spaces. The on-street parking can generally be divided into two categories, those parking areas open to the general public (i.e. 2 hour parking or no restrictions) and those that are residential parking only. Within the study area there are 263 on-street parking areas, of which 78 spaces are available for use by the general public and 185 are resident only parking spaces. When the off-street parking lots (153 spaces) are added to the other on-street parking available to the general public (78 spaces) there are approximately 231 public parking spaces in the study area.

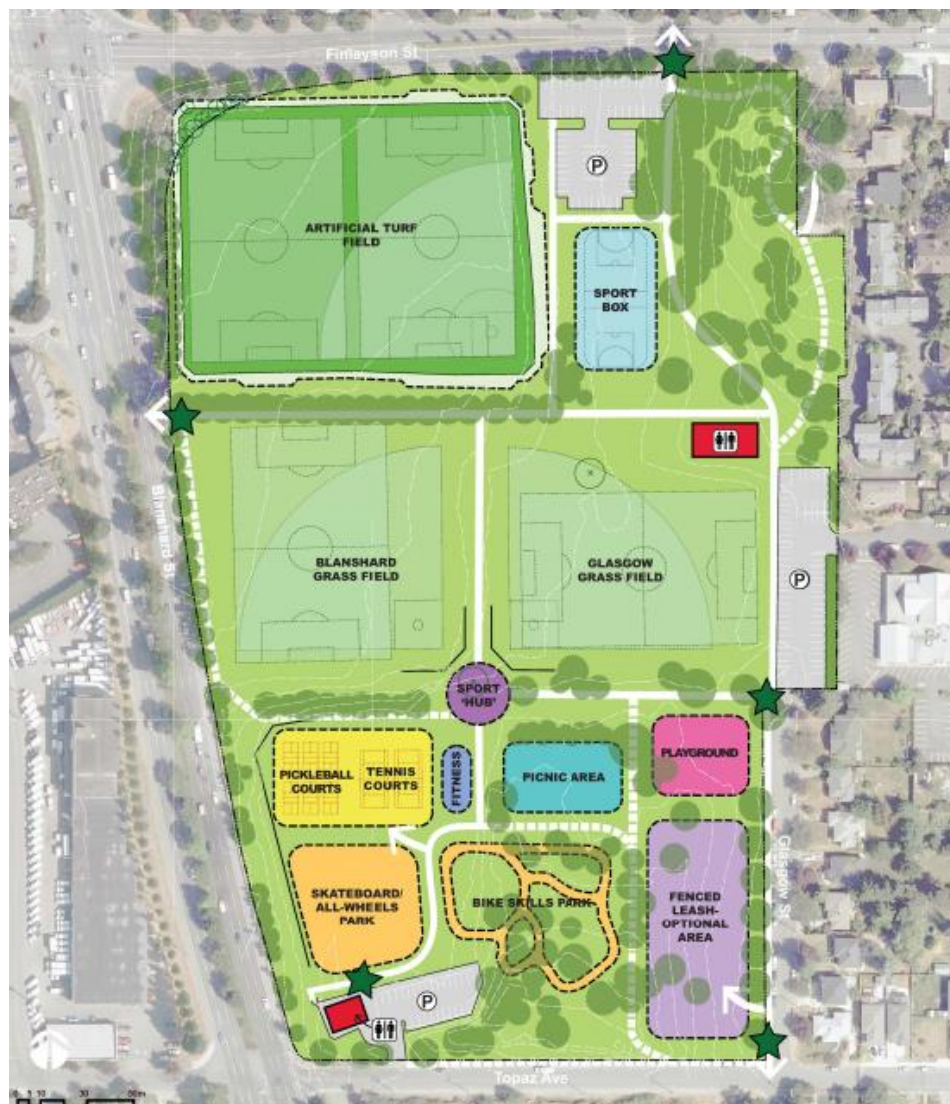
**Figure 4.0 – Proposed Topaz Park Improvements (Concept Plan)**

The proposed concept plan being reviewed through this analysis is shown in **Figure 4.0**. As shown by **Figure 4.0** the proposed redevelopment will add a sports hub (est. 2,000 sq. ft.), fitness area (est. 2,000 sq. ft.), picnic area, six pickleball courts and a skateboard / bike skills park.

On rare occasions when a major events are taking place and over 153 vehicles are accessing facilities at Topaz Park additional parking options may be required. As shown in **Table 7.0**, up to an additional 207 spaces may be required to meet peak demand for the Topaz Park Improvements shown in **Figure 4.0** (Proposed Concept Plan).

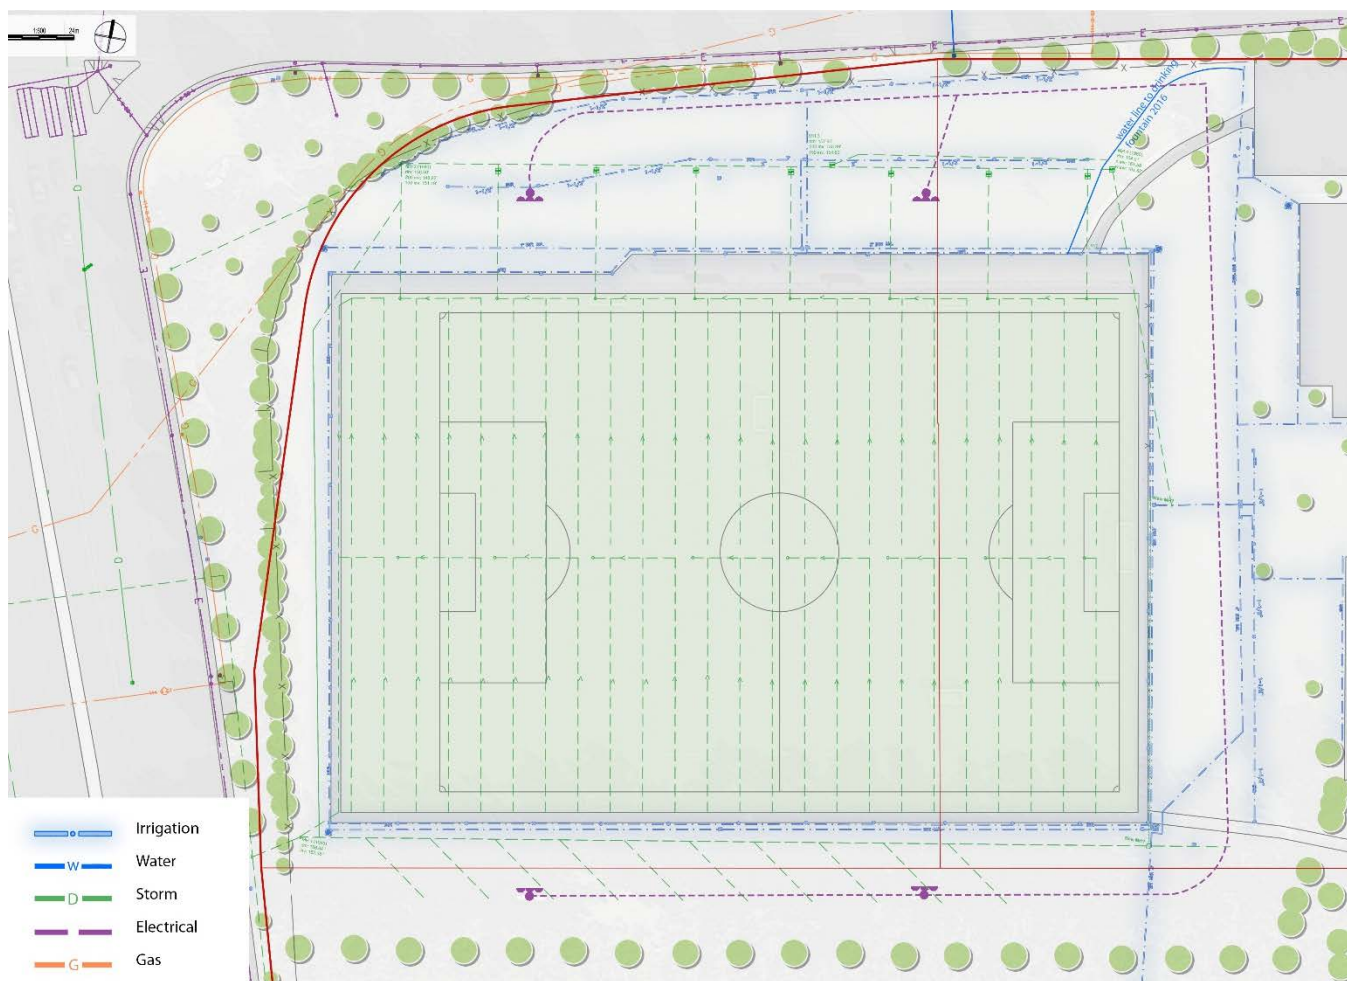
Existing Utilities Plan

**Stormwater Servicing:** The original grass field dates from the 1980's and had perforated laterals draining North into a 200mm diameter collector. The collector was tied into a Lawn Basin in the North West corner of the park at the bottom of the slope. From the information available, it appears this Lawn Basin ties into the storm drain under the east side of Blanchard Avenue. In 2005 an Artificial Turf Field (ATF) was installed, the perforated laterals underneath the ATF were replaced with a Multiflow system. The Multiflow system ties into the remaining perforated laterals outside the field footprint while the original 1980's collector is still in use today draining into the Lawn Basin. A 9 m wide natural grass area on the south side of the field is drained by perforated laterals. The collector for these laterals flows west and ties into a manhole adjacent to Blanchard Avenue. This area is inside the footprint of the proposed field and surrounding pathway, the perforated pipes will be removed for the construction of the new field.

A weather station/irrigation network antenna exists on the North East side of the field. The station will likely need to be relocated to accommodate an expanded artificial turf field.

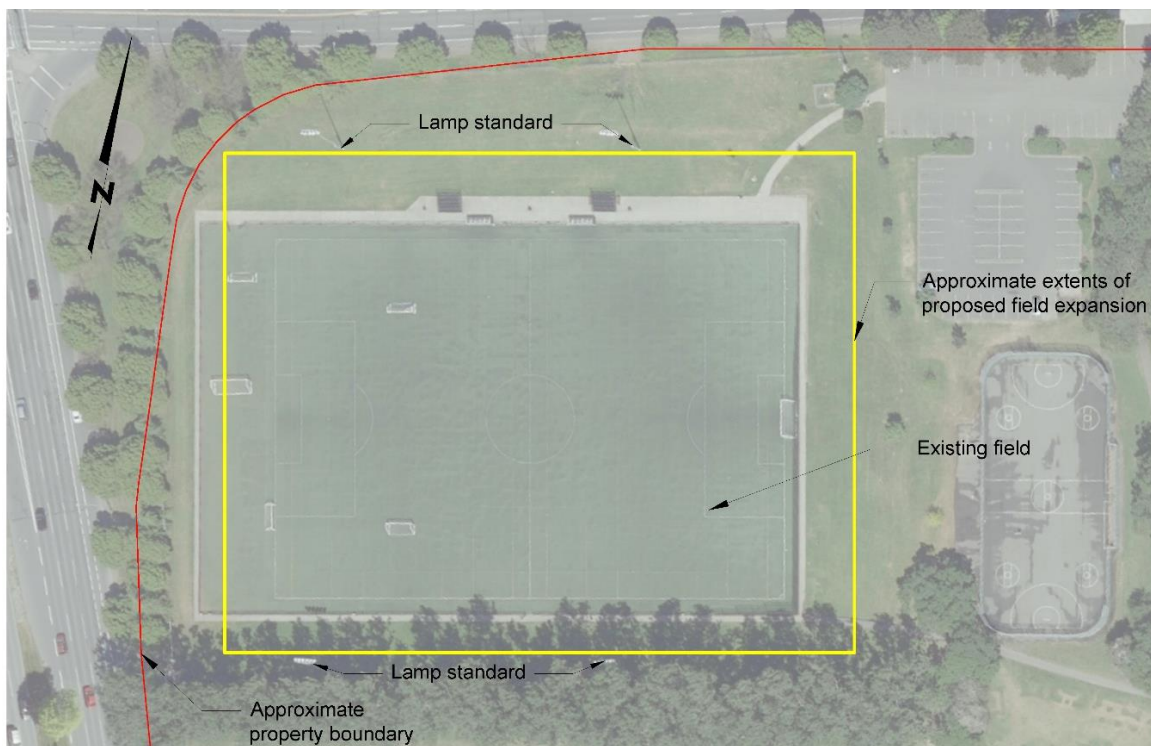
**Figure 1: Estimated extents of proposed field expansion**

Based on preliminary discussions, we understand that the new field would consist of an extension of the existing field footprint. To accommodate the roughly 100 m length requirement, the new field would extent north and south to roughly the location of the existing field lighting lamp standards. The western edge of the existing field is located near the western property line, as such, to accommodate the roughly 130 m width requirement, the new field would be extended to the east. An estimate of the extents of the field expansion can be seen in Figure 1.

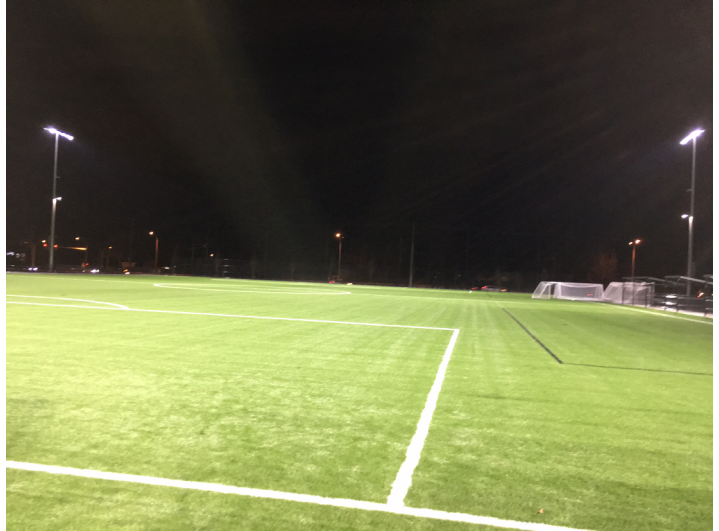
The City may also consider upgrading the existing luminaires to LED to improve lighting and reduce power consumption. An example of a recent LED sports lighting project is shown in the image right. The cost to convert to LED would need to be confirmed with the supplier, Musco Lighting.

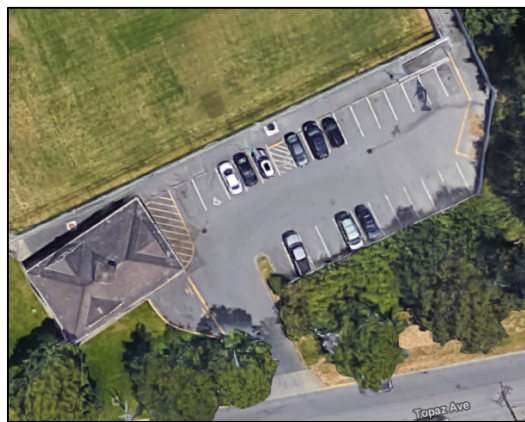
*Figure 1 Topaz Parking Lot*

It should be noted that Topaz Avenue parking lot has no corresponding sidewalk that leads up to the parking lot entrance that doesn't require the user to cross the street. There is only a sidewalk on the south side of Topaz Avenue. The parking lot provides 27 spaces, 2 of which have been designated as accessible spaces. This is a good ratio of general use parking spaces to accessible parking spaces.

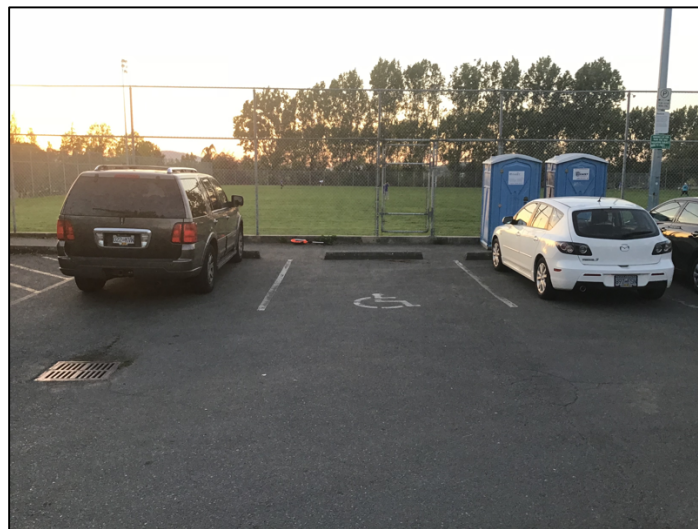
*Figure 2 Restricted pedestrian path access*

Furthermore, the gaps between the concrete parking blocks, which could provide safe access to the pedestrian pathway, are limited by the painted lines of the space, as they pass through the middle of the available clear width. In this way, this alternative is unreliable as a consistent safe means of accessing the pedestrian path. *See figure 2*

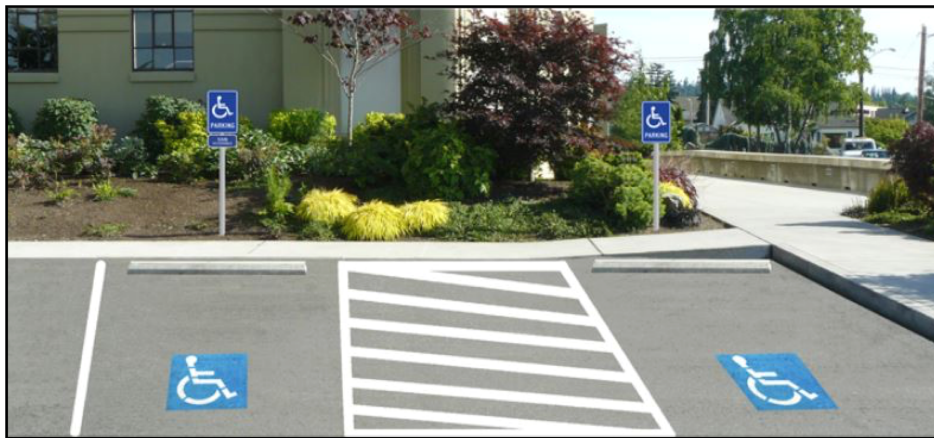
*Figure 3 Perpendicular Parking with Shared Access Aisle (not to be used as a design template)*

Any future design considerations to this parking lot could include the elimination of the space closest to Topaz Avenue. The utilization instead of the two to three closest spaces to the washroom facilities to create two universally designed parking spaces with a shared access aisle would be ideal in terms of safe access. The addition of upright signage in clear sightline of users of the parking lot would be of benefit as well. *See figure 3*

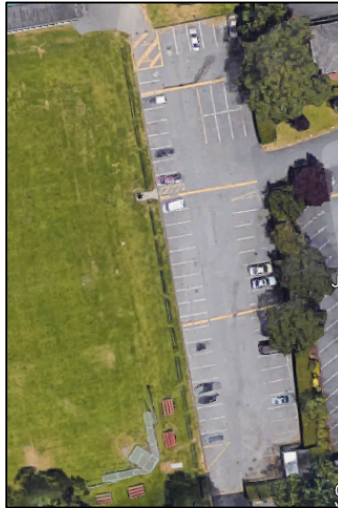
*Figure 4 Glasgow Street Parking Lot*

The Glasgow Street parking lot has two designated accessible spaces out of 66 which flank the shared access aisle that leads to the Glasgow Street washroom facilities. This is an adequate number of spaces for this lot.

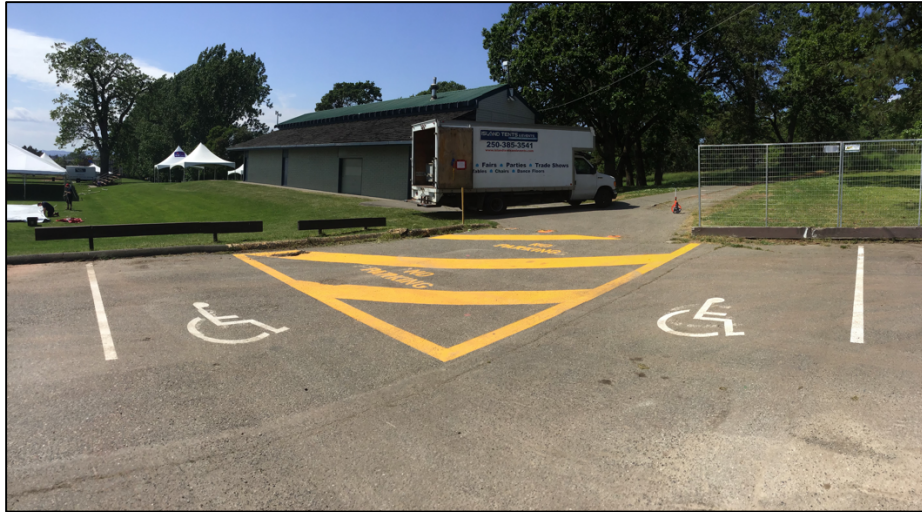
*Figure 5 Accessible spaces with shared access aisle*

- ✓ Provides a generous, shared access aisle that services both accessible spaces,
- ✓ Is in close proximity to the beginning of the path to the washroom facilities, nature trail and the path to the lacrosse box and Finlayson Turf.
- ✓ Presents the user with a manageable slope heading into the park itself.
- ✓ Has a curb cut leading into the park that has approximately 125 cm clear width.

The accessible spaces in the Glasgow parking lot lead directly to the entrance of the park. Initially there is uneven ground with a gentle slope. This then leads to a curb cut into the park that has an abrupt slope 14.2%. This is a tripping hazard to older adults and seniors, and those with vision or mobility limitations. *See figure 5*

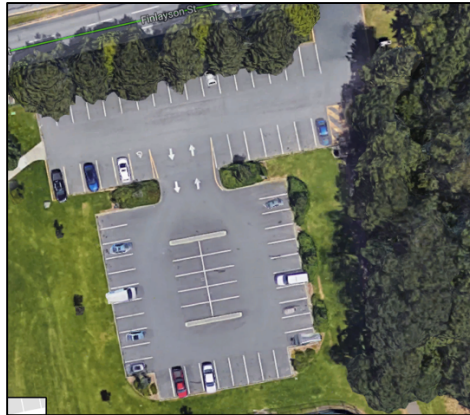
Figure 6 Finlayson Street Parking Lot

Finlayson parking lot provides one accessibly dimensioned space out of a total of 71. It would be recommended that at least two be provided that are close to the park access path. Efforts should be made to ensure the accessible parking spaces are firm, level and slip-resistant. See *figure 7*

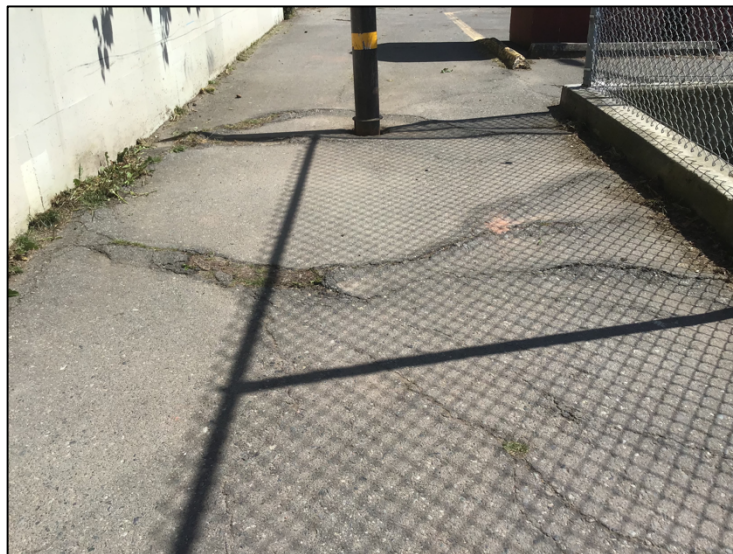
*Figure 8 Cracked and lifting asphalt*

This paved section of pathway is 300 cm wide. This is more than adequate width to allow two larger wheeled mobility devices to pass each other safely. However, the slope just inside the park path is 8.8%. This exceeds the recommended universally designed guidelines. There is a very slight cross slope but it was not a concern. The asphalt at the initial access is cracking and lifting, which is a tripping hazard to those with vision limitations, and the public in general. *See figure 8* The length of this paved section of path that ends at the dugouts of the baseball diamond is 84.66 M. It would be of benefit to add accessible seating halfway along this stretch of path.

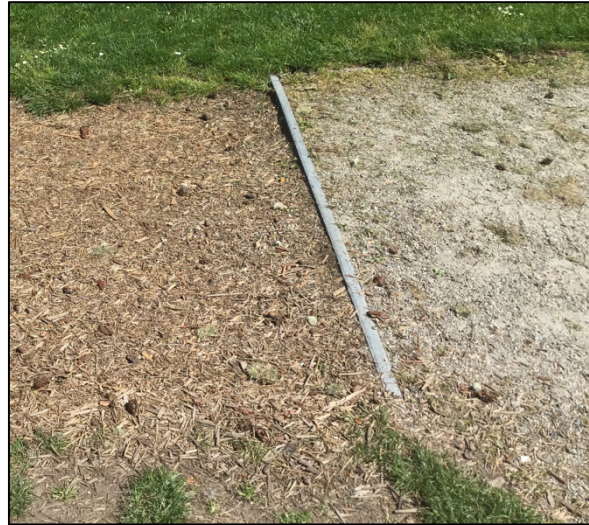
*Figure 9 Path transition tripping hazard*

The Topaz paved access path transitions to gravel by the Topaz baseball diamond. The gravel then transitions into the start of the wood chipped trail that leads to the Outdoor Gym and the Playground. The transition from the gravel section to the wood chipped trail presents a tripping hazard, and steps should be taken to bring both the gravel and wood chips flush with the plastic divider that crosses the clear width. *See figure 9*

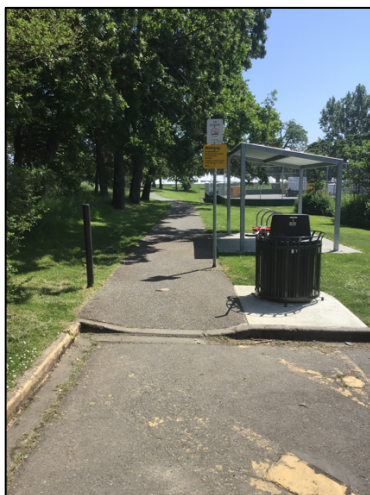
*Figure 10 Excessive lip to curb cut*

The curb cut has approximately 100 cm of clear width and there is a 3 cm high lip. See *figure 10* .

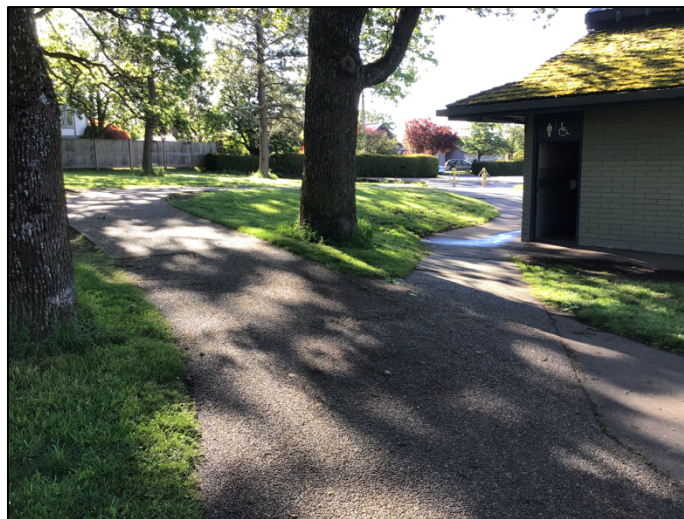
*Figure 11 Slope and cross slope to Glasgow washroom entrance*

Although this main stretch of path is functional, the path approach after the intersection of the aforementioned path leading to the Glasgow washroom facilities is a hazard due to excessive slope and cross-slope. *See figure 11*

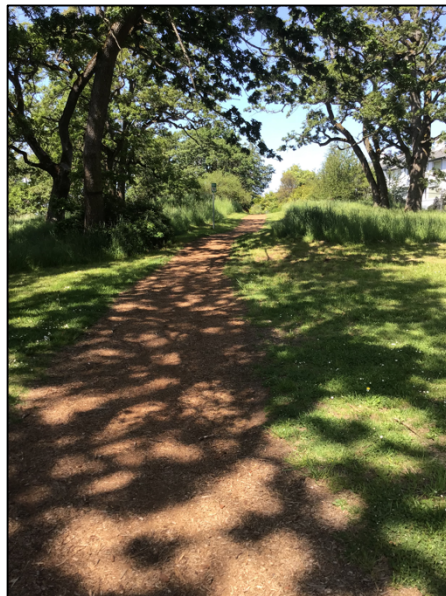
*Figure 12 Nature Trail to North Glasgow Street Access*

The initial slope, (12.3%) to this nature path from the Glasgow washroom facilities to the North Glasgow street access point is beyond what could be considered as useable for those who use wheeled mobility devices, those who struggle with chronic pain, or those with a lack of adequate muscle mass, such as older adults and seniors. *See figure 12*

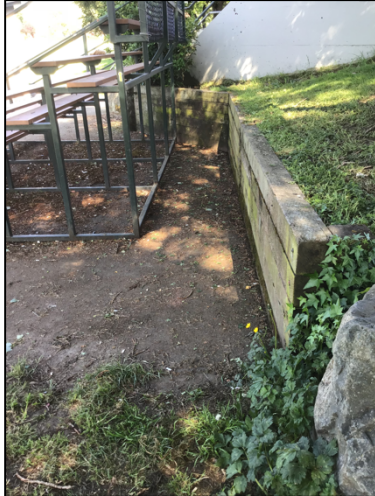
Figure 13 Falling Hazard

The area behind the bleachers nearest the stairs to Blanshard Field when coming from Topaz Field has a retaining wall that is unprotected from having people fall off. The addition of a guardrail would greatly reduce this hazard. *See figure 13*

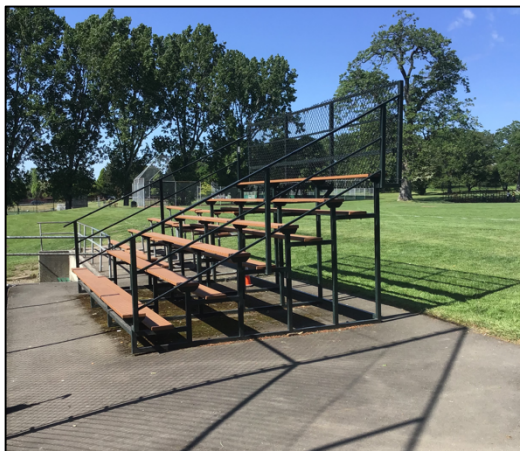
Figure 14 - Pre-existing bleachers

- The addition of non-slip surfaces where the finish displays the potential to be slippery when wet.
- Ensure there is adequate clear space in front of the bleachers to facilitate safe passage of at least one wheeled mobility device. This could include walkers and larger scooters.
- Colour the walking planks a contrasting colour from their mounting frames. A 70% difference in contrast between colours is ideal.
- Ensure that the path of travel between the fence and the first seat of the bleachers has adequate clear width for safe passage.

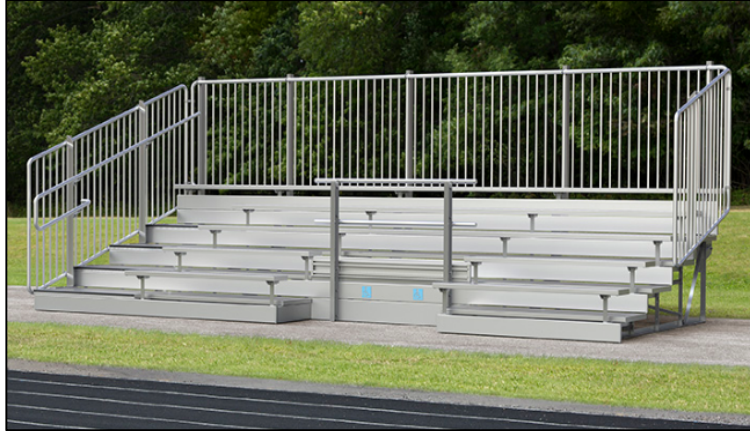
*Figure 15 - Example of Inclusive Bleachers. Image for descriptive purposes only*

*Kick-space is the ability to draw your feet under your shoulders to stand up efficiently. This becomes important Kick-space for the demographic of older adults and seniors in allowing them to stand up with more confidence and stability*

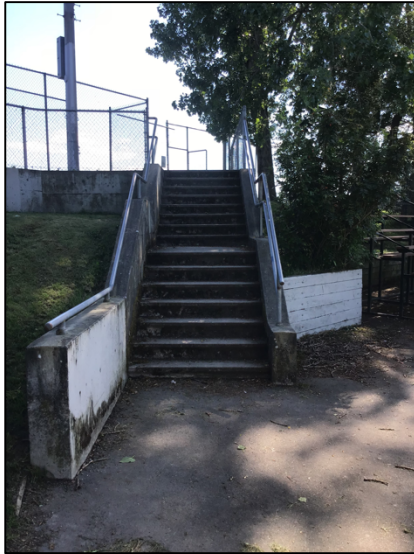
*Figure 16 Stairs to Blanshard Field from Topaz Field*

- ✓ A clear width of is 150 cm. This is sufficient to allow two average sized people to pass each other under reasonable circumstances.
- ✓ Graspable handrails (approximately 45 mm in diameter) that have a top reach of 100 cm.
- ✓ Have a rise 18 cm and a run of 31 cm, which is ideal in terms of the current standard that is expected to be seen.
- ✓ Abrupt undersides that measure approximately 25 mm. However, they are tapered up towards the nosing of the stairs. The tapering of the undersides mitigates the potential risk of a tripping hazard; however, abrupt undersides should be avoided when possible.

- The top of the stairs where the concrete meets the gravel pathway should be flush. This reduces tripping hazards at the tops of the flights. *See figure 16*

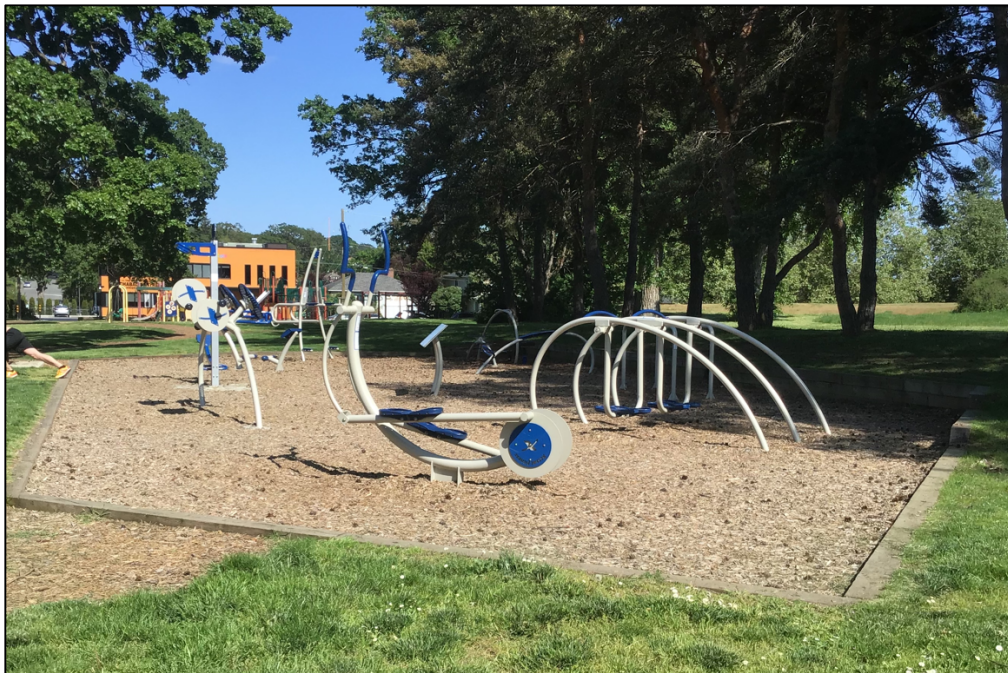
*Figure 17 Outdoor Gym Access*

The Outdoor Gym, however, does not allow for access and enjoyment for those with a variety of abilities, particularly those who use wheeled mobility devices. The bark mulch surface is loose and would be unusable to people who use wheeled mobility devices. *See figure 17*

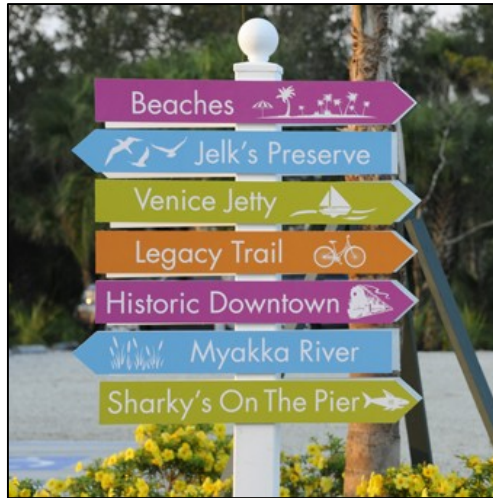
Figure 18 Example of high contrast, colour-coded directional signage

broadest group possible including people with a wide range of sensory abilities, intellectual abilities, literacy levels, languages and physical statures.”

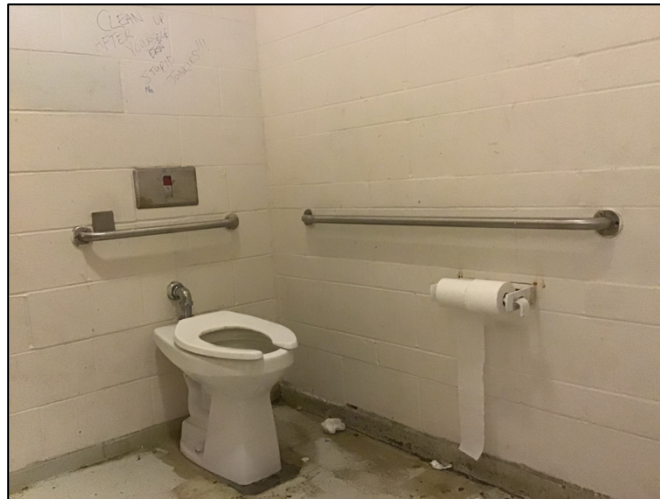
Figure 19 Topaz Women's washroom accessible stall

- Ensure that there is adequate colour contrast between the plate steel stall dividers, the floor and the walls of the washroom. This aids those with partial vision in wayfinding and provides context as to where key areas of the washroom are.
- The opening handle to the accessible stall is an acceptably sized D handle.
- The slide latch inside the stall is large enough to be usable to those with reduced dexterity.

*The location of toilet paper in terms of their distance from the backing wall is important. If it is too far away to access safely for those with limited or no core strength, such as those with quadriplegia, there is a risk of falling. People who do not have adequate core strength are at risk of toppling over if they lean beyond the point of balance.*
