6. Development Variance Permit Application No. 00184 for 1265 Vista Heights (Hillside-Quadra)

**SHORTT RESIDENCE
1265 VISTA HEIGHTS
VICTORIA, B.C.**

**PASSIVE,
NET ZERO HOUSE**

**ISSUED FOR
DEVELOPMENT VARIANCE
PERMIT #00184
AMENDMENT #3
AUG 22, 2017**

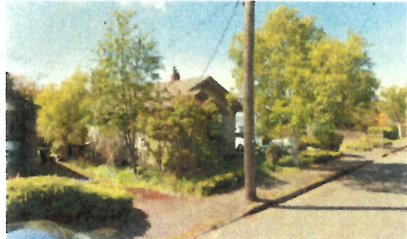
NON CONFORMING FRONT YARD SETBACK
1239 VISTA HEIGHTS 9

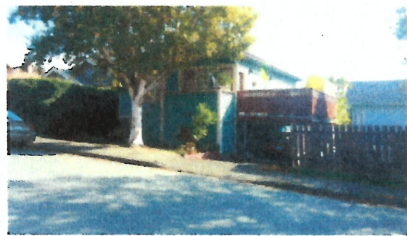
NON CONFORMING FRONT YARD SETBACK
1203 VISTA HEIGHTS 10

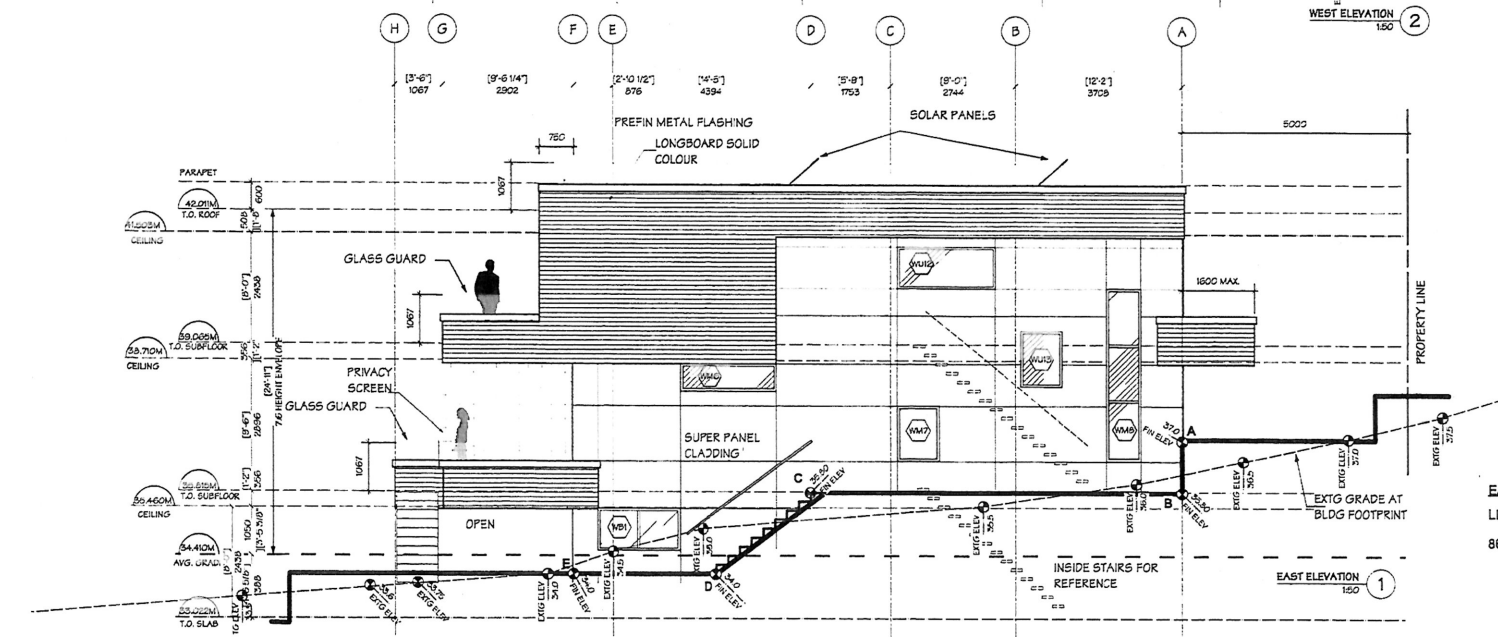
EAST EXPOSED BLDG FACE
 LIMITING DISTANCE 2.438M (8'-0")
 86.0sqm X 11.75% = 10.1 SQM
 PROPOSED 9.78 SQM

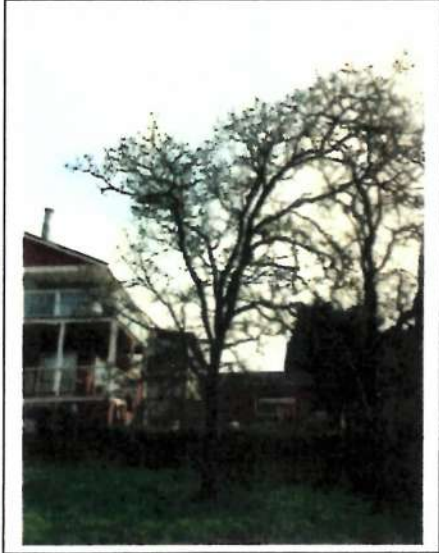
28 cm Garry oak

Summary: The 28 cm d.b.h. Garry oak tree *Quercus garryana* that was examined is a young specimen that is healthy, and, in our opinion, does not currently pose a risk of failure. The one structural defect that was observed can be corrected through judicious pruning over several years to encourage the growth of one dominant stem and to correct the canopy asymmetry. We defined a 4-metre critical rooting area surrounding the trunk on all sides. The options for this site are to either remove the tree to provide the optimum area for urban food production or retain the tree and mitigate the impacts of the site development as much as possible.

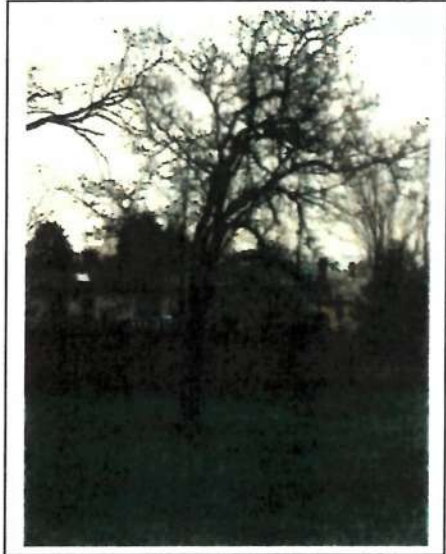
Canopy asymmetry

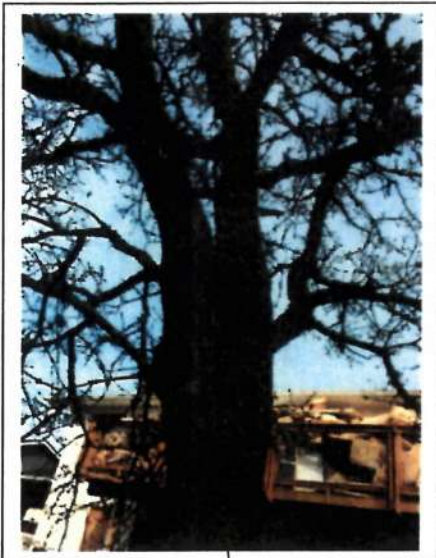
Narrow union between co-dominant stems

The tree has been allowed to develop with co-dominant stems within its canopy. The union between the stems is narrow with some bark included at this stem union. The defect that was observed can be corrected while the tree is still young by pruning cyclically over several years to gradually reduce one of the stems and allowing the remaining stem to become dominant.

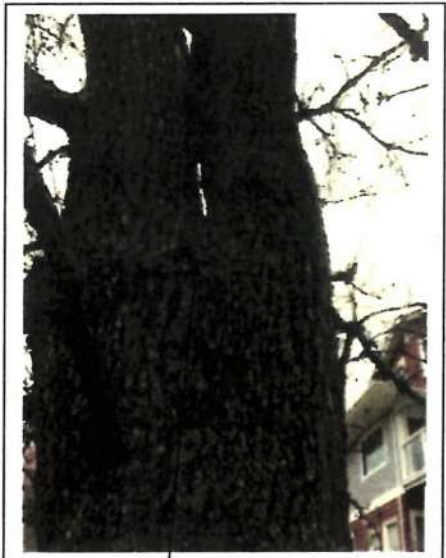
Weakness at stem union

Notes, explanations, descriptions Young tree with an unbalanced canopy and some weakness and bark included at union
Failure potential low within the 5-year inspection time-frame

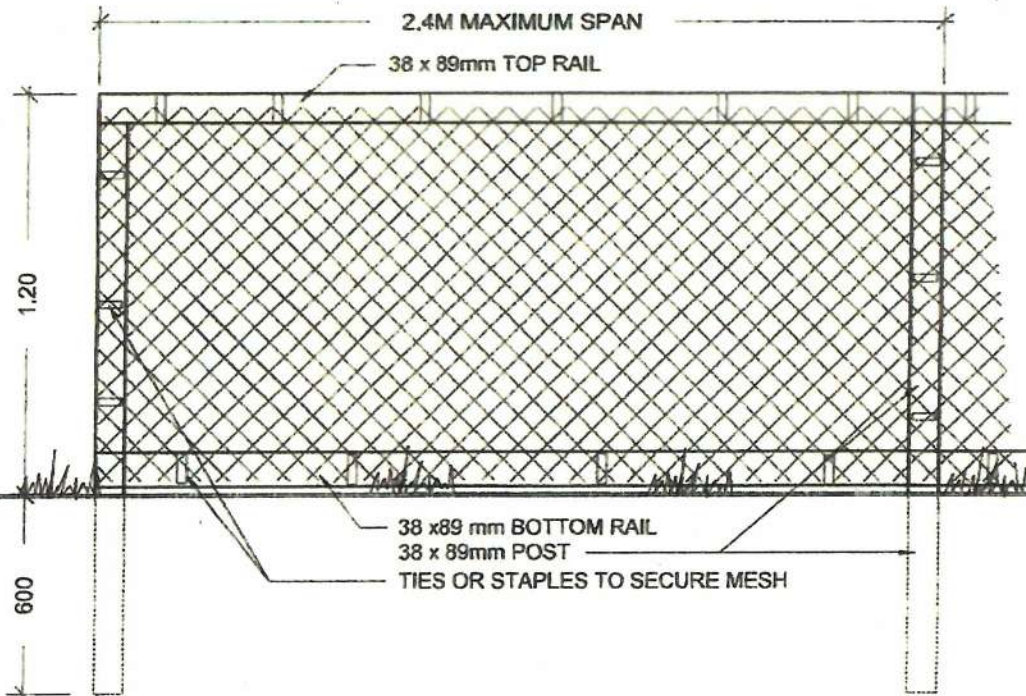
TREE PROTECTION FENCING
 FENCE WILL BE CONSTRUCTED USING
 38 X 89 mm (2"X4") WOOD FRAME:
 TOP, BOTTOM AND POSTS. *
 USE ORANGE SNOW-FENCING MESH AND
 SECURE TO THE WOOD FRAME WITH
 "ZIP" TIES OR GALVANIZED STAPLES

* IN ROCKY AREAS, METAL POSTS (T-BAR
 OR REBAR) DRILLED INTO ROCK WILL BE
 ACCEPTED

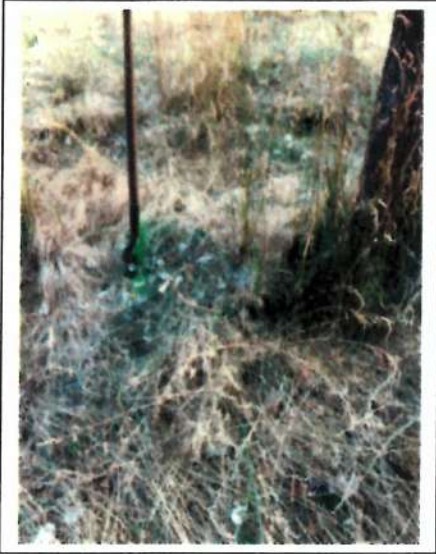
Cistern location - west side

Our excavation found that the oak tree is growing in an area of fill soil. A depth of more than 60 cm of fill material was excavated around the root collar before the root flair at the base of the trunk was exposed. Adventitious roots were found growing directly from the trunk and growing upward into the fill soil surrounding the tree. Our excavation to the depth of the root flair exposed the following root structures that are extending into the service corridor:

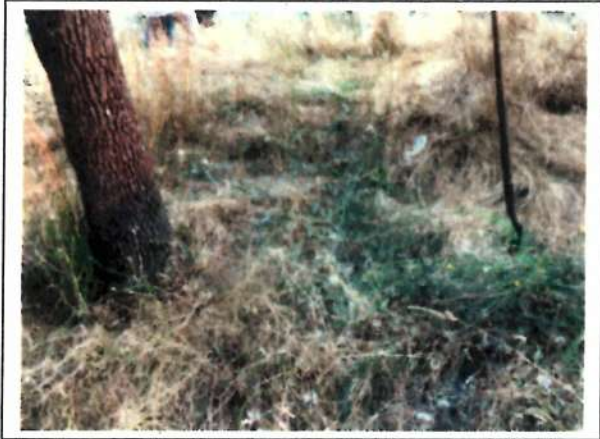
Wall footprint location - east side

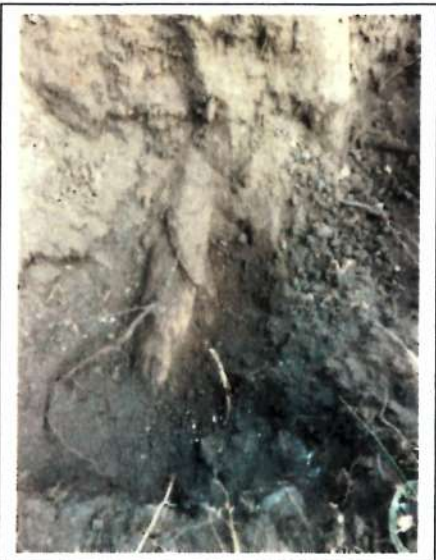
Exposed root - west side

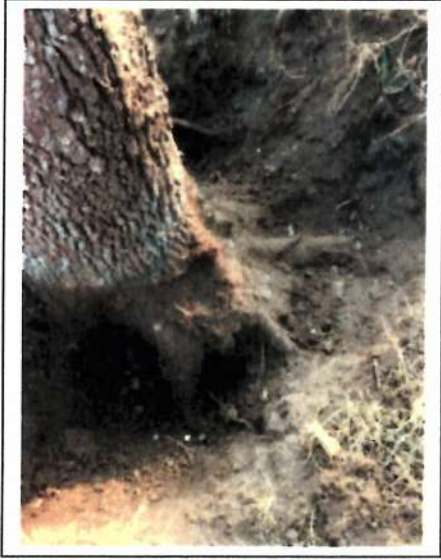
Exposed roots - south and east side
