Home Inspection Report

PROPERTY INSPECTED:
1012 Oliphant Avenue
Victoria, BC V8V 2V1

Date of Inspection: 08/07/2024

Inspection No. 1013-2-3237

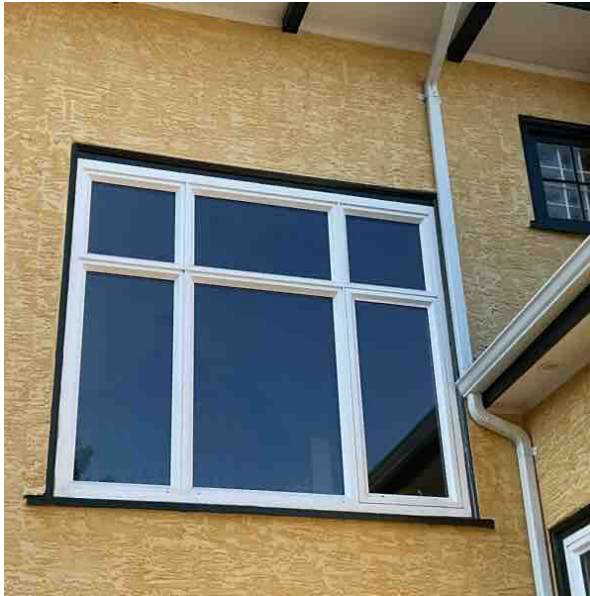
3.7.1 Inspected newer thermal windows in some/all areas, this is a nice upgrade feature.

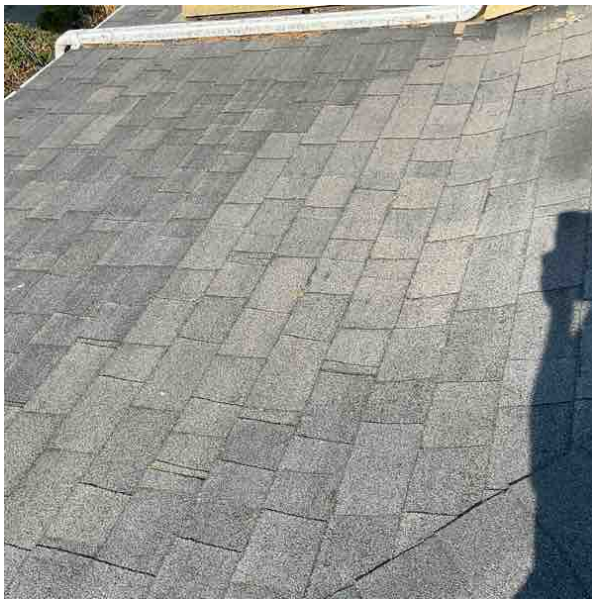
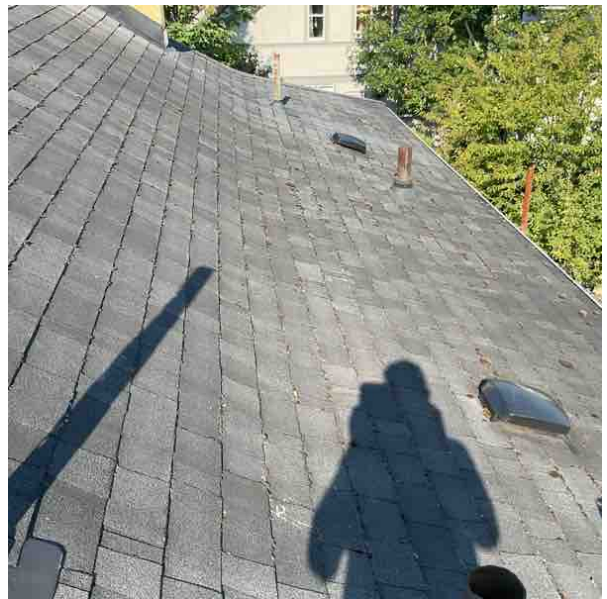
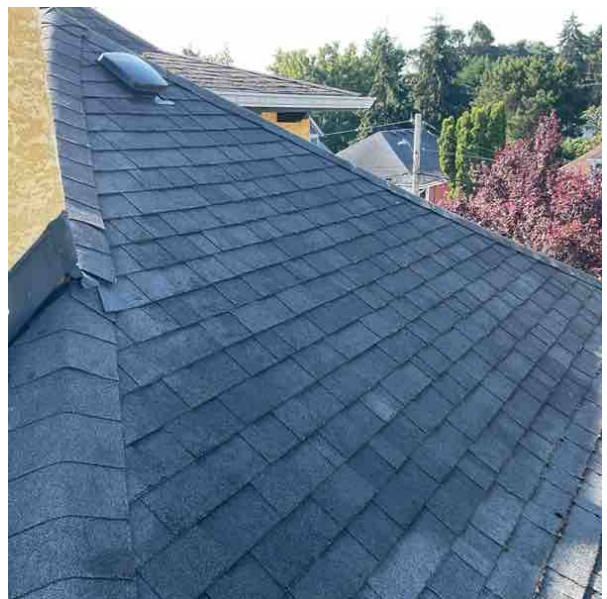
4.3.2 Typical life expectancy of this roofing product is 25-35 years with routine maintenance.

4.3.1 We recommend having the roof serviced and de-mossed to increase longevity.

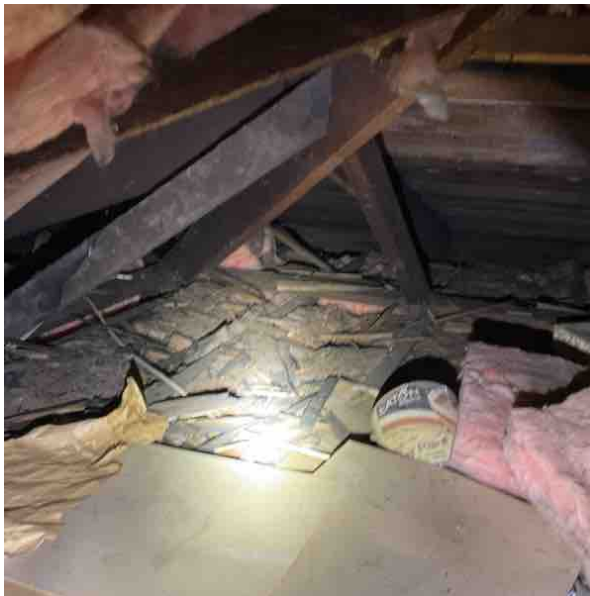
5.4.2 Approximate depth: 1-5"

5.4.1 Home heating costs and interior comfort would benefit from increasing insulation levels to the current standard. Consult an insulation specialist for options and costs.

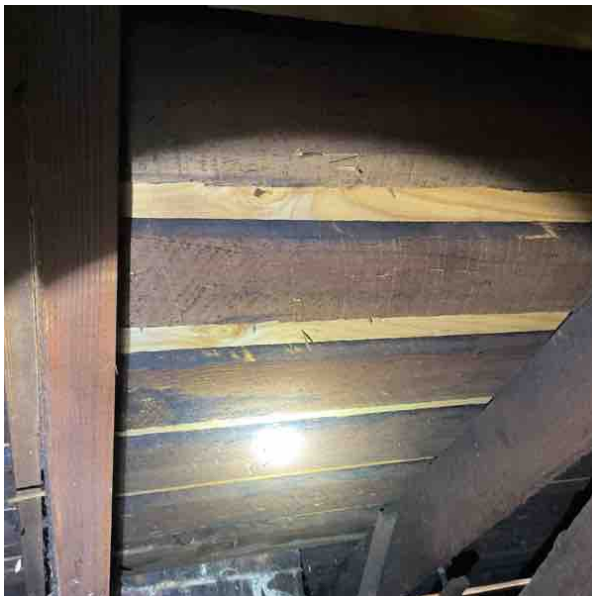
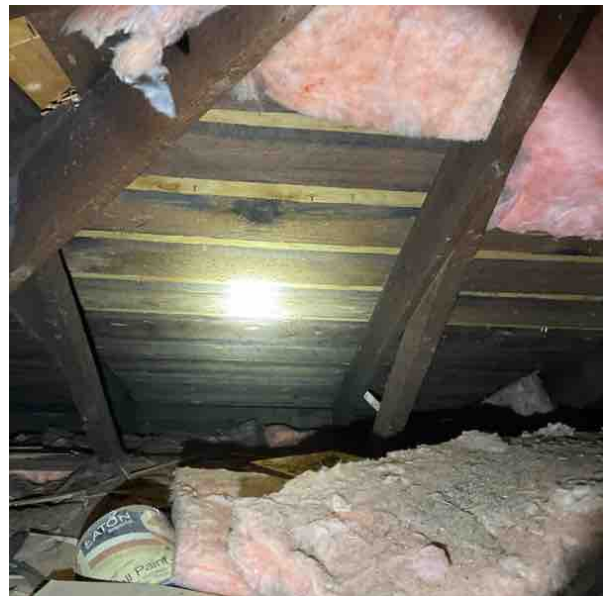
5.8.1 Attic sheathing is in good condition, no visible signs of organic growth. Attics should be checked routinely during winter months for leaks and moisture. This is the best way to spot early maintenance needs.

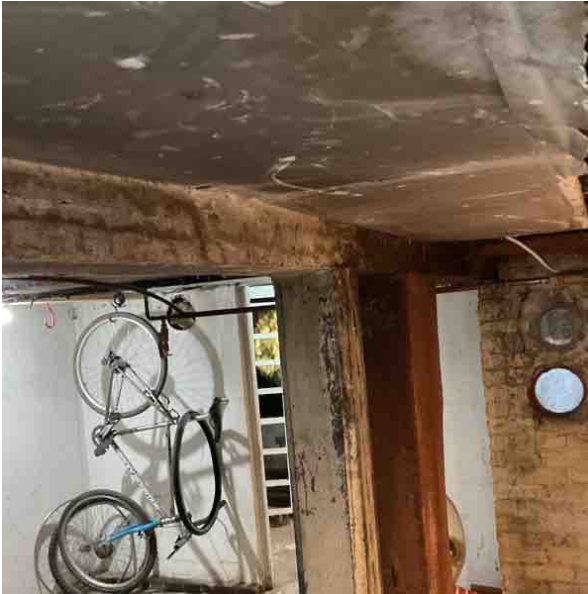
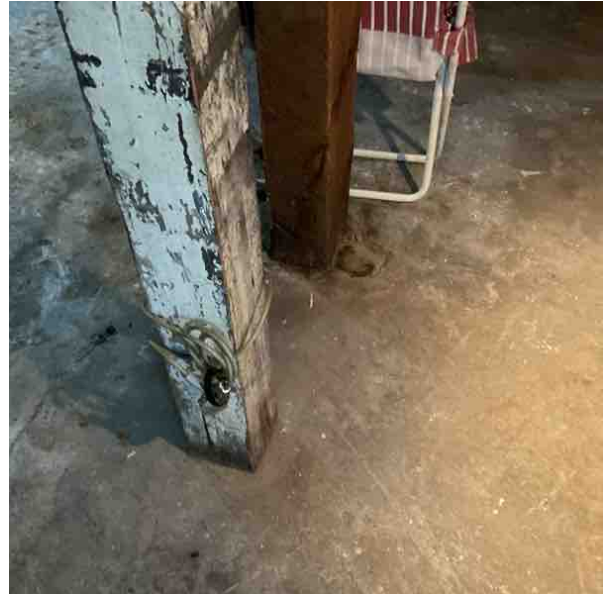
6.4.1 The primary load bearing structure is in good condition. There is no visible evidence of settlement or movement.

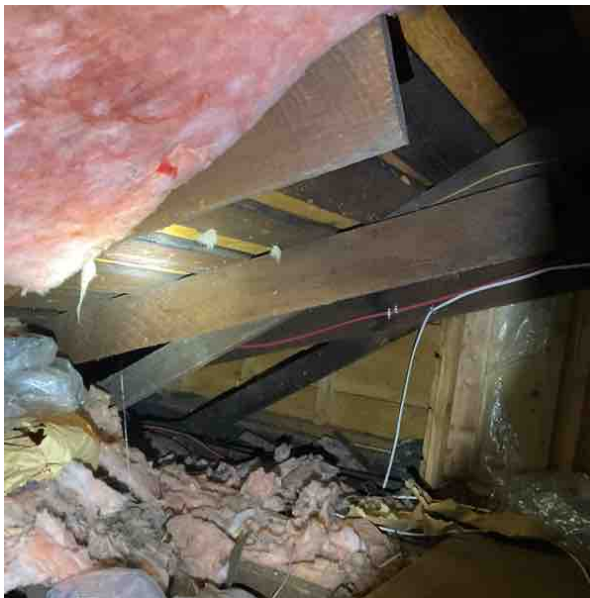
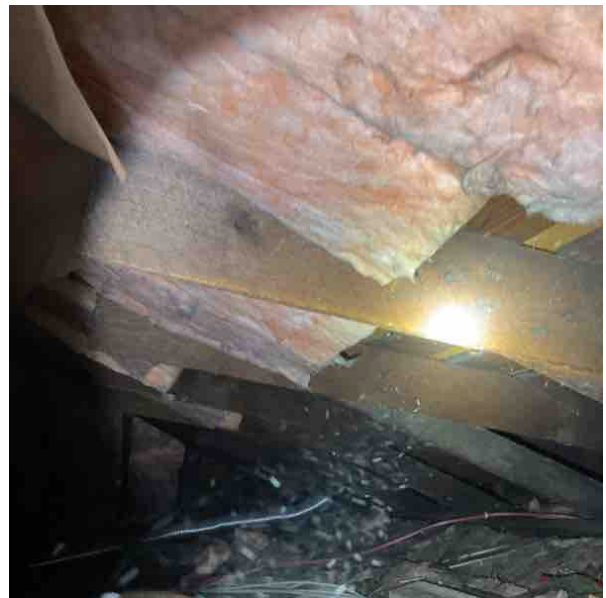
6.7.1 Roof framing appears in good condition, no visible signs of substantial structural movement.

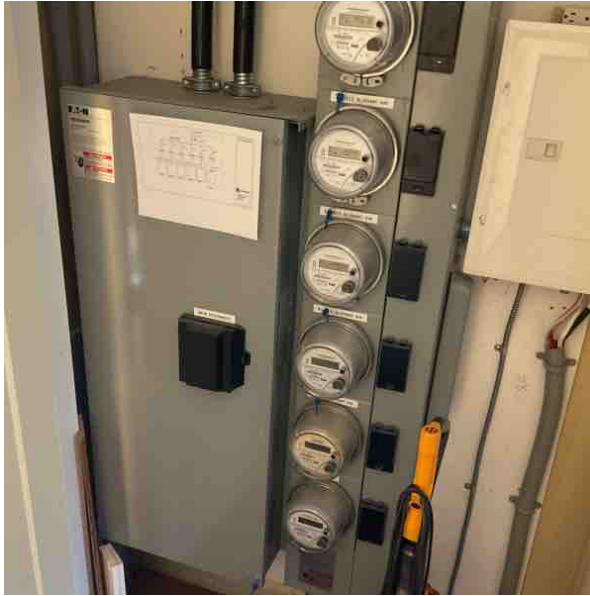
7.2.1 The electrical system appears to be updated since original construction, this is a nice feature. Obtain permits and inspection records from seller.

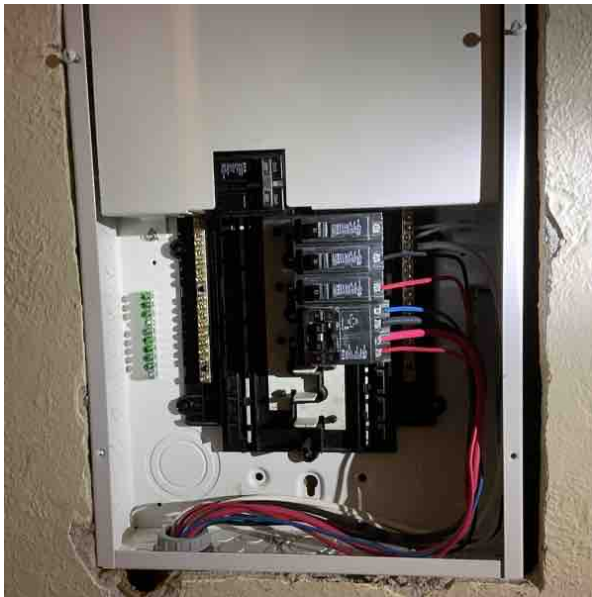
7.6.4 Branch circuits appear compatible with disconnect ratings. **(Unit 2)**

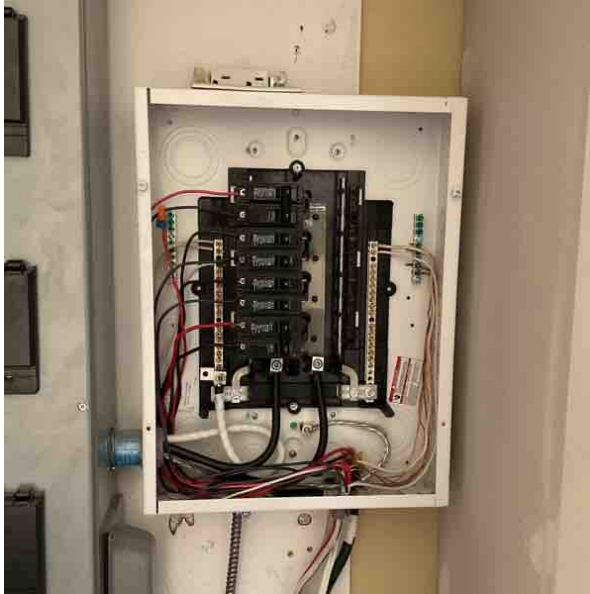
7.7.1 Branch circuits appear compatible with disconnect ratings. **(Foyer)**

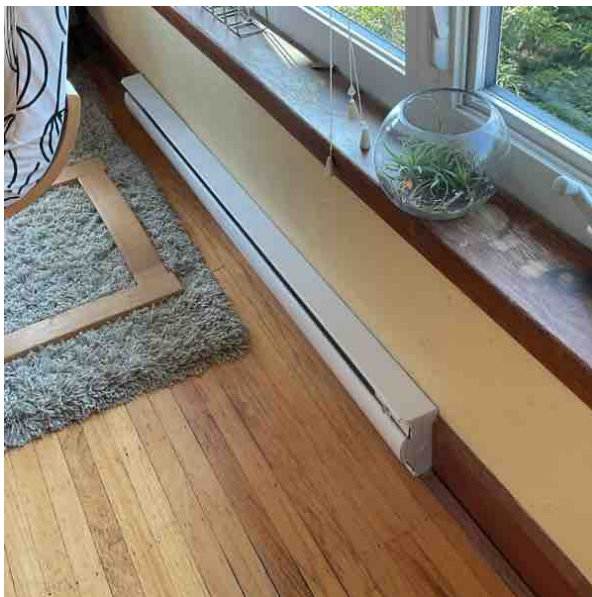
8.2.1 The electric baseboard heaters should be cleaned regularly to ensure safe use and prevent unwanted odors upon activation.

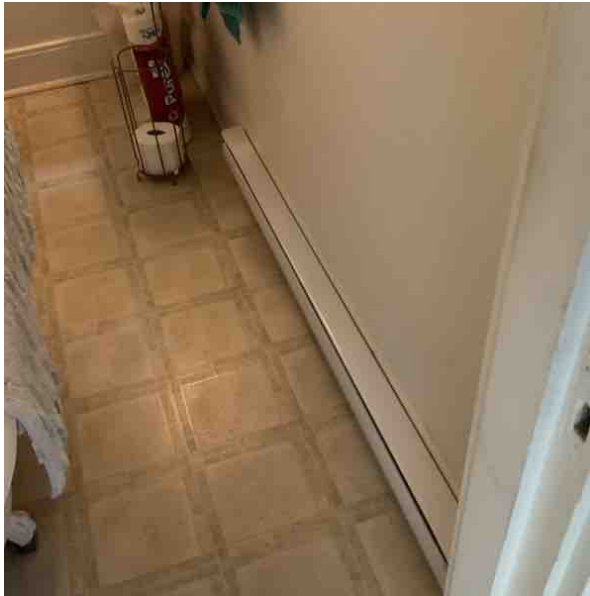
8.2.2 Heater did not respond to normal operating controls and appears to blow the breaker. Conduct further review. (unit 5)

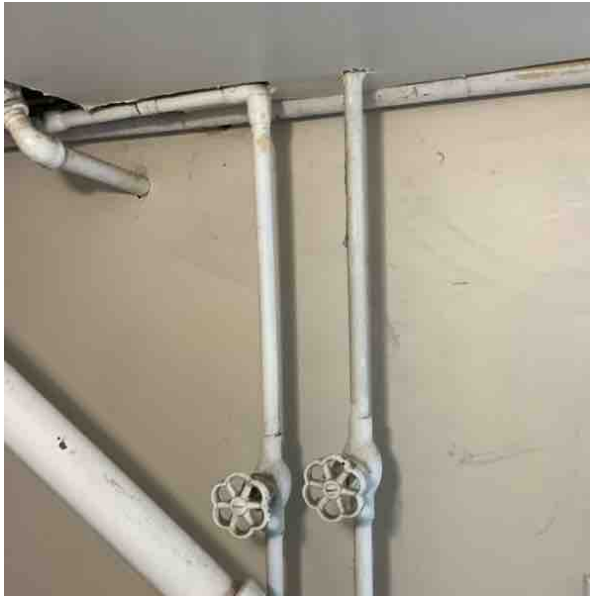
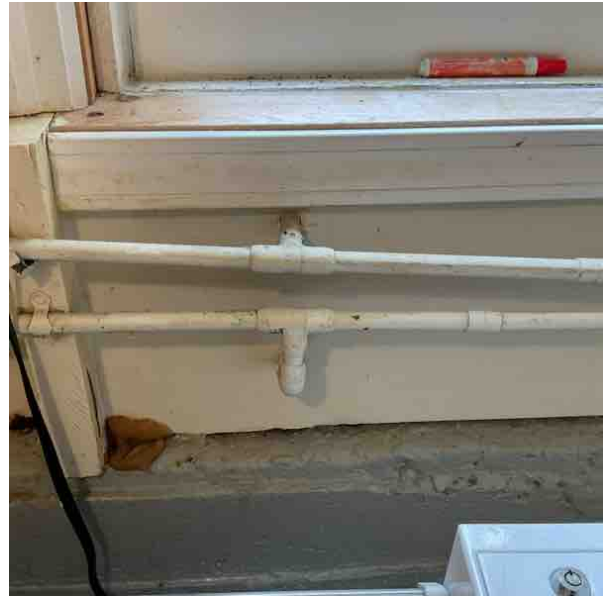
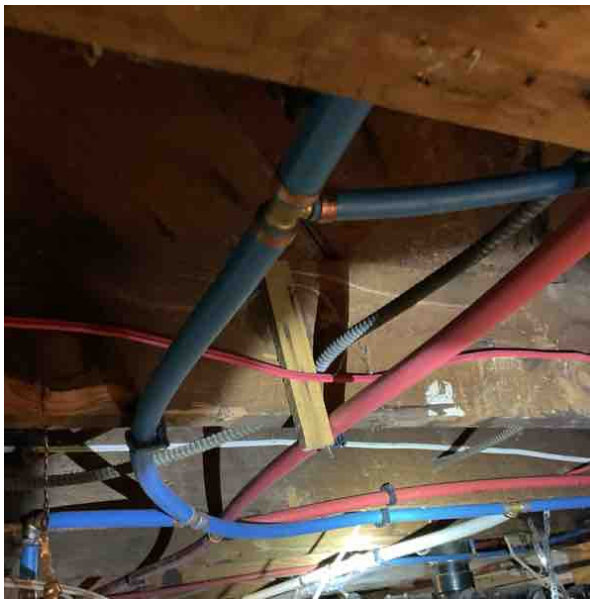
9.3.1 The visible distribution piping is a combination of copper and plastic.

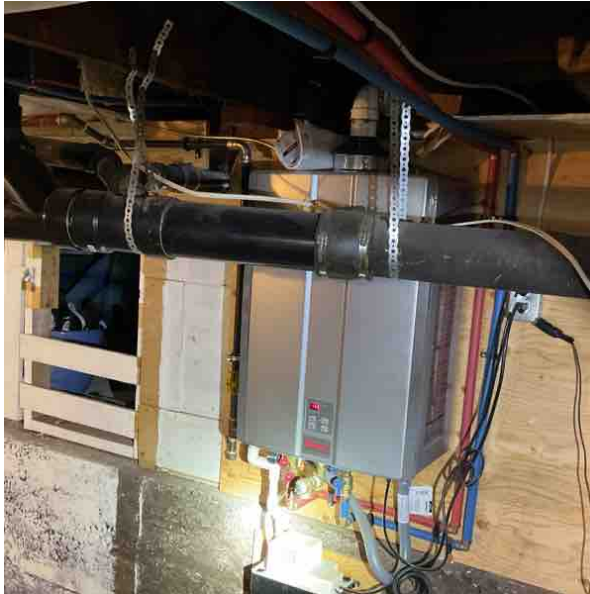
9.5.1 Typical life expectancy of an "On Demand" water heater is 20-25 years depending on frequency of service.

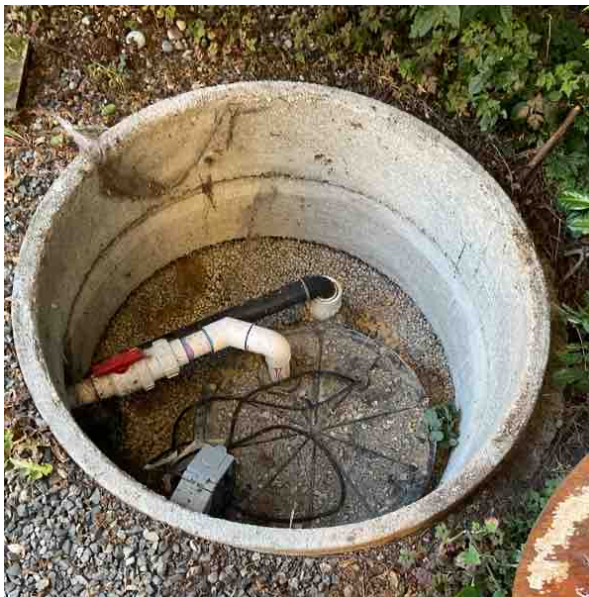
9.10.1 We recommend routine service for trouble free operation. Sewage pumps do not operate during a power outage and consumption of water should be kept to a minimum until power is restored. Installing a battery backup can help reduce the risk during outages. **(Exterior Back)**

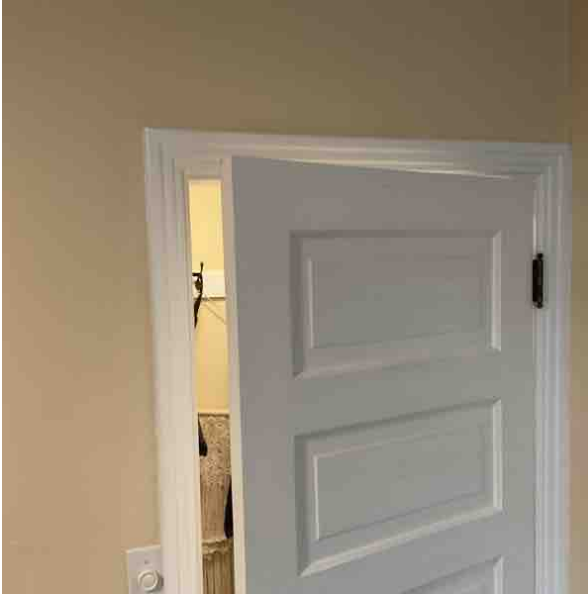
10.6.1 Door rubs or binds in bedroom. Adjust door/hardware to ease fit as desired. **(unit 1)**

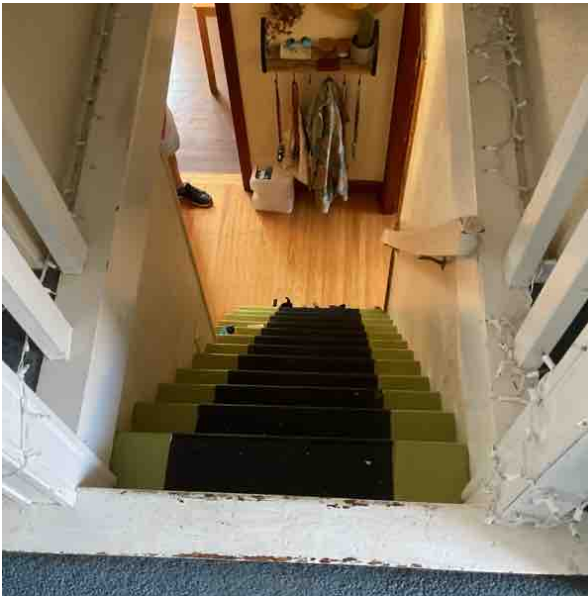
10.8.1 Stair is steep and narrow, this is typical for the age. Low headroom is also common in older homes. Budget for modifications as desired. **(Unit 4)**

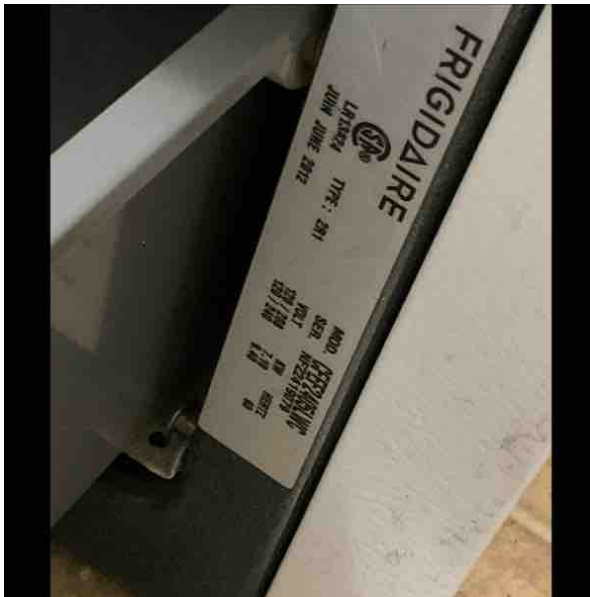
12.3.2 Refer to enclosed photos for appliance model and serial number. **(Unit 3)**

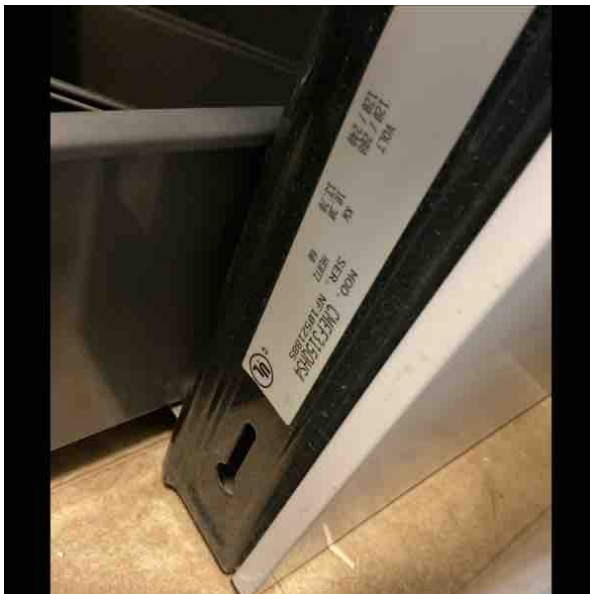
12.3.3 Refer to enclosed photos for appliance model and serial number. **(unit 1)**

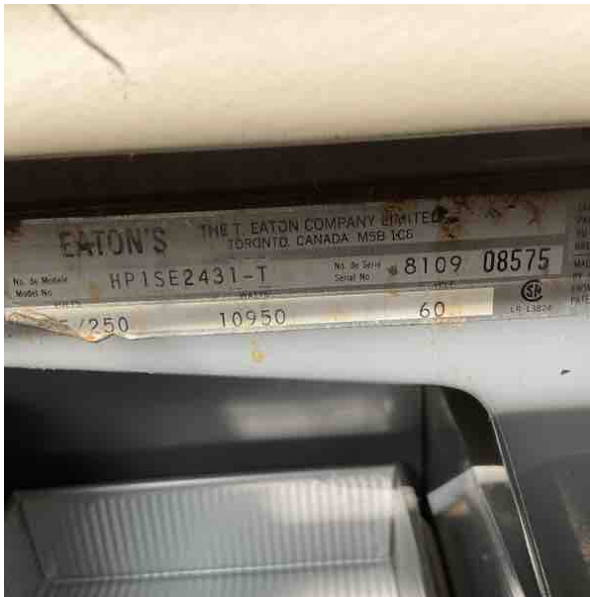
12.3.4 Refer to enclosed photos for appliance model and serial number. **(Unit 2)**

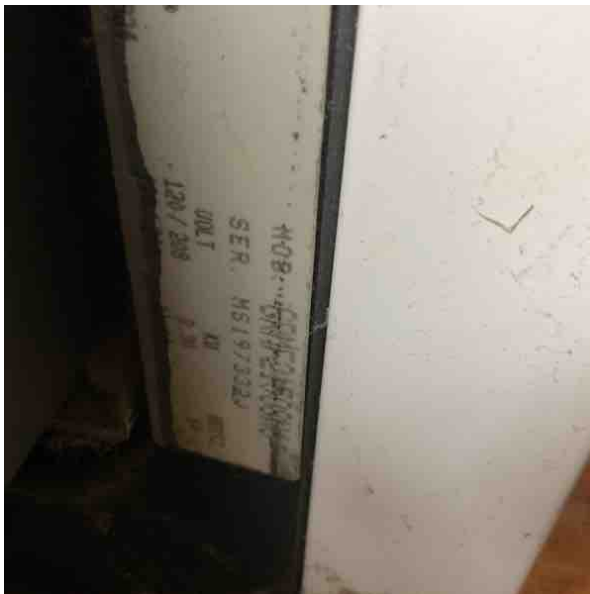
12.3.5 Refer to enclosed photos for appliance model and serial number. **(unit 5)**
